100 Cathedral Square – Christchurch Cathedral

CHRISTCHURCH CATHEDRAL STRENGTHENING

106324 Damage
Report.pdf

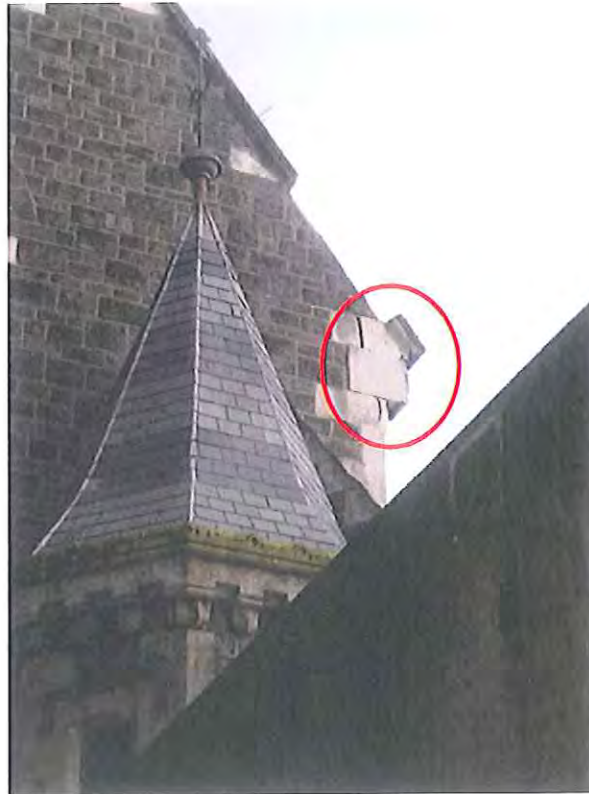
Figure 1 Falling hazard above Clergy Vestry

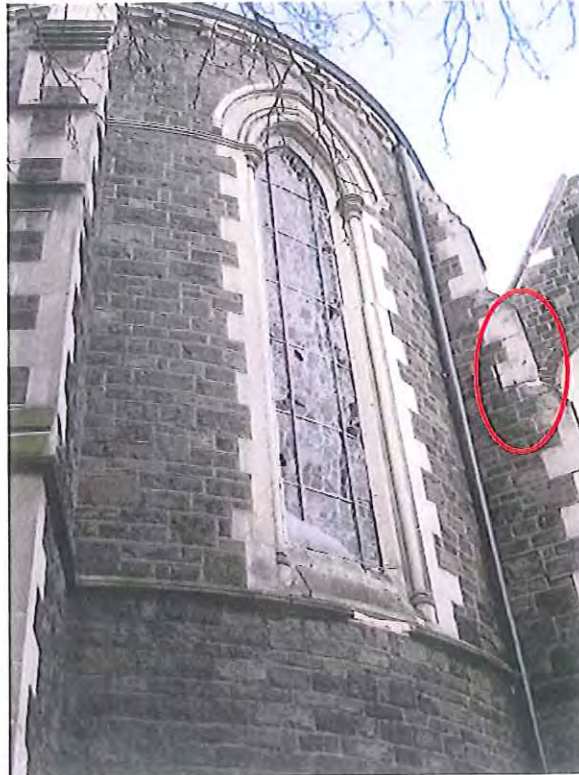
Figure 2 Re-check falling hazard above Clergy Vestry

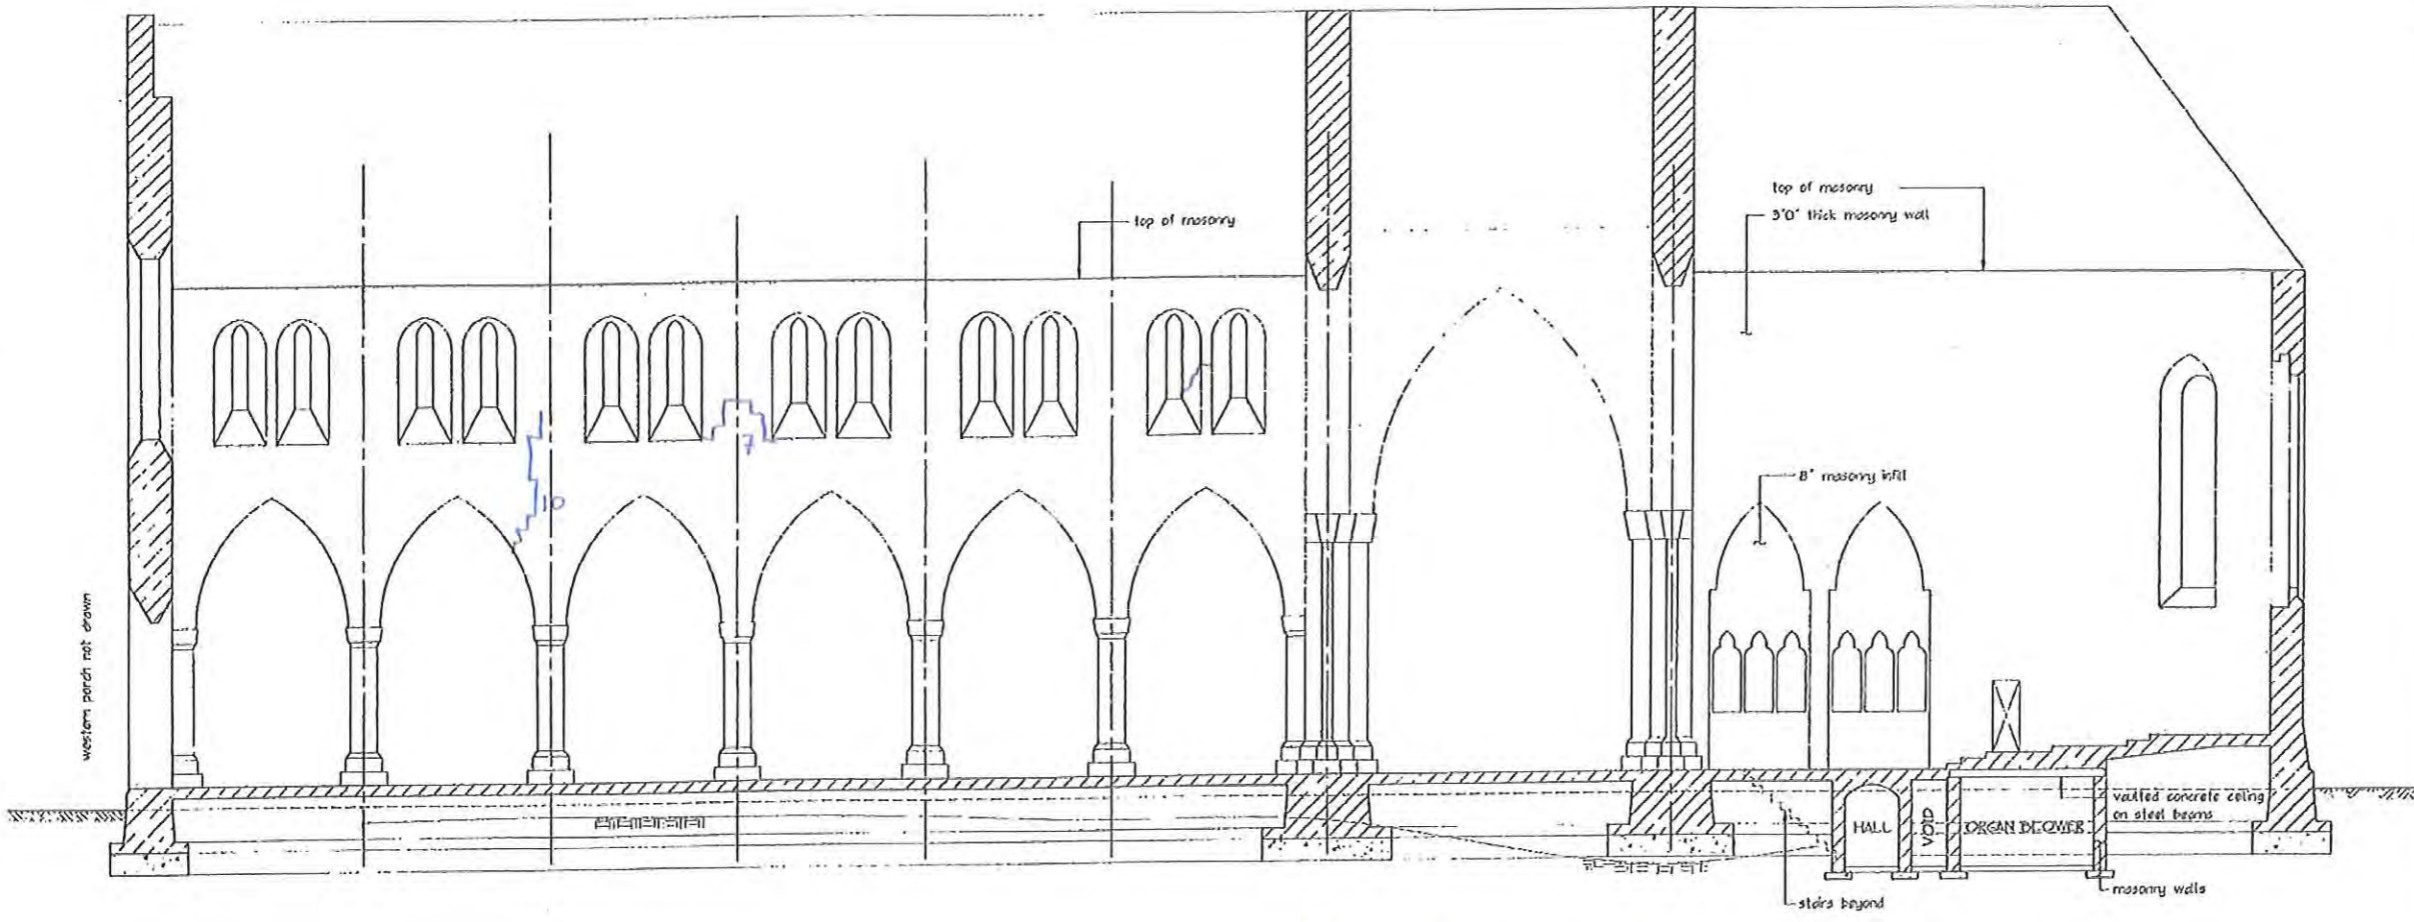
longitudinal section nave (3) (NORTH WALL) S1-1

NOTE: NO DAMAGE OBSERVED IN SOUTH WALL

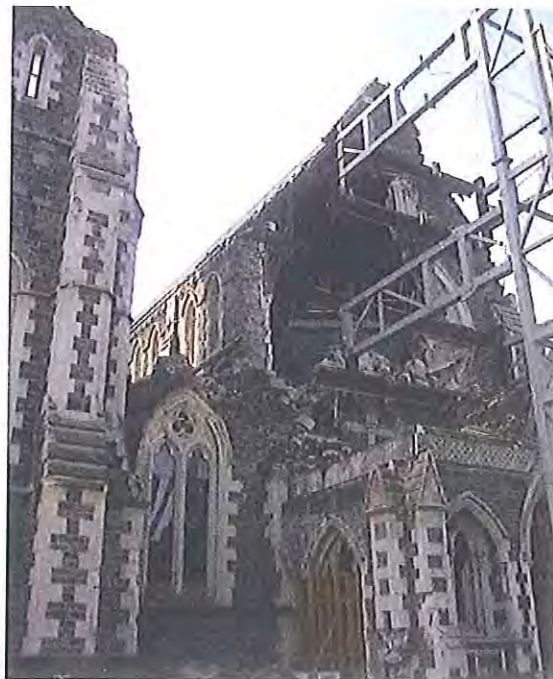
Figure 1 Christchurch Cathedral following June 13th aftershock

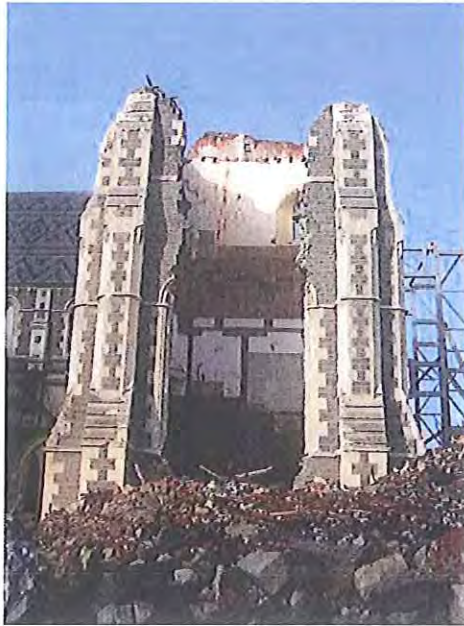
Figure 1 Damage observed to the Tower

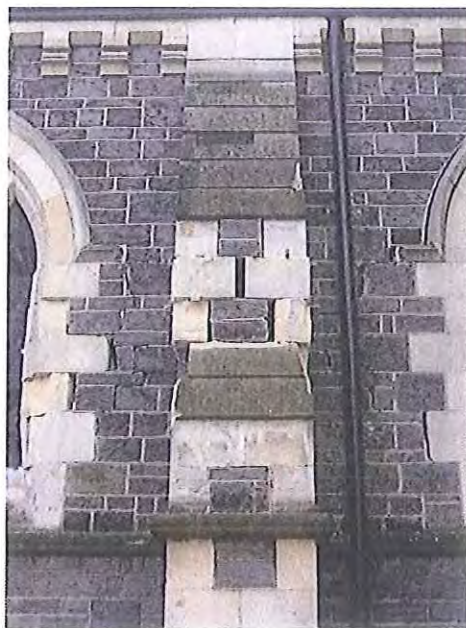
Figure 2 Typical damage pier observed to the south wall.

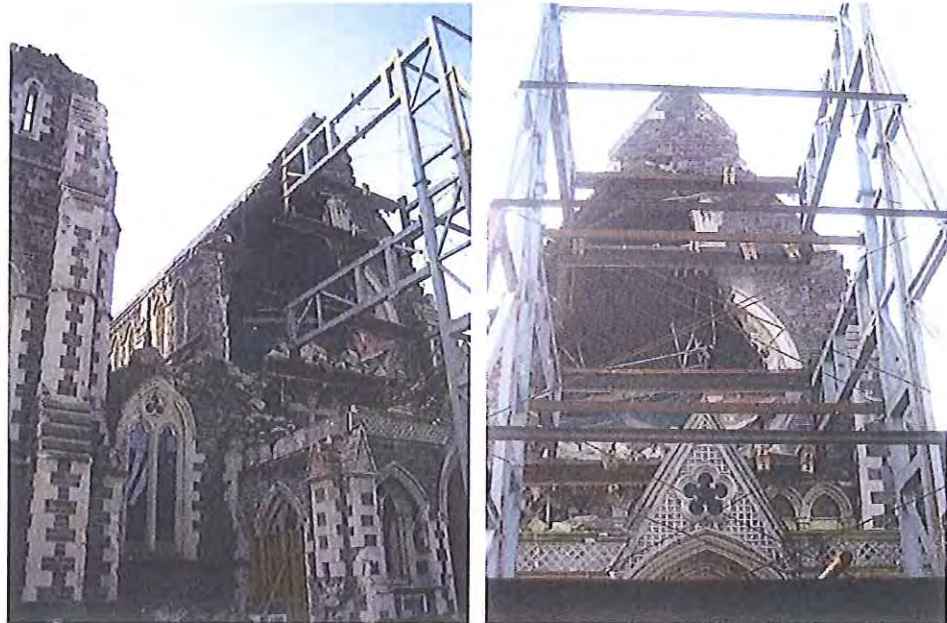
The west wall has sustained significant additional damage. With reference to Figure 1 a significant portion of the west wall, including most of the the Rose Window, has collapsed with much of the debris landing on the roof of the west porch below. The remaining portions of the west wall are badly distorted and severely compromised. Additional spalling and glass damage has also occurred to the Hawdon Window presumably from falling west wall debris (refer Figure 2).

Figure 1 Damage Observed to the West Wall

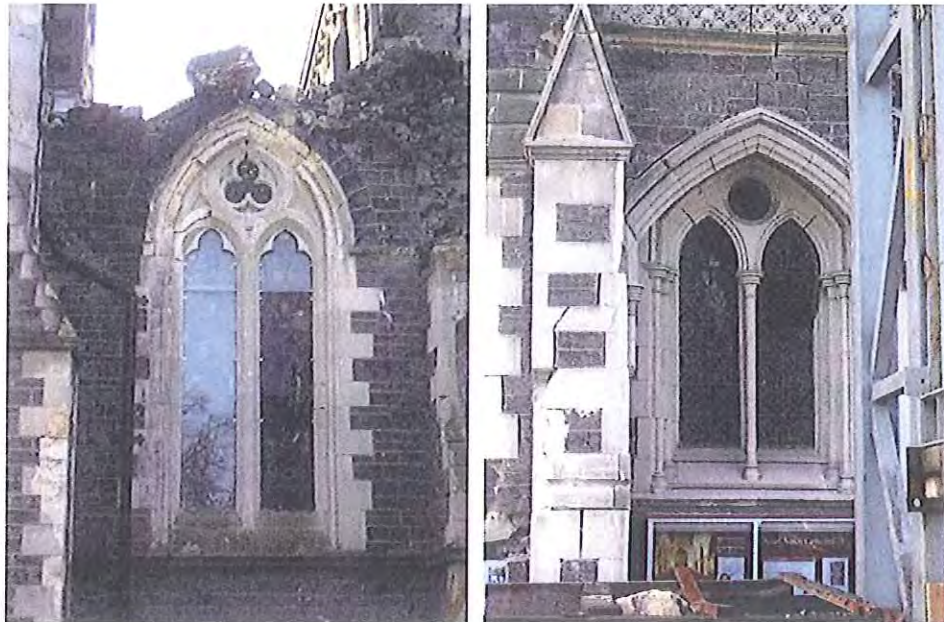
Figure 2 Damage Observed to the Hawdon (left) and West Porch Window (right)

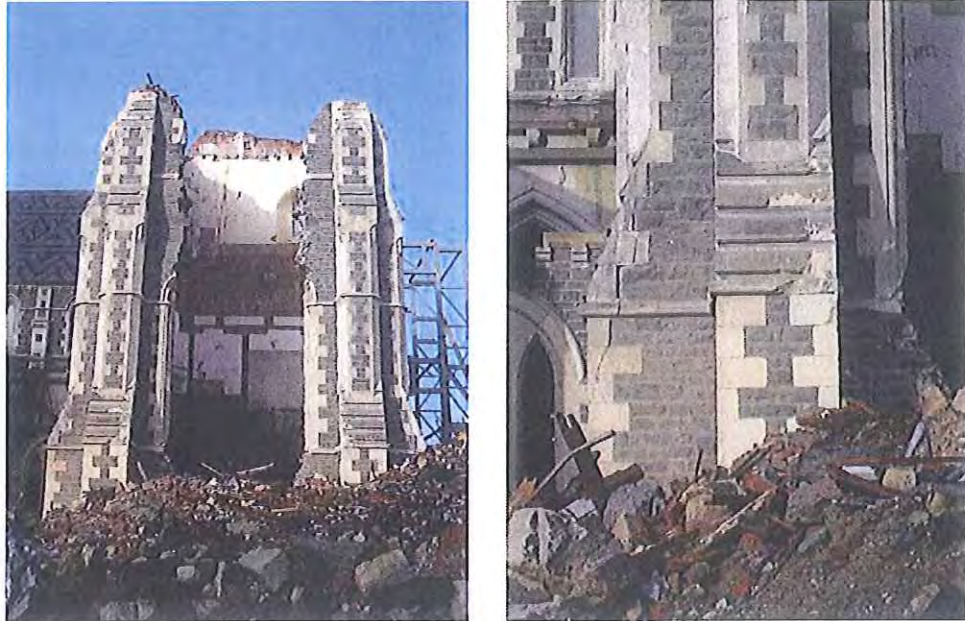
A closer inspection using a man cage will be required to confirm this assessment.

Figure 3 Damage Observed to the Cathedral Tower

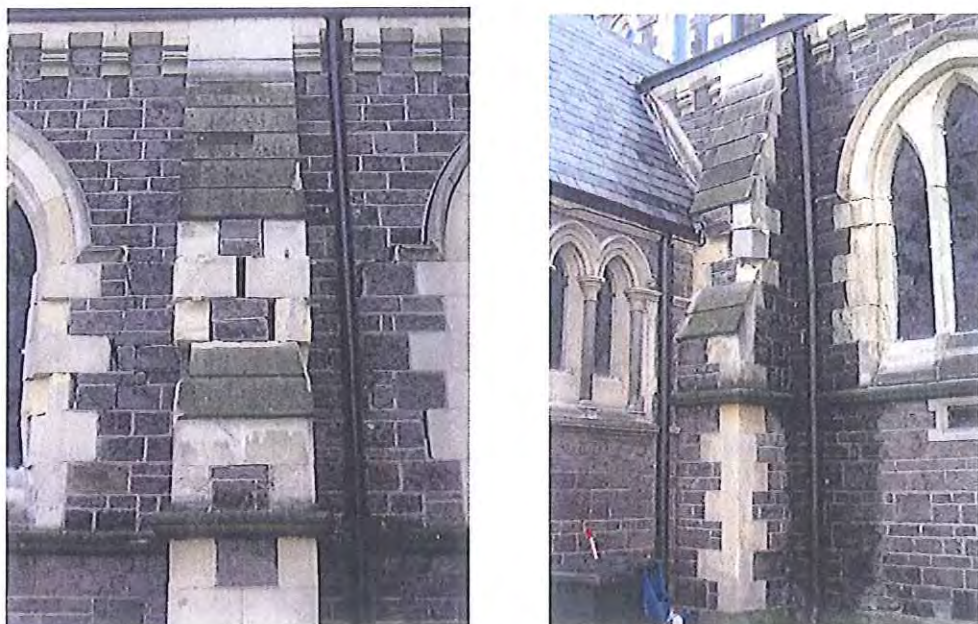
Figure 4 Damage Observed to the South Wall

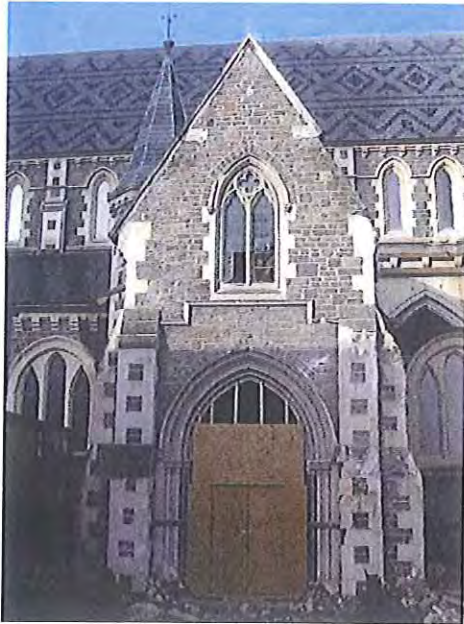
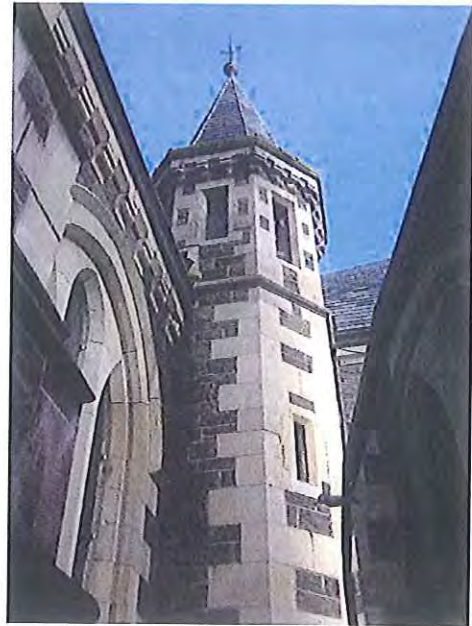
Figure 5 Damage Observed to the North Porch & North Turret

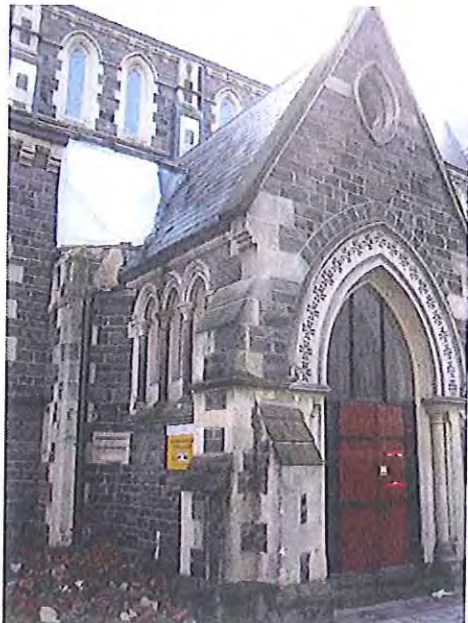
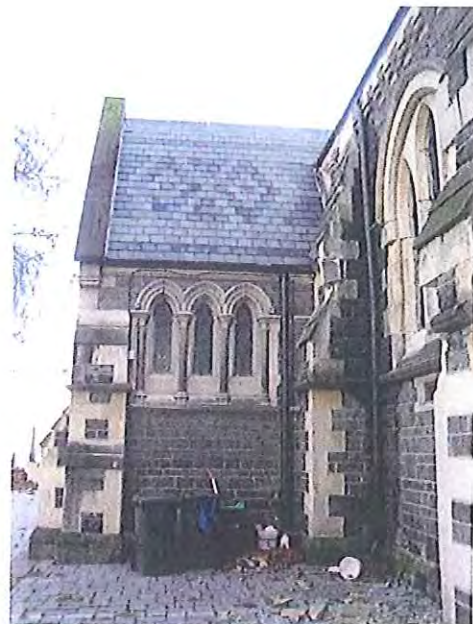
Figure 6 Damage Observed to the South Porch

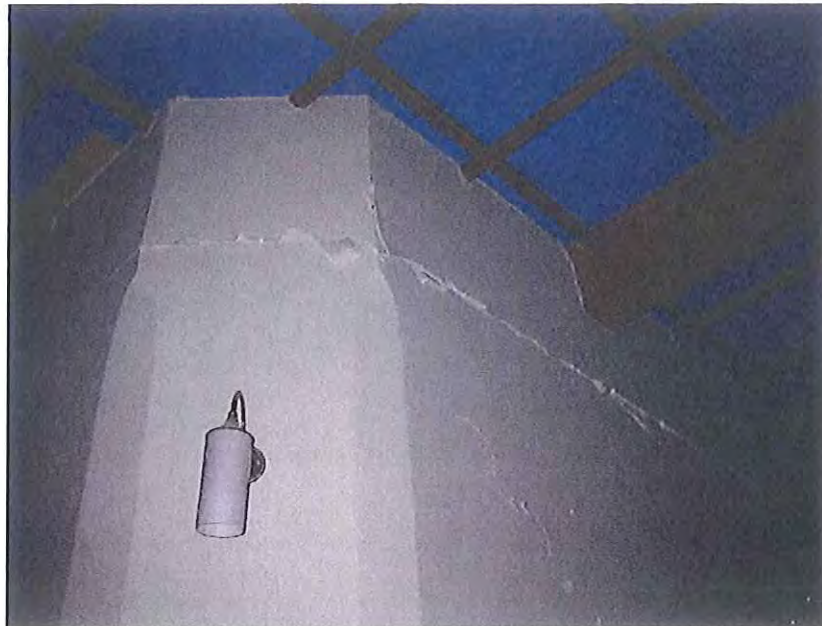
Figure 7 Damage Observed to the Clergy Vestry Stone Pier

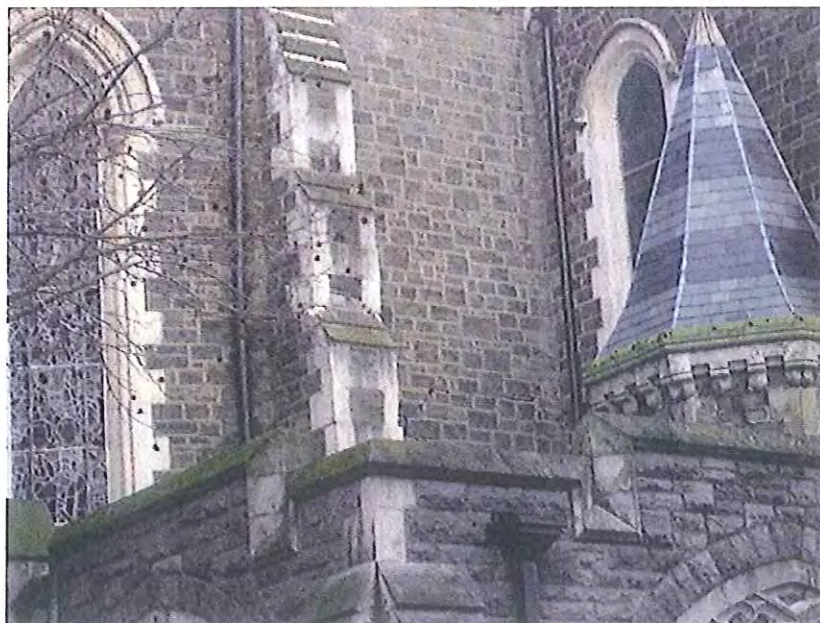
Figure 8 Damage Observed to the Apse North Wall

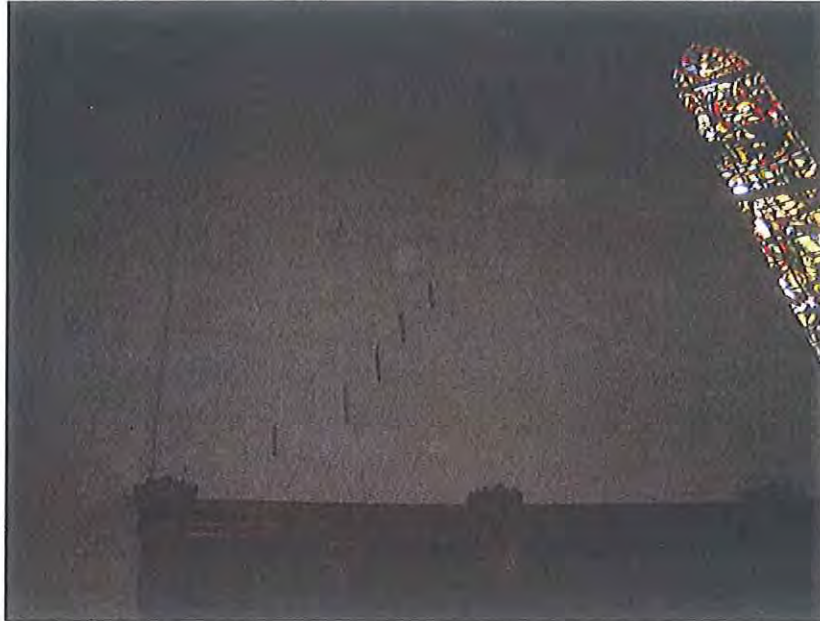
Figure 9 Interior View of Damage Observed to the Apse North Wall

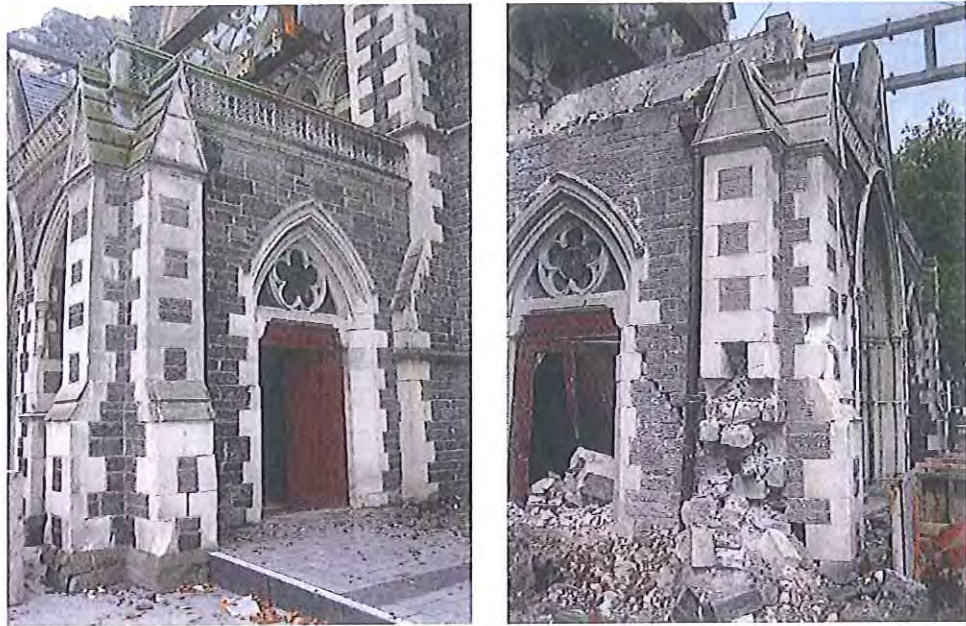
Figure 1 Damage Observed to the West Porch

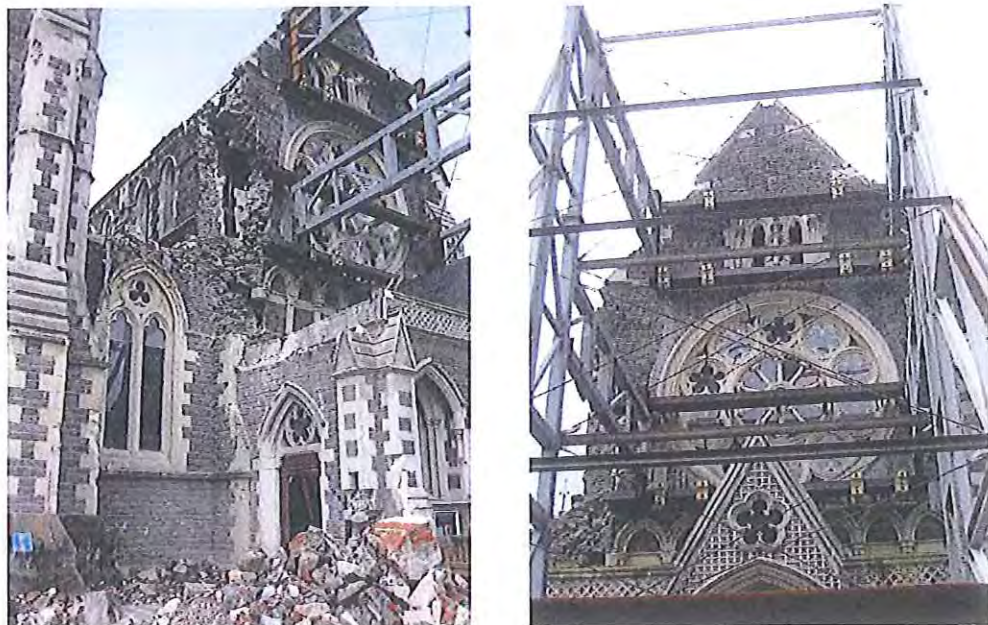
The west wall has sustained severe damage. With reference to Figure 2, the north buttress and part of the adjoining section of nave wall has collapsed. The south buttress has become separated from the west and south nave walls. A number of the capping stones have buckled but remain in place. The wall itself is significantly distorted.

Figure 2 Damage Observed to the West Wall

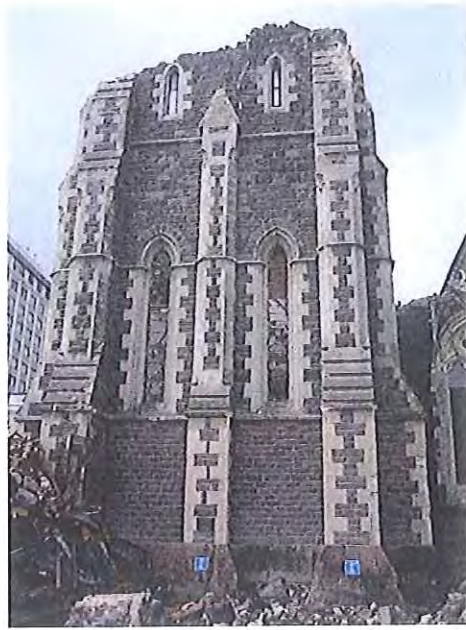
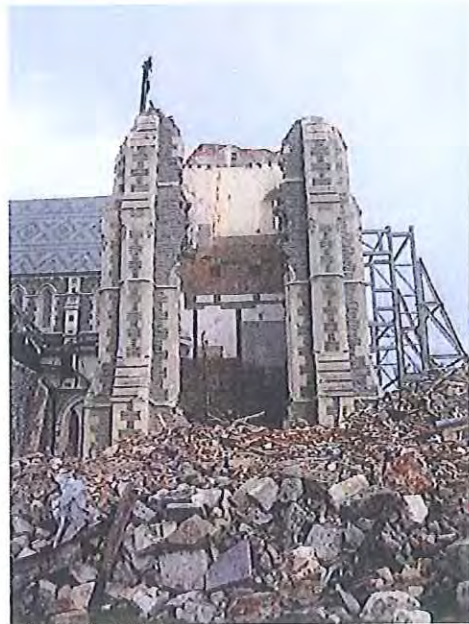
Figure 3 Damage Observed to the Cathedral Tower

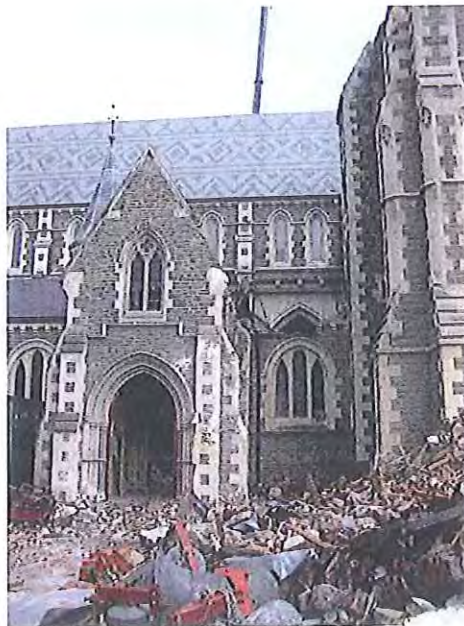
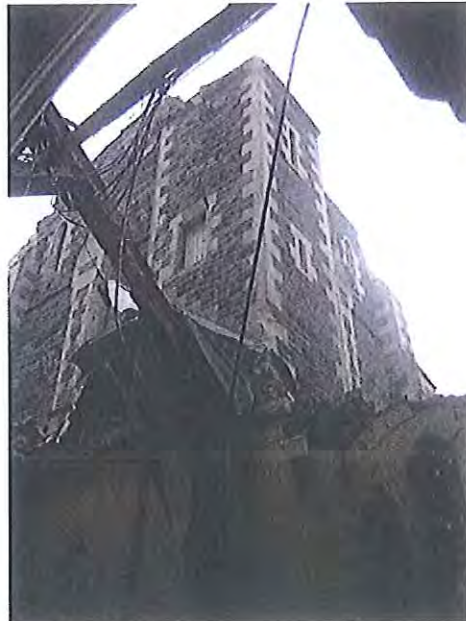
Figure 4 Damage Observed to the North Isle

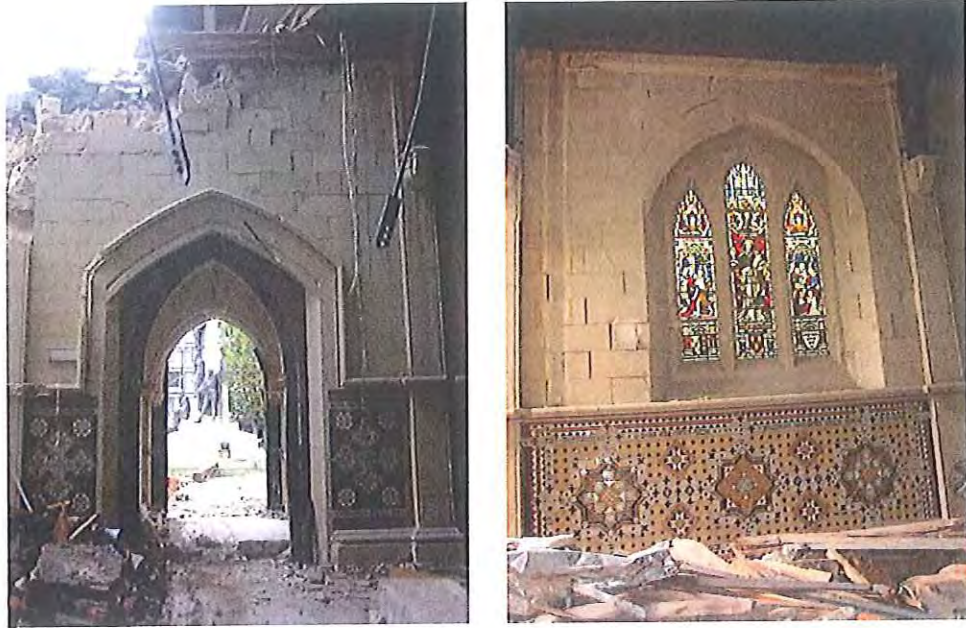
Figure 5 Damage Observed to the North Wall

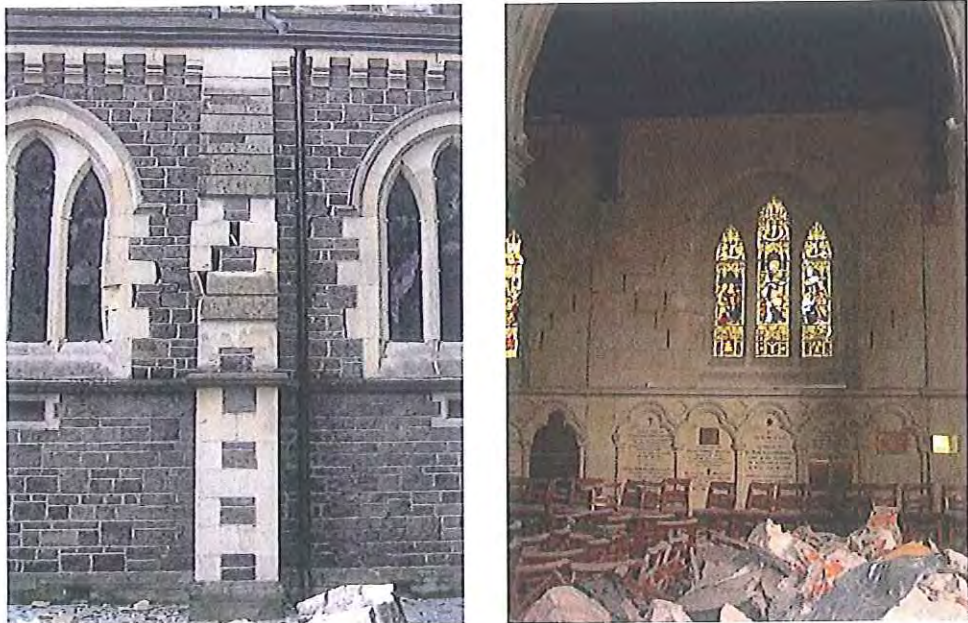
South wall piers and buttresses have sustained damaged similar to that observed in the north wall. With reference to Figure 6 in this instance the cracks are significantly wider (i.e. approx 10 – 30 mm wide). Some glass damage has also occurred as a result of the structural deformations.

Figure 6 Damage Observed to the South Wall

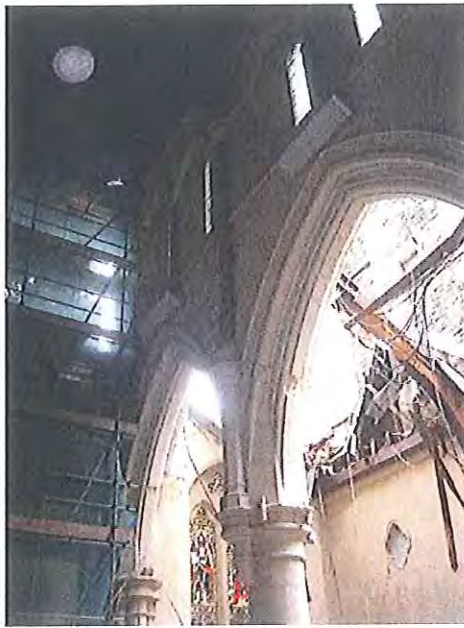
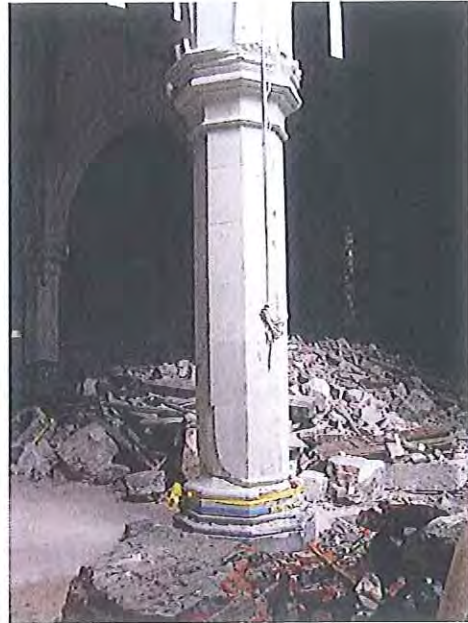
Figure 7 Damage Observed to the Nave

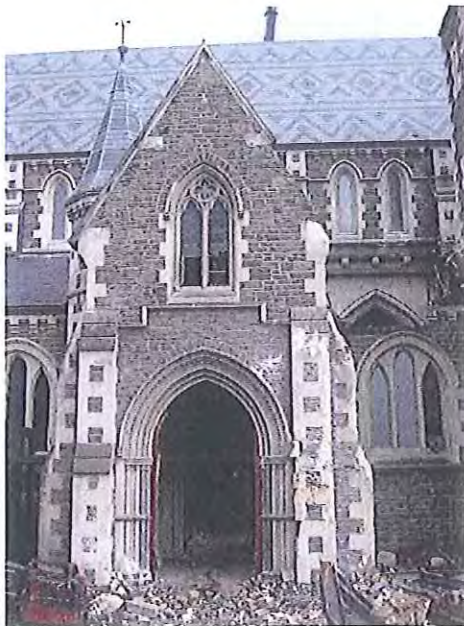
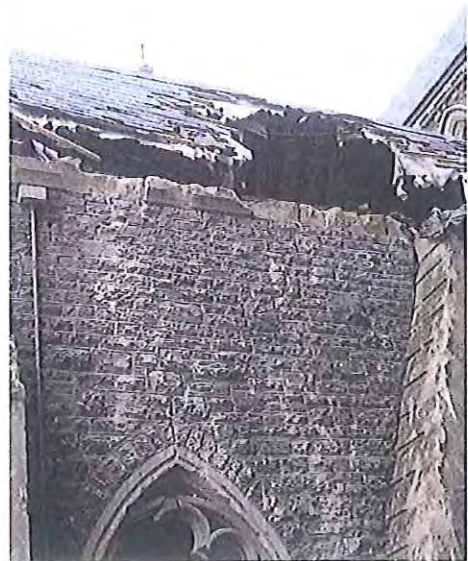
Figure 8 Damage Observed to the North Porch

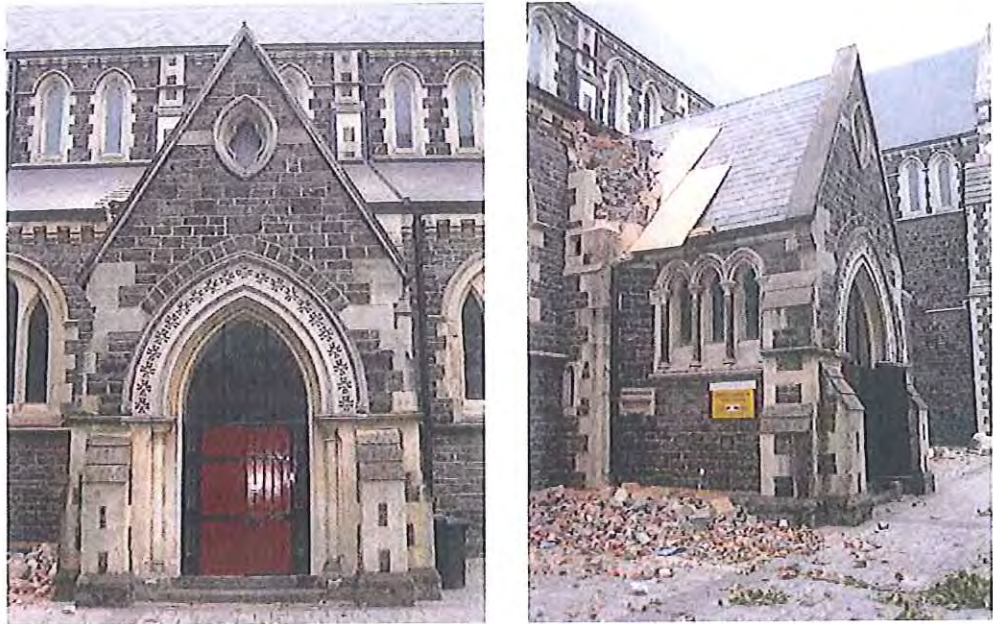
Figure 9 Damage Observed to the South Porch

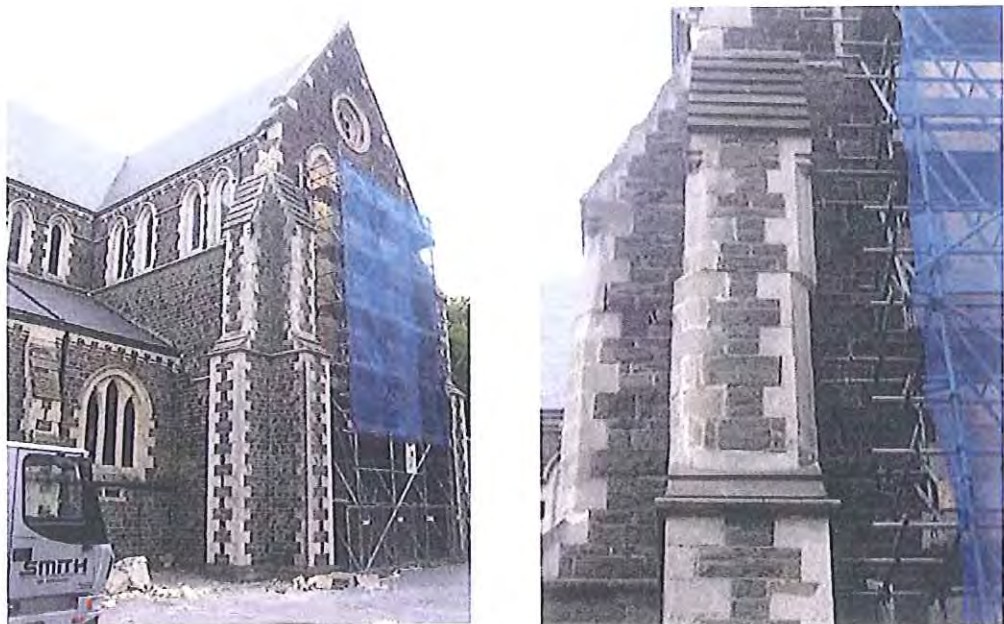
Figure 10 Damage Observed to the South Transept Wall

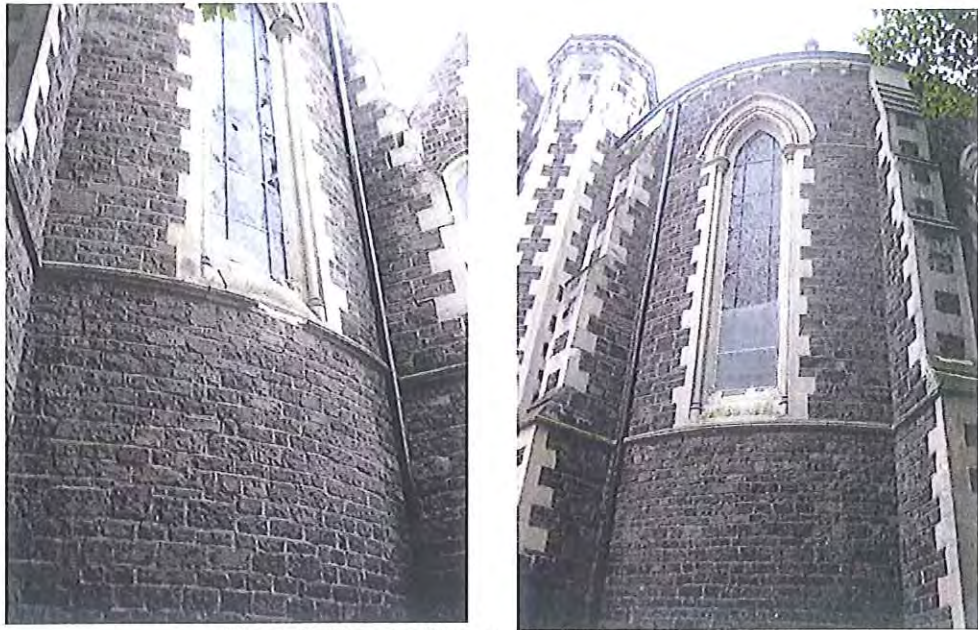
Figure 11 Damage Observed to the Apse

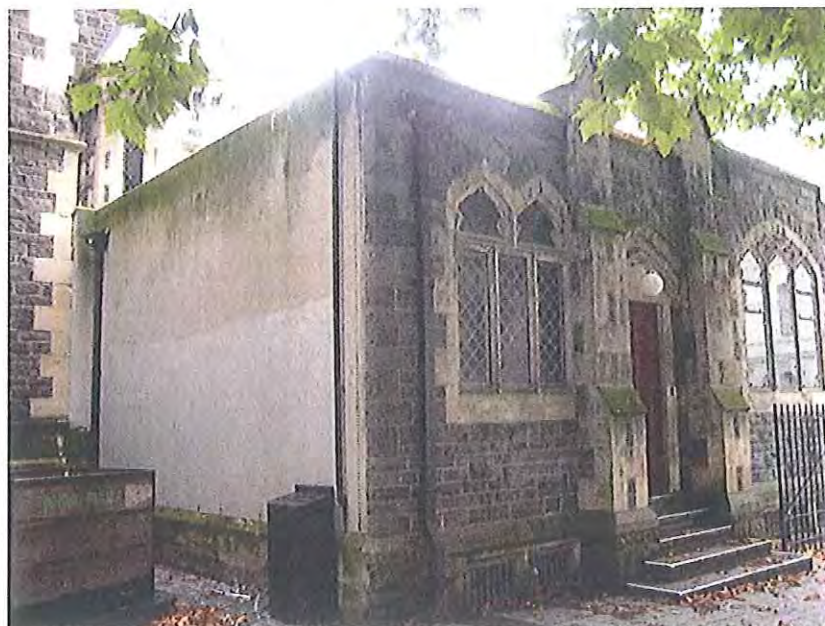
Damage was observed to be similar to that seen to the Clergy Vestry.

Figure 12 Damage Observed to the Clergy Vestry

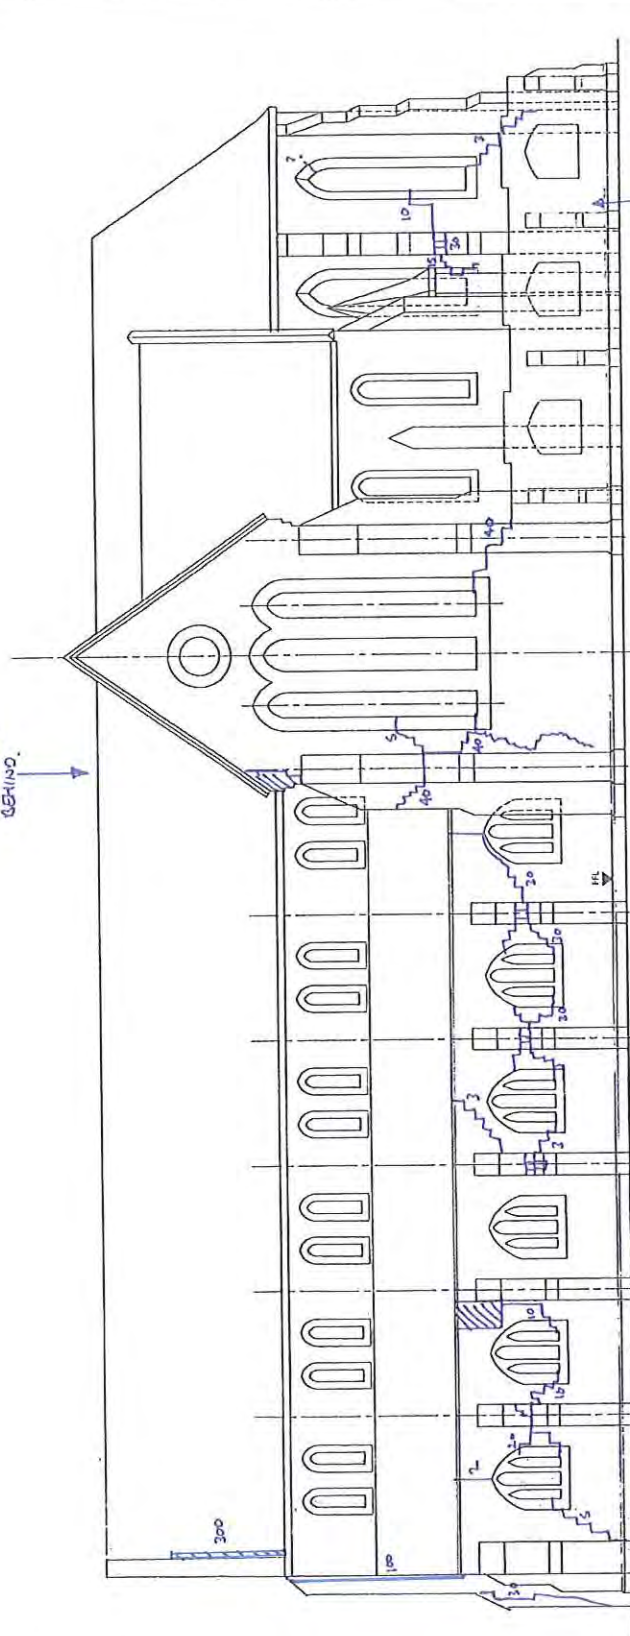
south elevation

CRACK IN
 MASS ANGLE
 BEHIND.

NO DAMAGE
 TO SOUTH PORCHES
 OF 1960'S
 ADDITION.

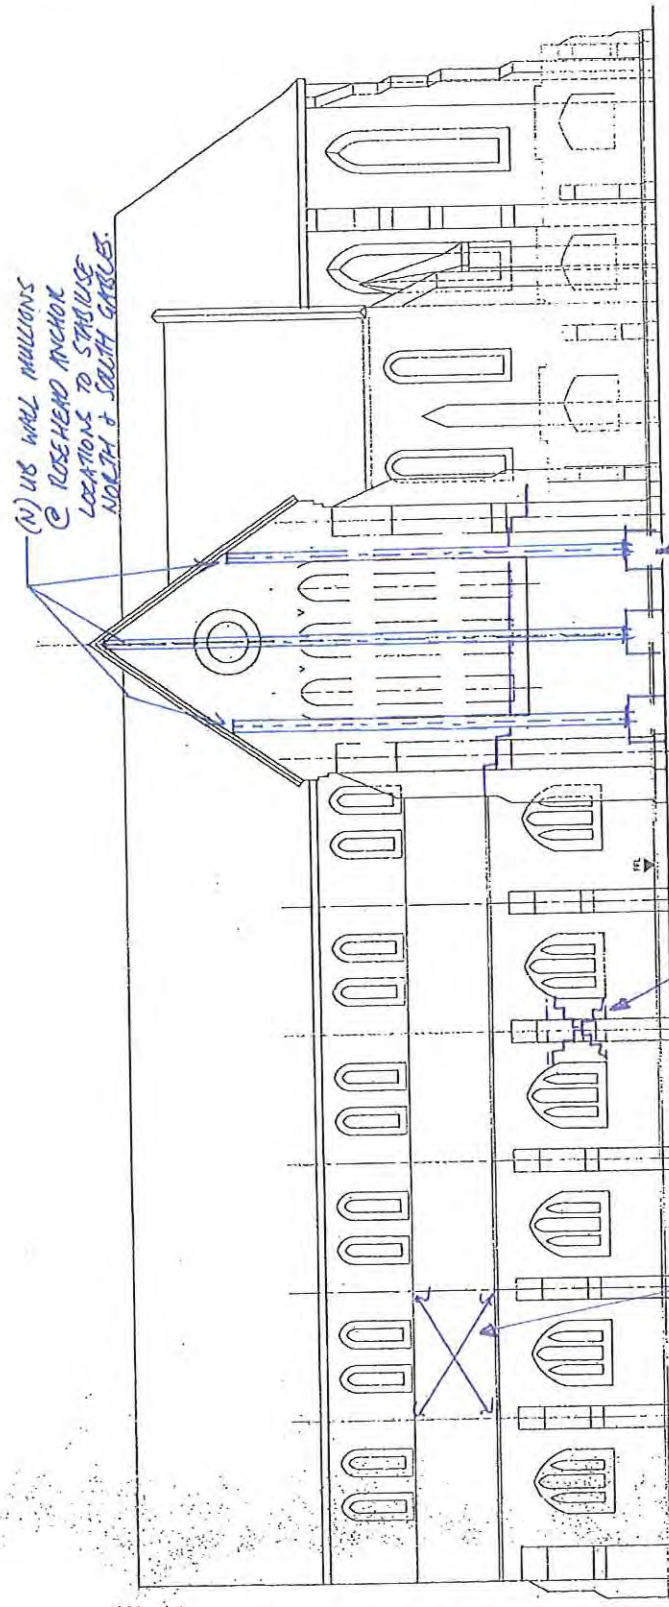
south elevation
(NORTH ELEVATION SIM.)

(E) DAMAGED PIERS
TO REMAIN IN
PLACE
