## Area-wide geotechnical information summary for CERA zoning review panel

Table 1 – Area-wide geotechnical and engineering considerations for Brooklands to Spencerville

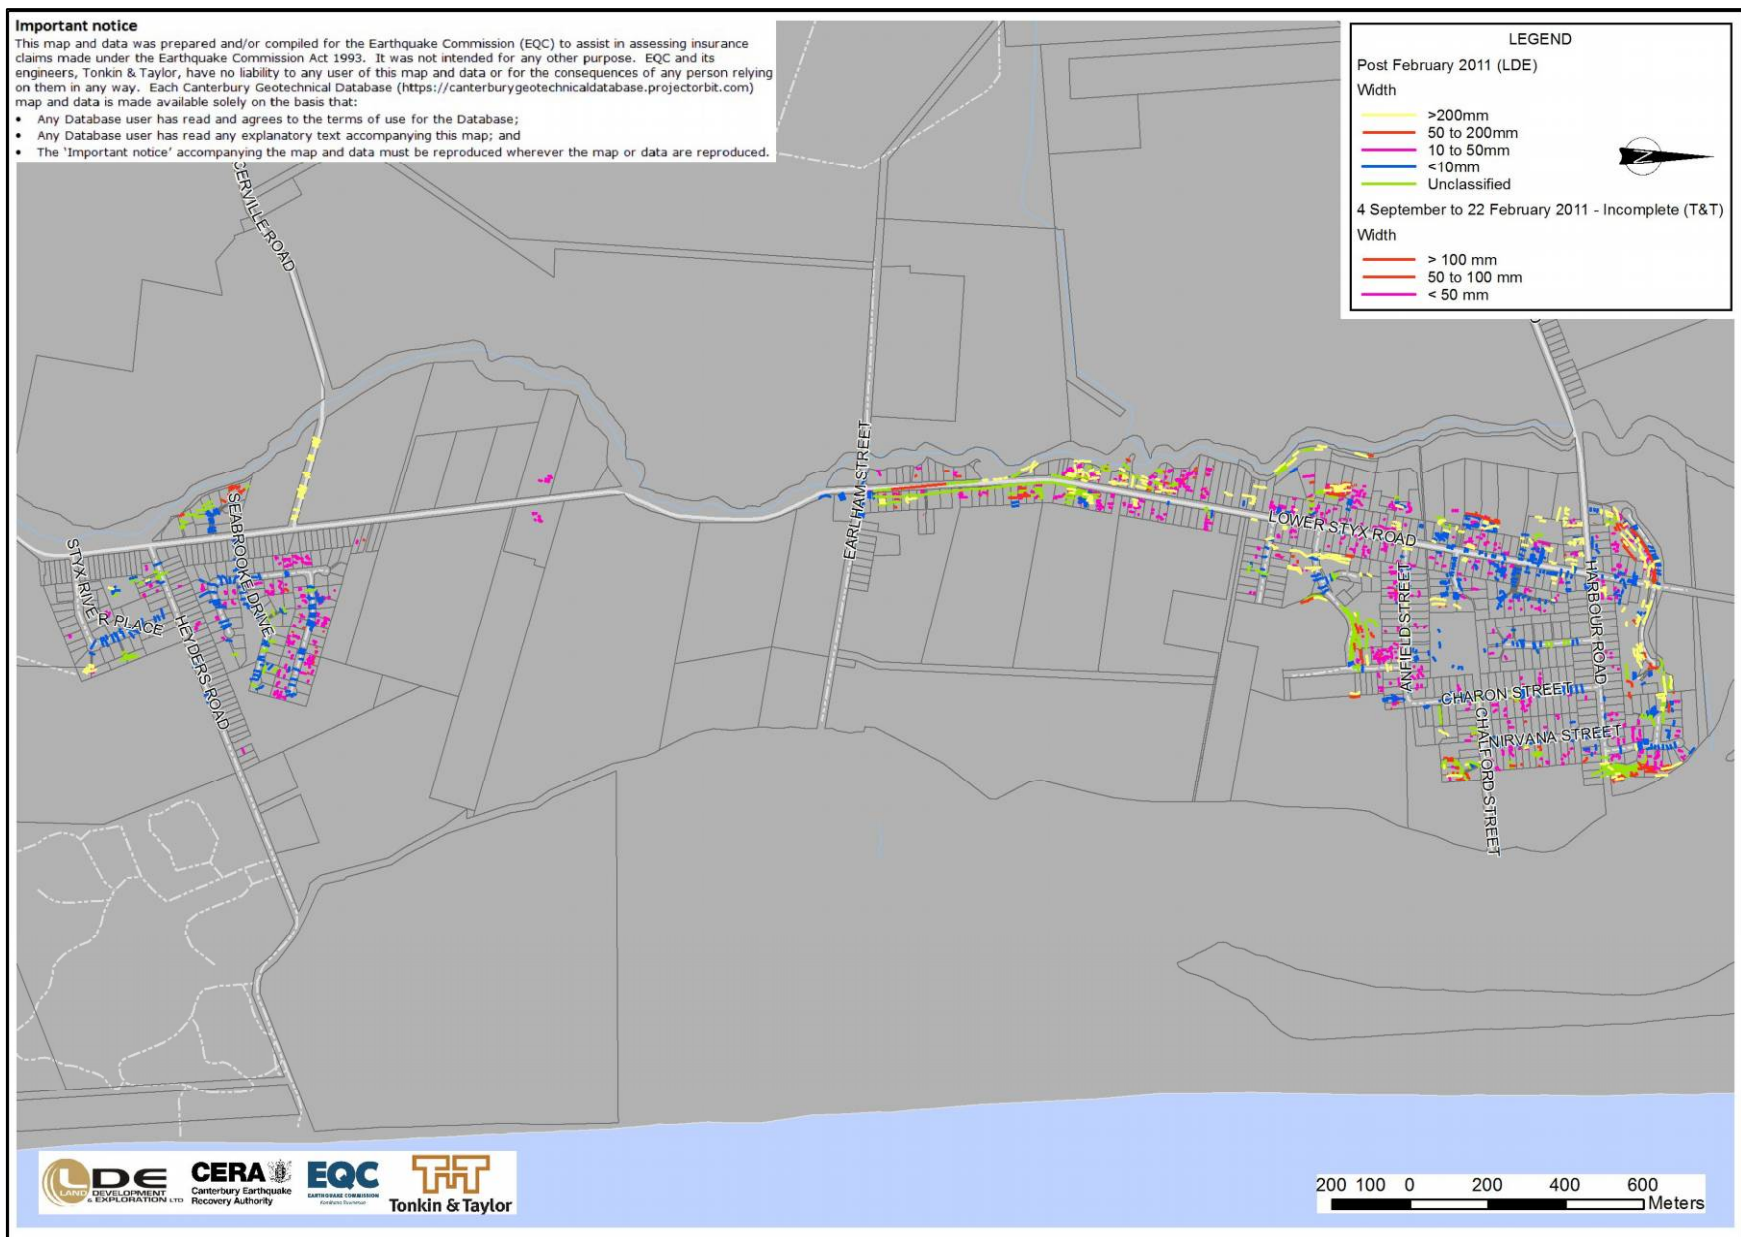
Figure 2 – Observed ground crack locations

Crack locations were mapped in order to infer the general direction, magnitude and extent of the lateral ground movements. The mapping objectives changed in response to the varying situation following the two earthquakes. Observations after the 4 Sept 2010 Earthquake were principally for insurance claim settlements. The crack widths were recorded in property-by-property observations, but cracks were not tracked across property boundaries and only a portion of properties were mapped before the 22 Feb 2011 Earthquake. Cracks were mapped at a scale of 1:5000 to 1:10000 for about two weeks following the 22 Feb 2011 Earthquake in order to rapidly identify the extent of lateral spreading following the earthquake. The individual crack widths were not recorded. From early March 2011, cracks were generally mapped at a scale of 1:2000 and classified according to their maximum width. Cracks were tracked through properties in order to identify regional patterns.

The crack mapping is incomplete and only observations made by the mapping teams are presented. In particular, the mapping following the 4 Sept 2010 Earthquake was incomplete before the 22 Feb 2011 Earthquake occurred and subsequent mapping remains incomplete within the residential 'red zone' areas. Also, cracks in roads were often not able to be mapped because many were filled and the roads resealed before a mapping team arrived.

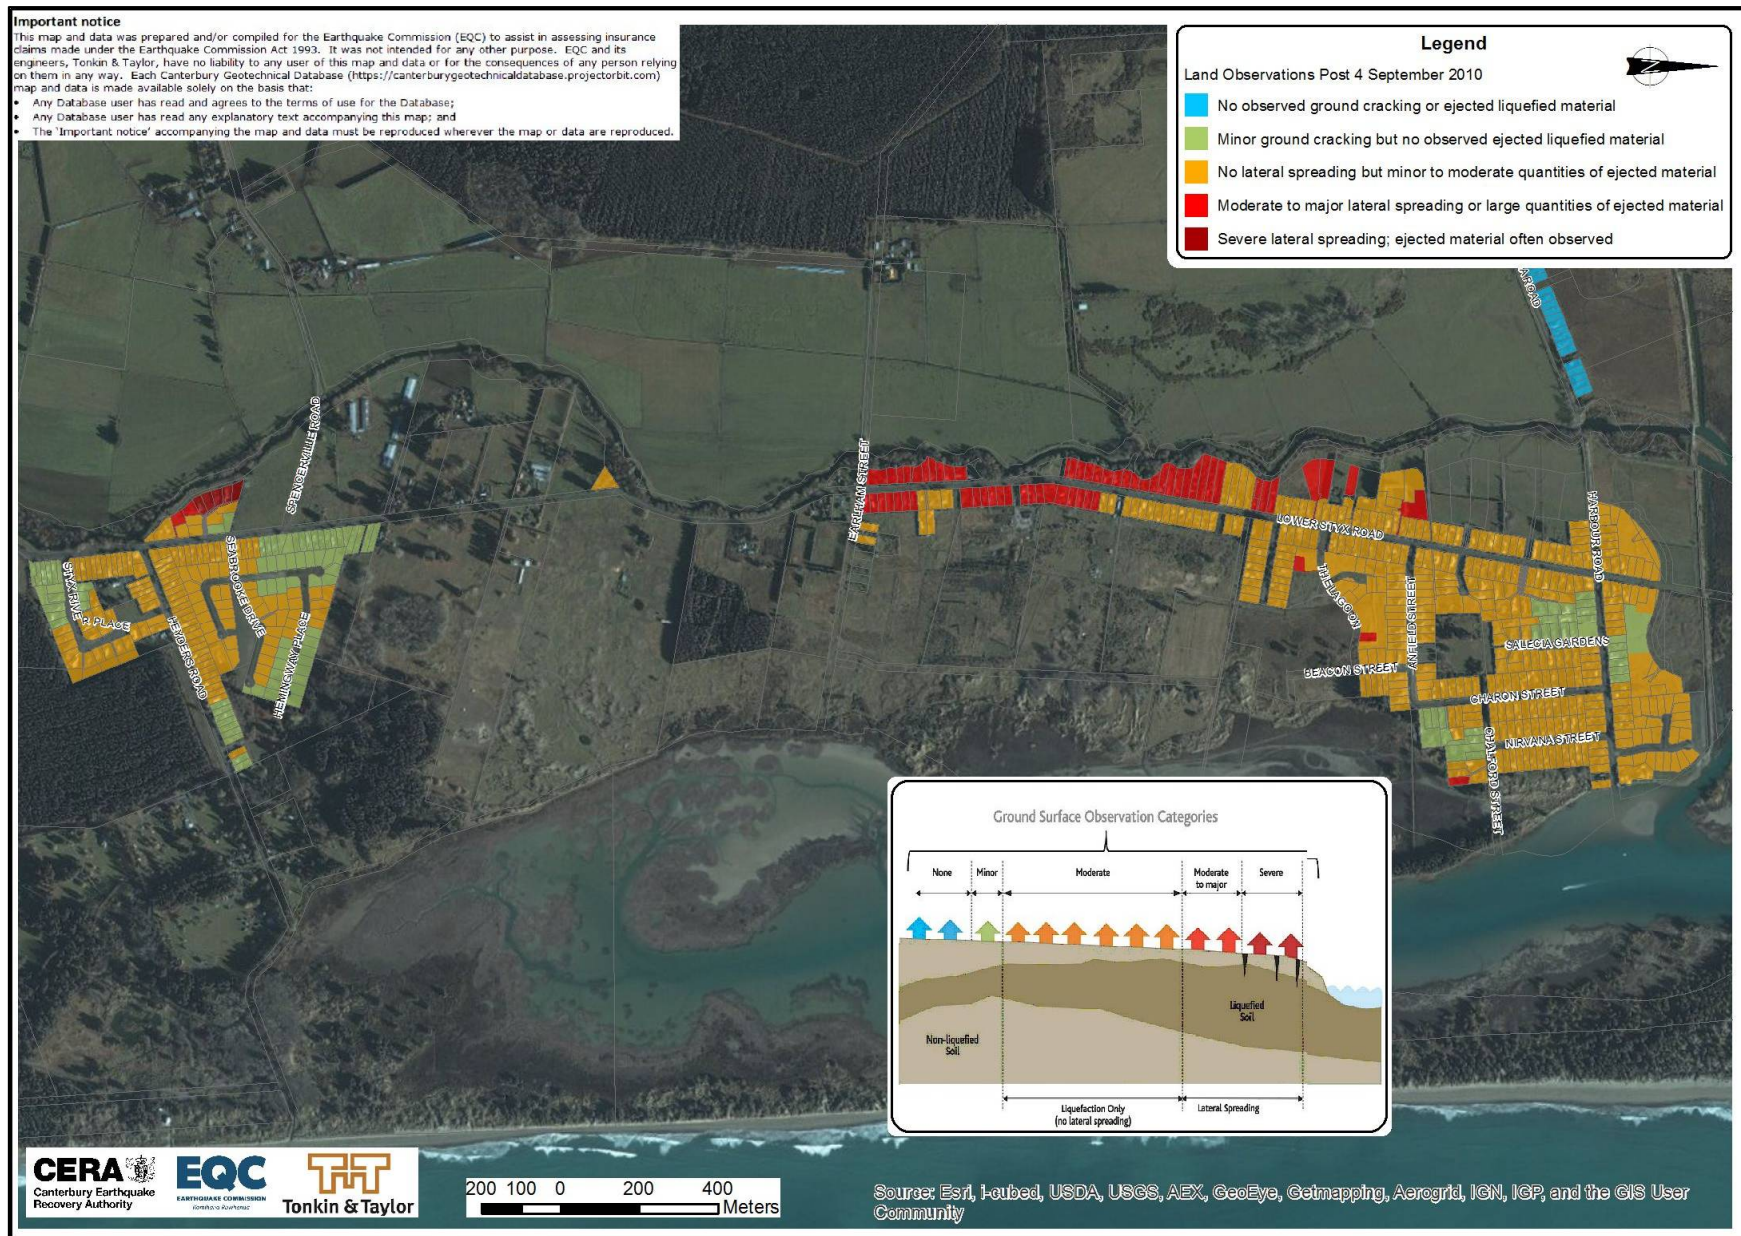
Figure 3 – Ground surface observations of liquefaction and lateral spreading following 4<sup>th</sup> September 2010 earthquake (from property-level ground mapping)

The quantities of material ejected due to liquefaction and observations of lateral spreading were collated from on-foot rapid inspection of individual properties following each significant earthquake. The observations were categorized according to the quantity of ejected material observed on the ground surface and according to the presence or absence of evidence of lateral spreading. Each of these three categories was further subdivided according to the severity. The colour coding used on these maps has completely different meaning to colours used by CERA for land zoning and DBH for technical categories.

The observations were collected for the Earthquake Commission and were only made in residential areas. The mapping only identified liquefaction and lateral spreading that was visible at the surface at the time of inspection. Liquefaction may have occurred at depth without obvious evidence at the surface and evidence of liquefaction may have been removed before the inspection. (Removed material may be identifiable within the aerial photographs that were taken within a day or two of the earthquake.)

The properties were not all inspected between each pair of consecutive earthquakes (e.g. between 4 Sept 2010 and 22 Feb 2011) so the extent of the land deformations is most likely incomplete. Also, some observations following the 22 Feb 2011 and 13 Jun 2011 earthquakes could have been induced by preceding earthquakes.

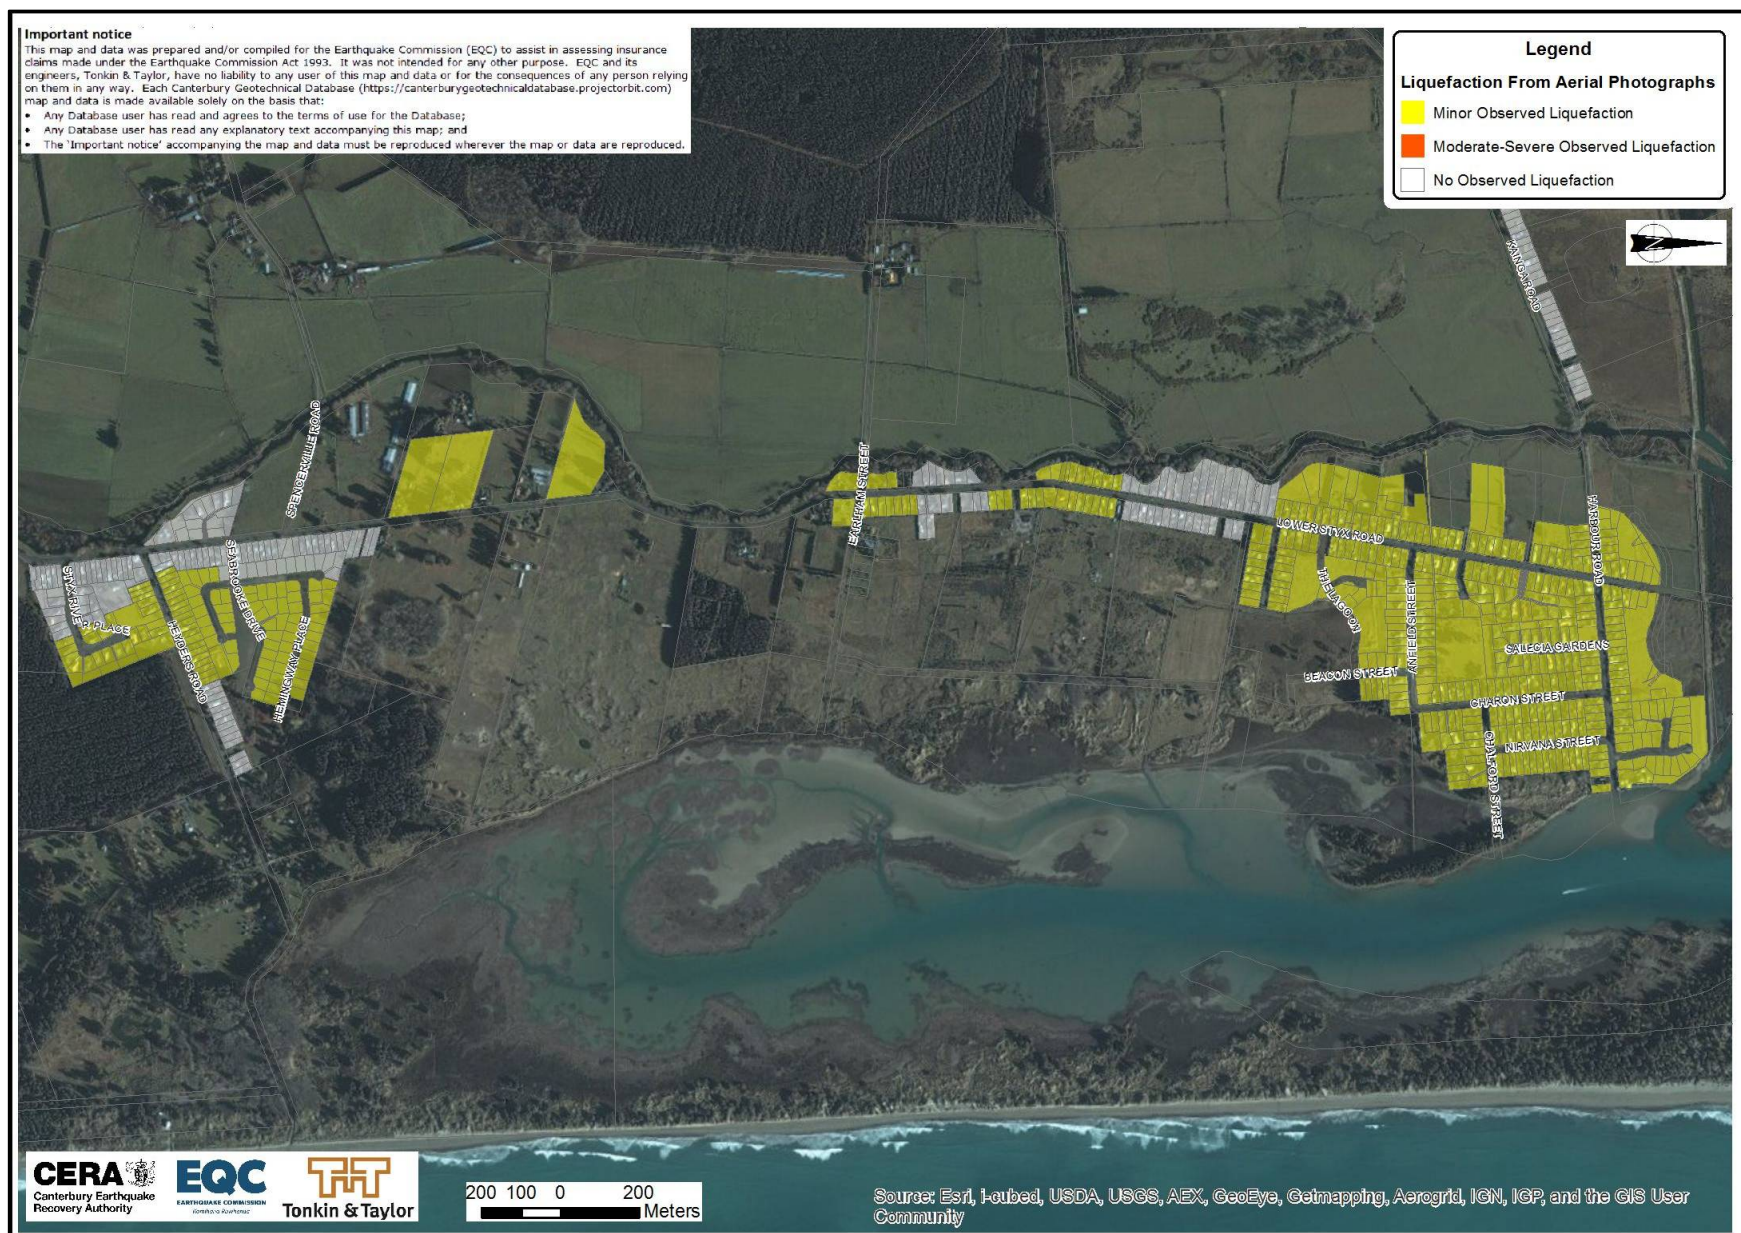
Figure 4 – Ground surface observations of liquefaction and lateral spreading following 22<sup>nd</sup> February 2011 earthquake (from air-photo interpretation)

A regional-scale map showing the extents of ejected liquefaction material interpreted from aerial photographs. The quantity of ejected liquefaction material deposited on the streets was visually identified using the aerial photographs. The region boundaries were aligned with road centre-lines and property boundaries rather than the boundaries of the individual surface features being mapped.

MODERATE to SEVERE: Roads had either ejected material or wet patches wider than a typical vehicle width. Ejected material in grass or on roads. Groups of 2-3 ejected material 'boils' within properties or parks.

MINOR: Roads had either ejected material or wet patches narrower than a typical vehicle. One or two ejected material 'boils' within a property or park.

NONE: None of the above features were observed.

The photographs were of varying quality and light conditions. Shadows from low sun angles in some areas and sets of photographs may have been misidentified as ejected liquefaction material. Water from burst pipes or springs could also be misidentified as ejected material. Conversely, ejected material may have been obscured from view or removed before the photographs were taken. Photographs were not available for all areas of the city. These maps should be used in conjunction with the associated Aerial Photograph and property-scale observations to form a complete picture of the extent and severity of the liquefaction.

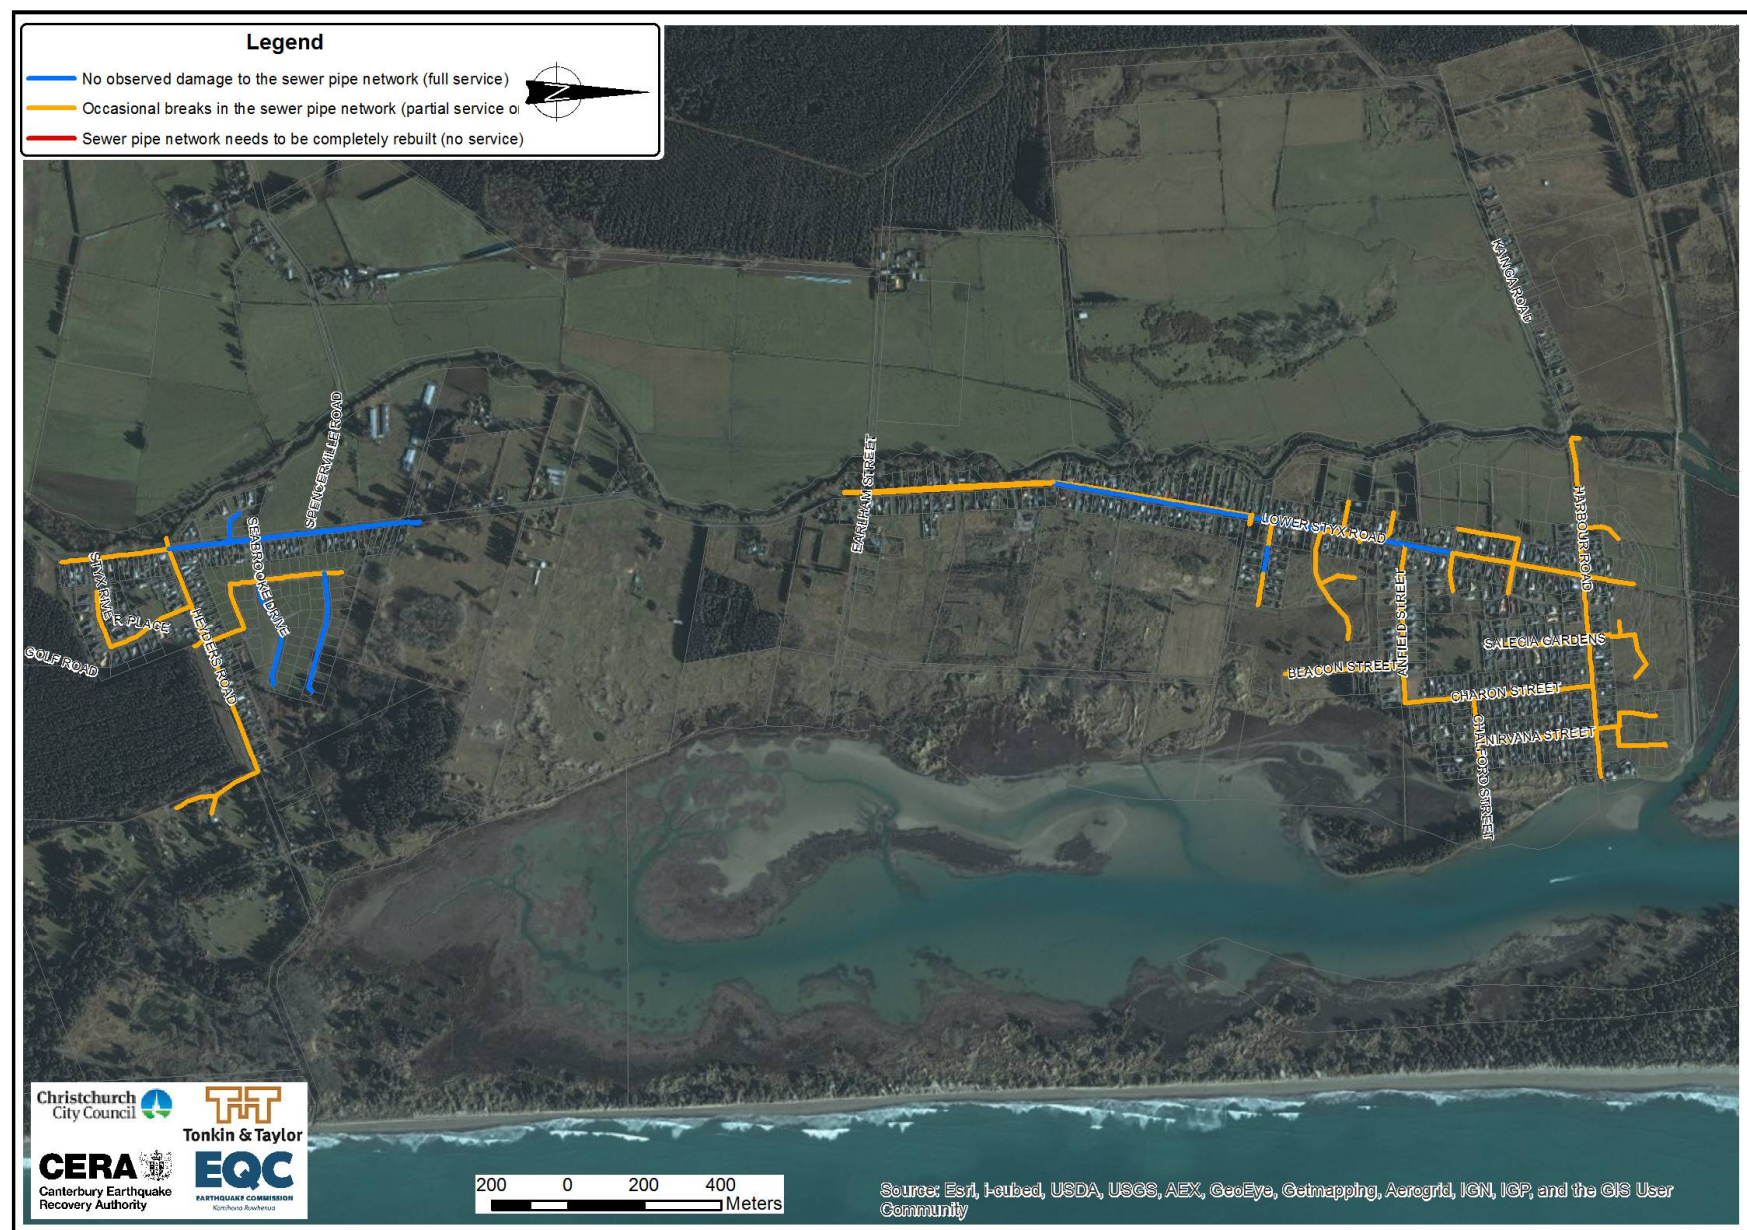
Figure 6 – Status of wastewater network as assessed at 20<sup>th</sup> April 2011 (NOW SUPERSEDED)

Since this map was compiled there has been significant additional assessment of the infrastructure network, so this map is now superseded. It is included only to show the best available information at the time of the zoning decisions. For an up to date assessment of the infrastructure network, SCIRT or the City Council should be consulted.

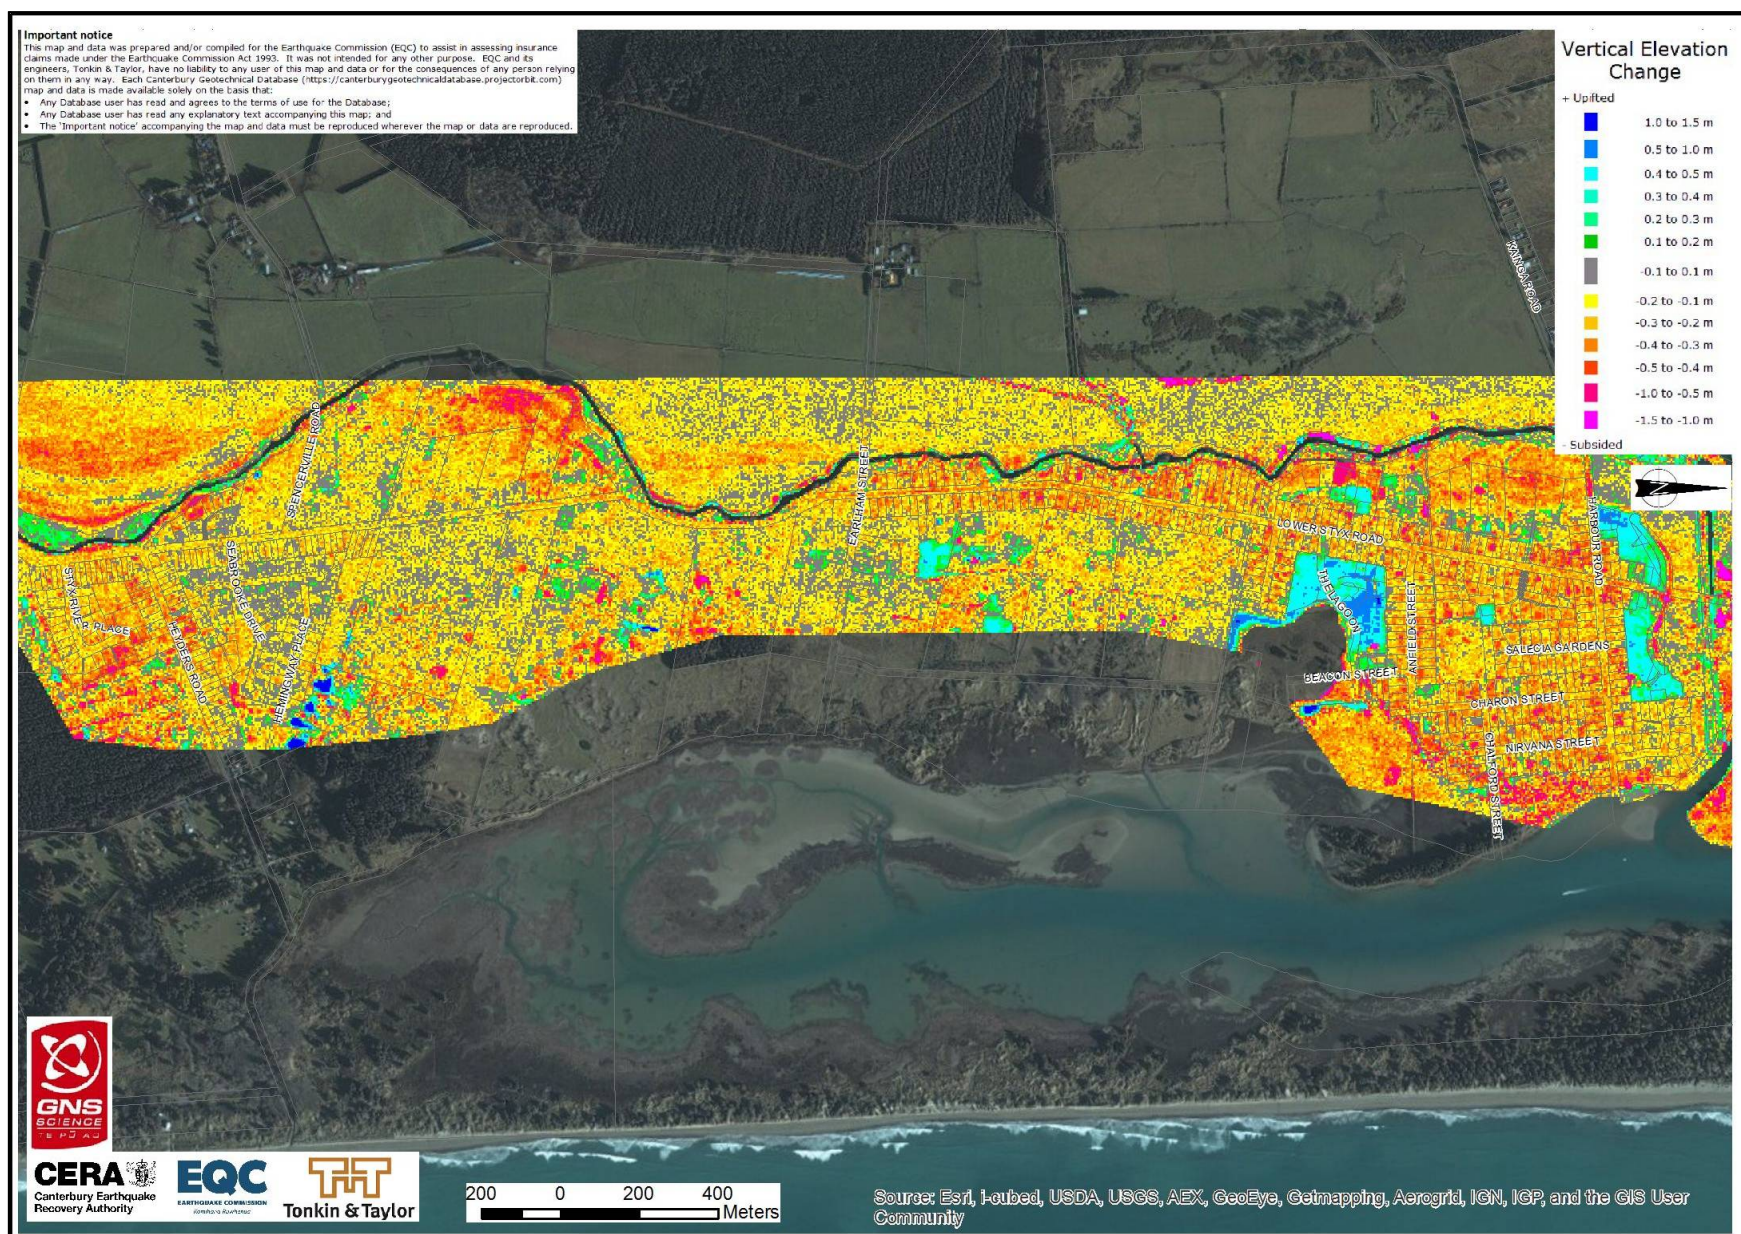
Figure 8 – Change in ground elevation between LiDAR in July 2003 and February 2012, with regional tectonic component of ground displacement removed

Vertical elevation changes between LiDAR sets that approximate the vertical ground movements during significant earthquakes. Elevation changes were calculated as differences between pairs of Digital Elevation Models (DEM). Local vertical movements were calculated as differences between the 'observed' elevation differences and the regional tectonic displacement from GNS Science dislocation models of the vertical tectonic movements during each earthquake.

All of the movements are differences between DEMs and are inherently less accurate than their source DEM's. The pre-earthquake source DEM is less accurate than the post-earthquake DEMs. Some of the DEMs have visually distinguishable lines or ripples within the colour bands that are almost certainly artefacts from the data acquisition and subsequent processing rather than from physical vertical movements. Notable examples are several approximately NNE-SSW swathes visible in the Feb 2011 difference set and an almost E-W line at 43.48°S in the 13 Jun 2011 difference set.
