Area-wide geotechnical information summary for CERA zoning review panel

This document contains all the area-wide geotechnical information which was considered by CERA as part of the process for making flat-land zoning decisions, and the subsequent zoning review.

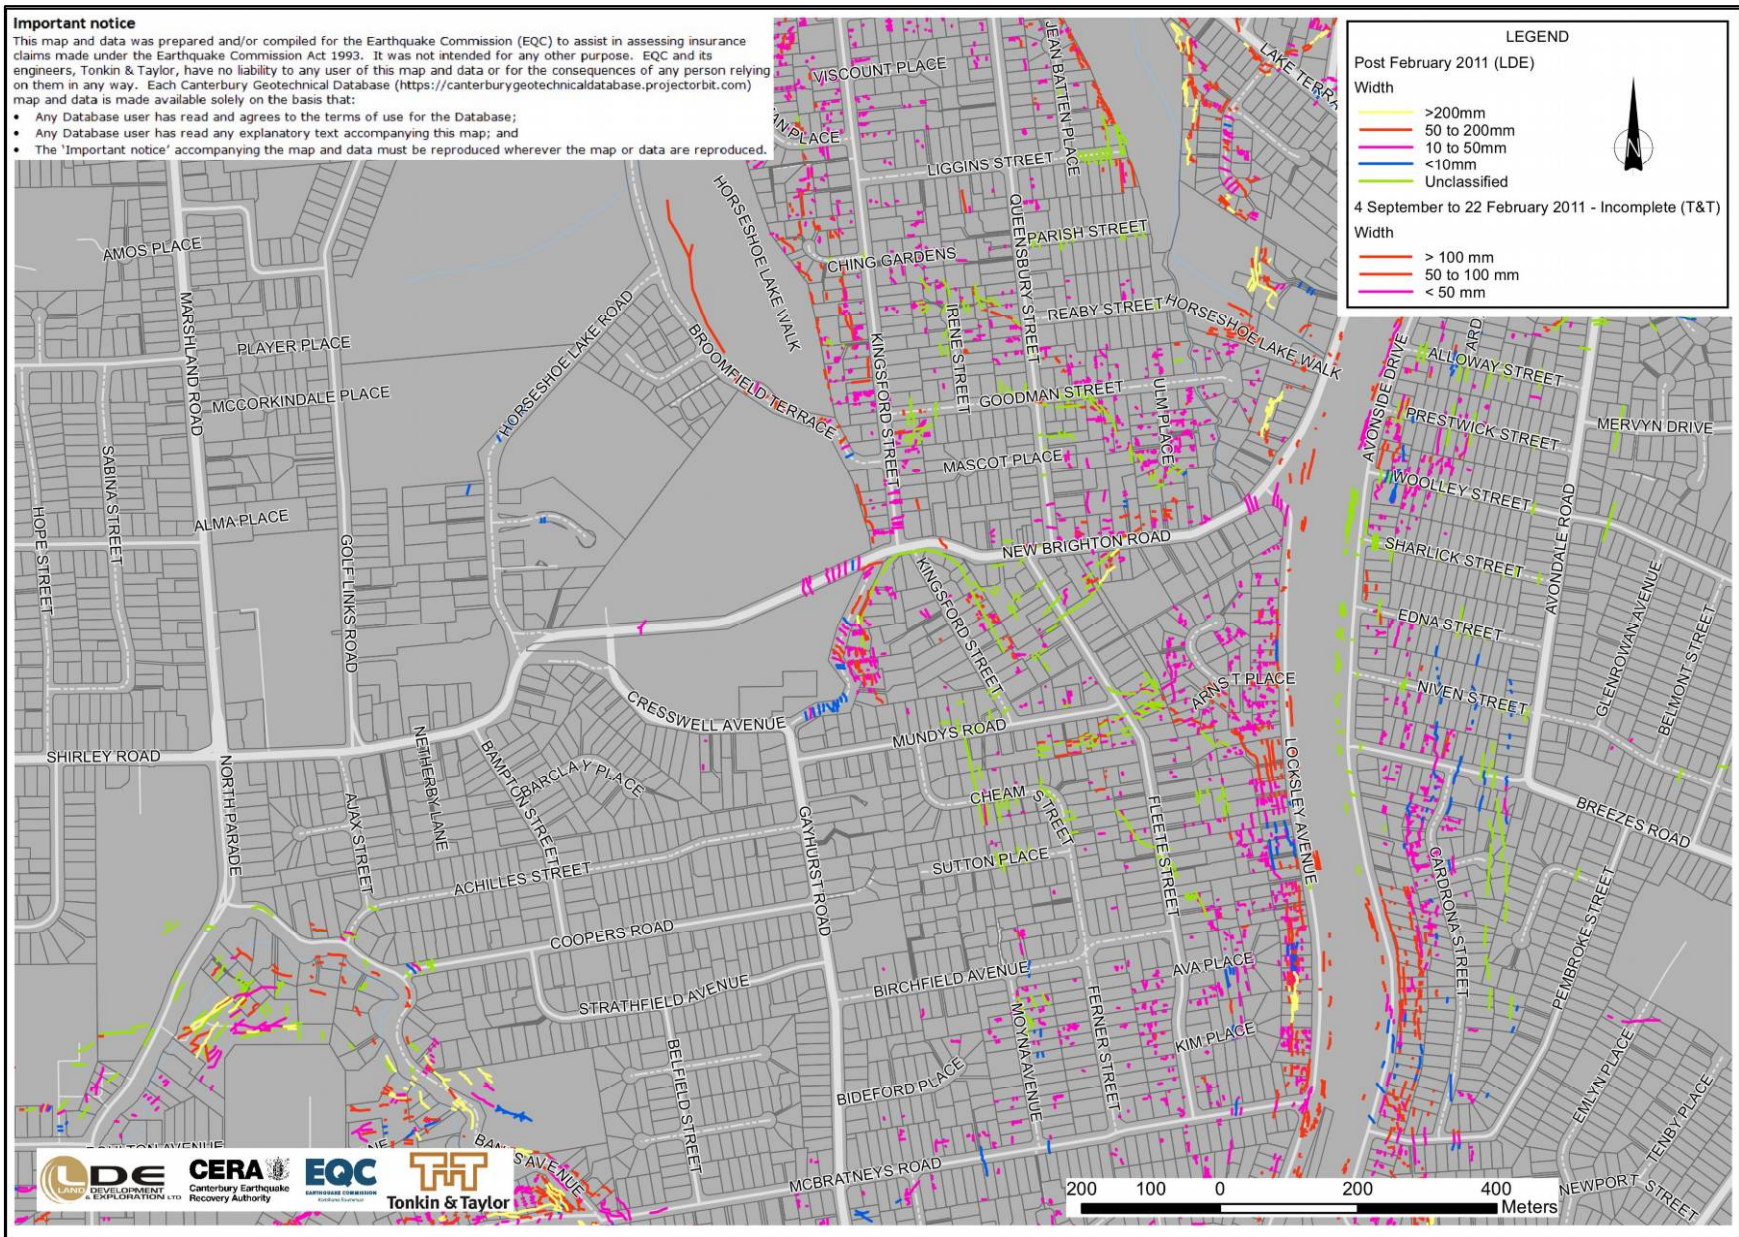
Figure 2 – Observed ground crack locations

Crack locations were mapped in order to infer the general direction, magnitude and extent of the lateral ground movements. The mapping objectives changed in response to the varying situation following the two earthquakes. Observations after the 4 Sept 2010 Earthquake were principally for insurance claim settlements. The crack widths were recorded in property-by-property observations, but cracks were not tracked across property boundaries and only a portion of properties were mapped before the 22 Feb 2011 Earthquake. Cracks were mapped at a scale of 1:5000 to 1:10000 for about two weeks following the 22 Feb 2011 Earthquake in order to rapidly identify the extent of lateral spreading following the earthquake. The individual crack widths were not recorded. From early March 2011, cracks were generally mapped at a scale of 1:2000 and classified according to their maximum width. Cracks were tracked through properties in order to identify regional patterns.

The crack mapping is incomplete and only observations made by the mapping teams are presented. In particular, the mapping following the 4 Sept 2010 Earthquake was incomplete before the 22 Feb 2011 Earthquake occurred and subsequent mapping remains incomplete within the residential 'red zone' areas. Also, cracks in roads were often not able to be mapped because many were filled and the roads resealed before a mapping team arrived.

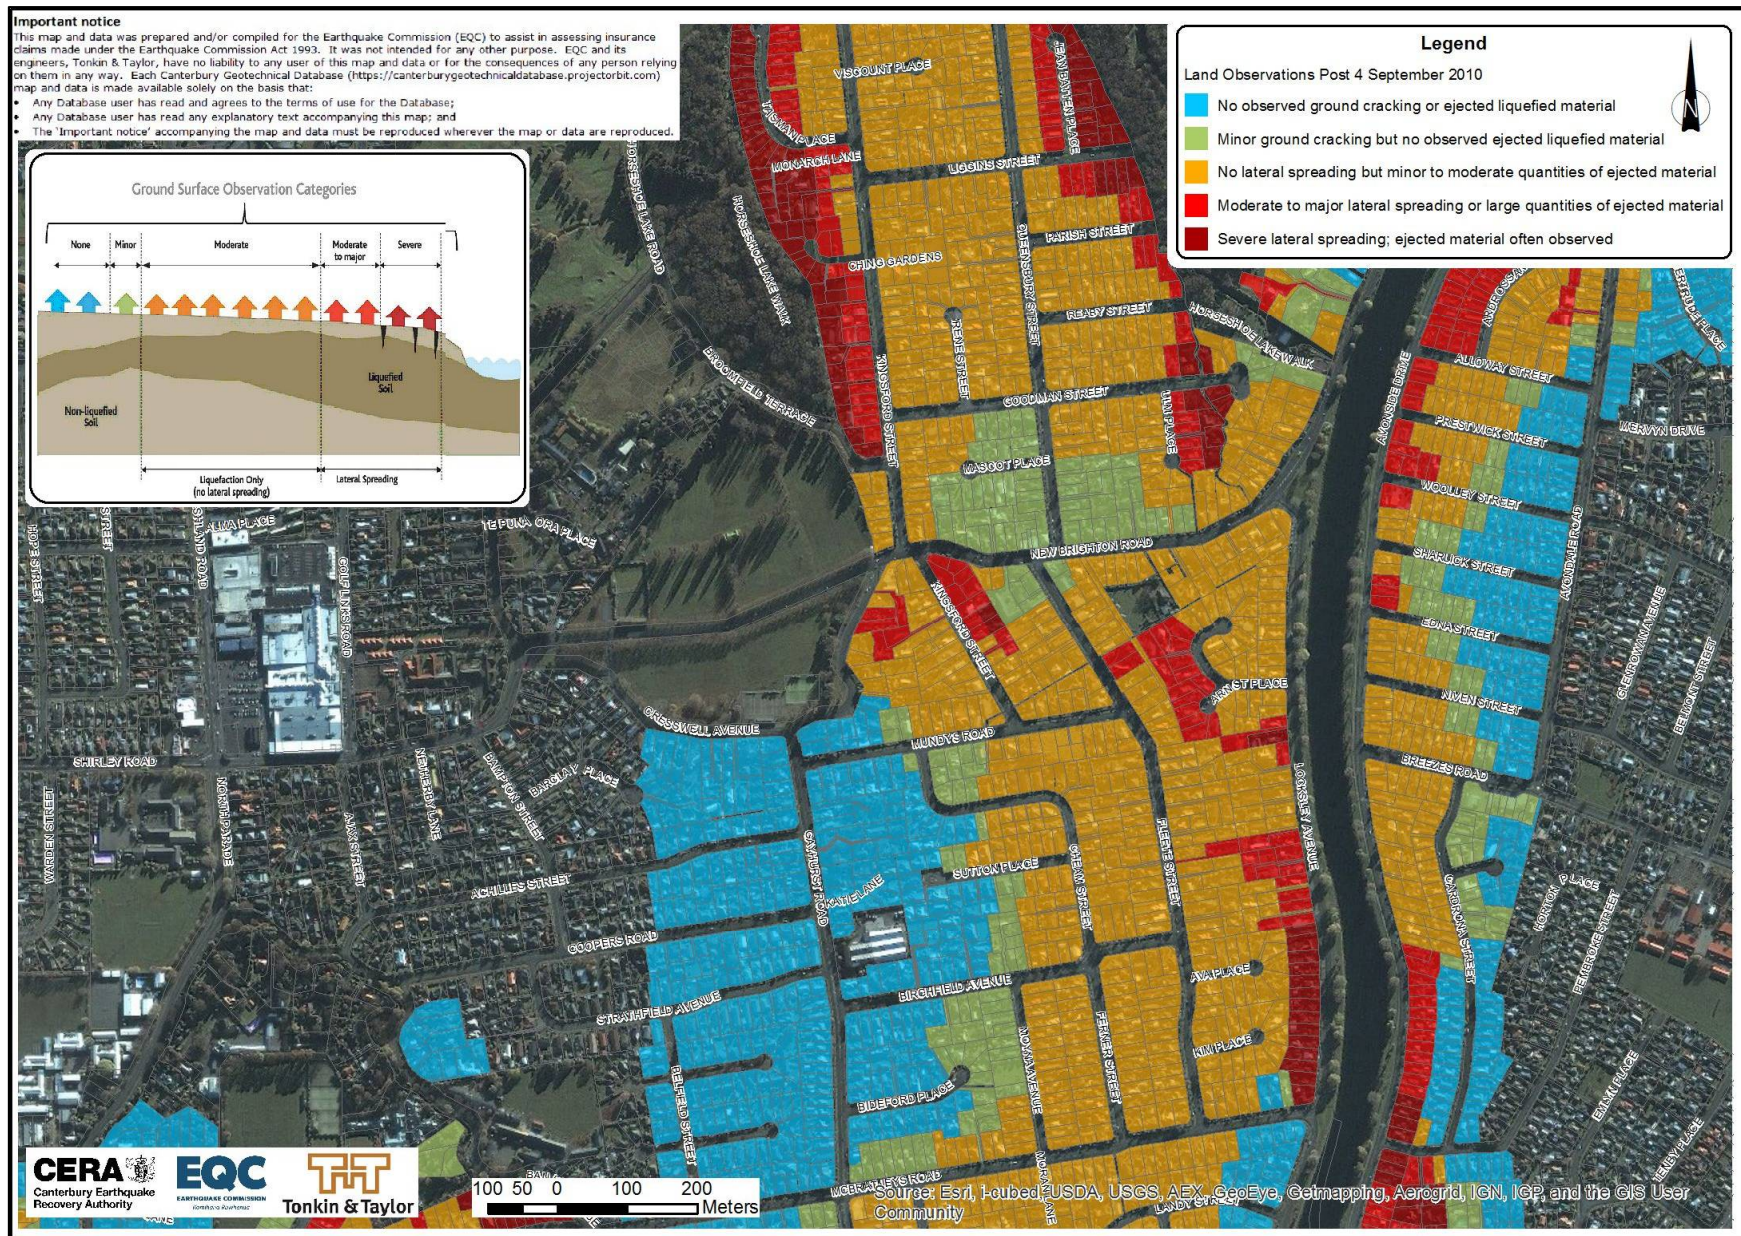
Figure 3 – Ground surface observations of liquefaction and lateral spreading following 4th September 2010 earthquake (from property-level ground mapping)

The quantities of material ejected due to liquefaction and observations of lateral spreading were collated from on-foot rapid inspection of individual properties following each significant earthquake. The observations were categorized according to the quantity of ejected material observed on the ground surface and according to the presence or absence of evidence of lateral spreading. Each of these three categories was further subdivided according to the severity. The colour coding used on these maps has completely different meaning to colours used by CERA for land zoning and DBH for technical categories.

The observations were collected for the Earthquake Commission and were only made in residential areas. The mapping only identified liquefaction and lateral spreading that was visible at the surface at the time of inspection. Liquefaction may have occurred at depth without obvious evidence at the surface and evidence of liquefaction may have been removed before the inspection. (Removed material may be identifiable within the aerial photographs that were taken within a day or two of the earthquake.)

The properties were not all inspected between each pair of consecutive earthquakes (e.g. between 4 Sept 2010 and 22 Feb 2011) so the extent of the land deformations is most likely incomplete. Also, some observations following the 22 Feb 2011 and 13 Jun 2011 earthquakes could have been induced by preceding earthquakes.

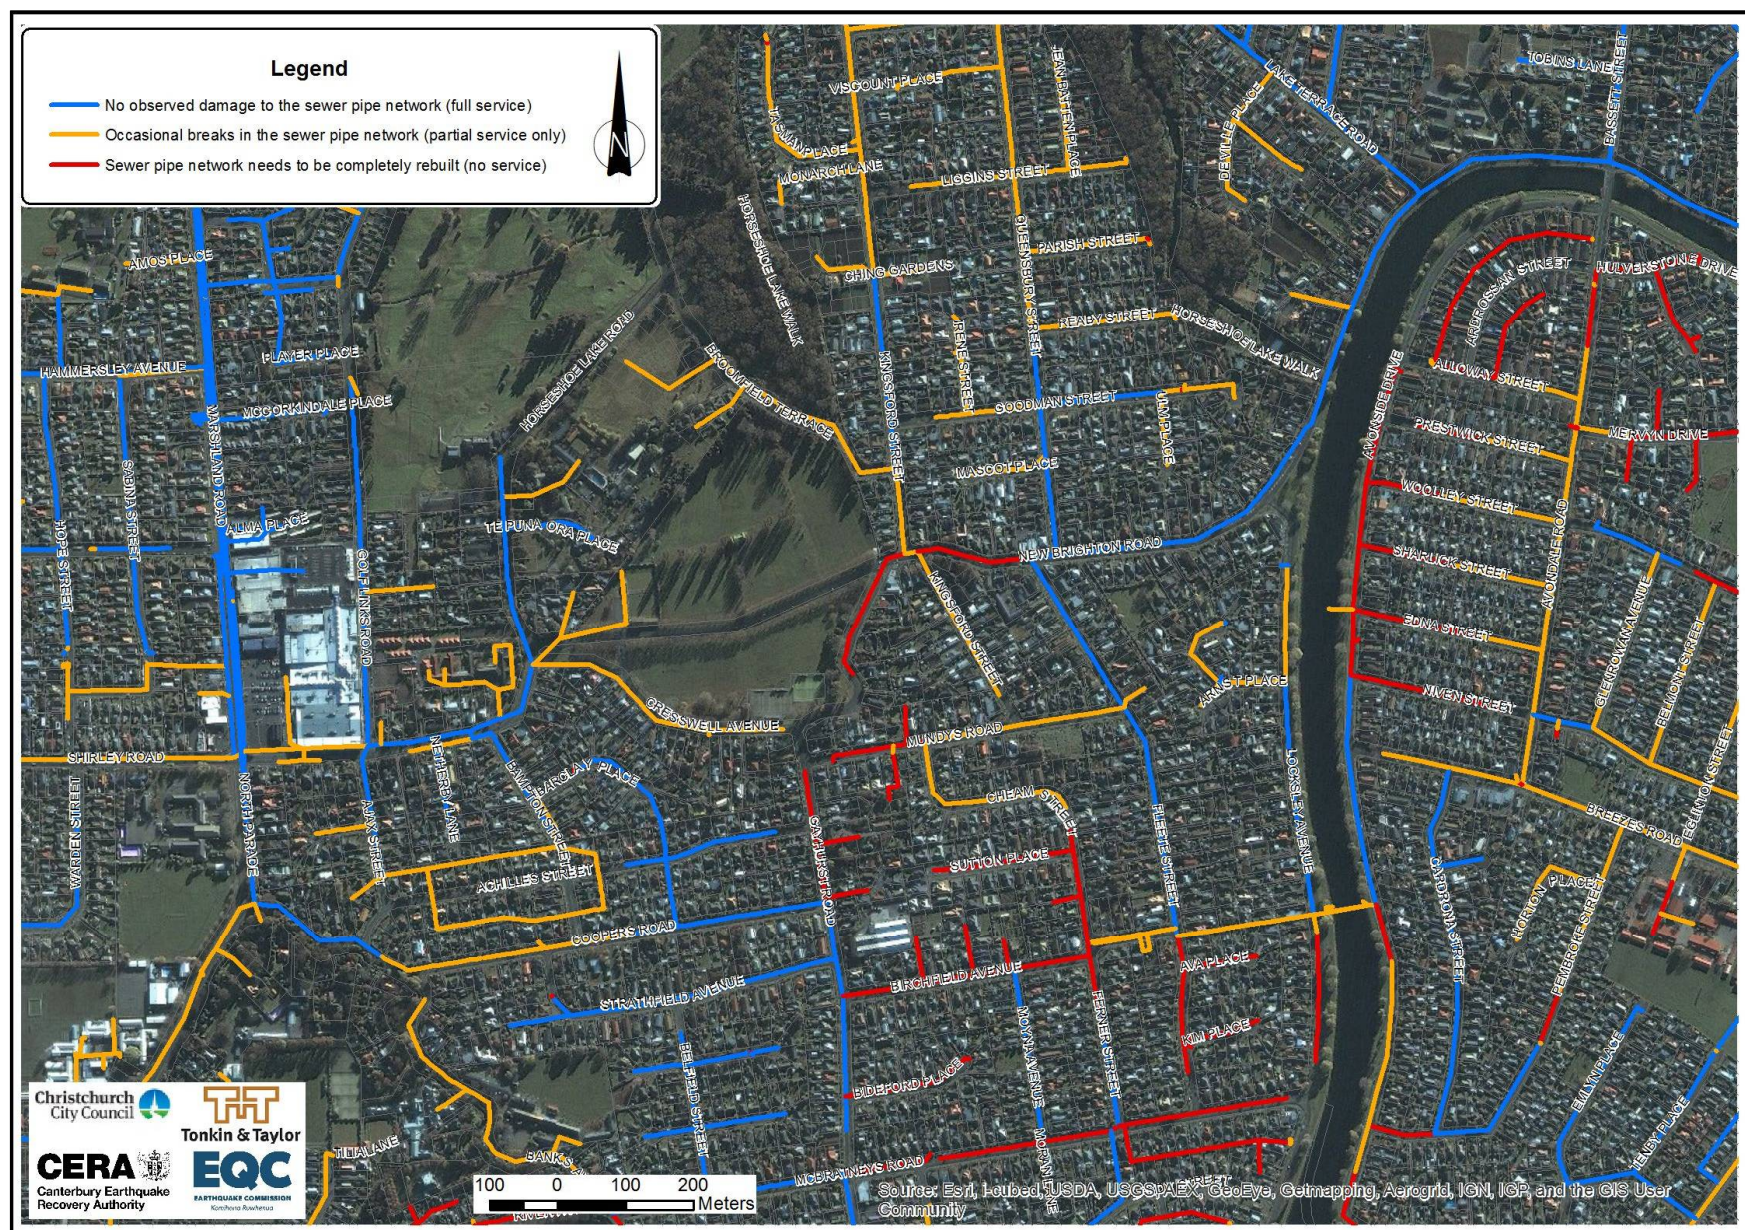
Figure 6 – Status of wastewater network as assessed at 20th April 2011 (NOW SUPERSEDED)

Since this map was compiled there has been significant additional assessment of the infrastructure network, so this map is now superseded. It is included only to show the best available information at the time of the zoning decisions. For an up to date assessment of the infrastructure network, SCIRT or the City Council should be consulted.

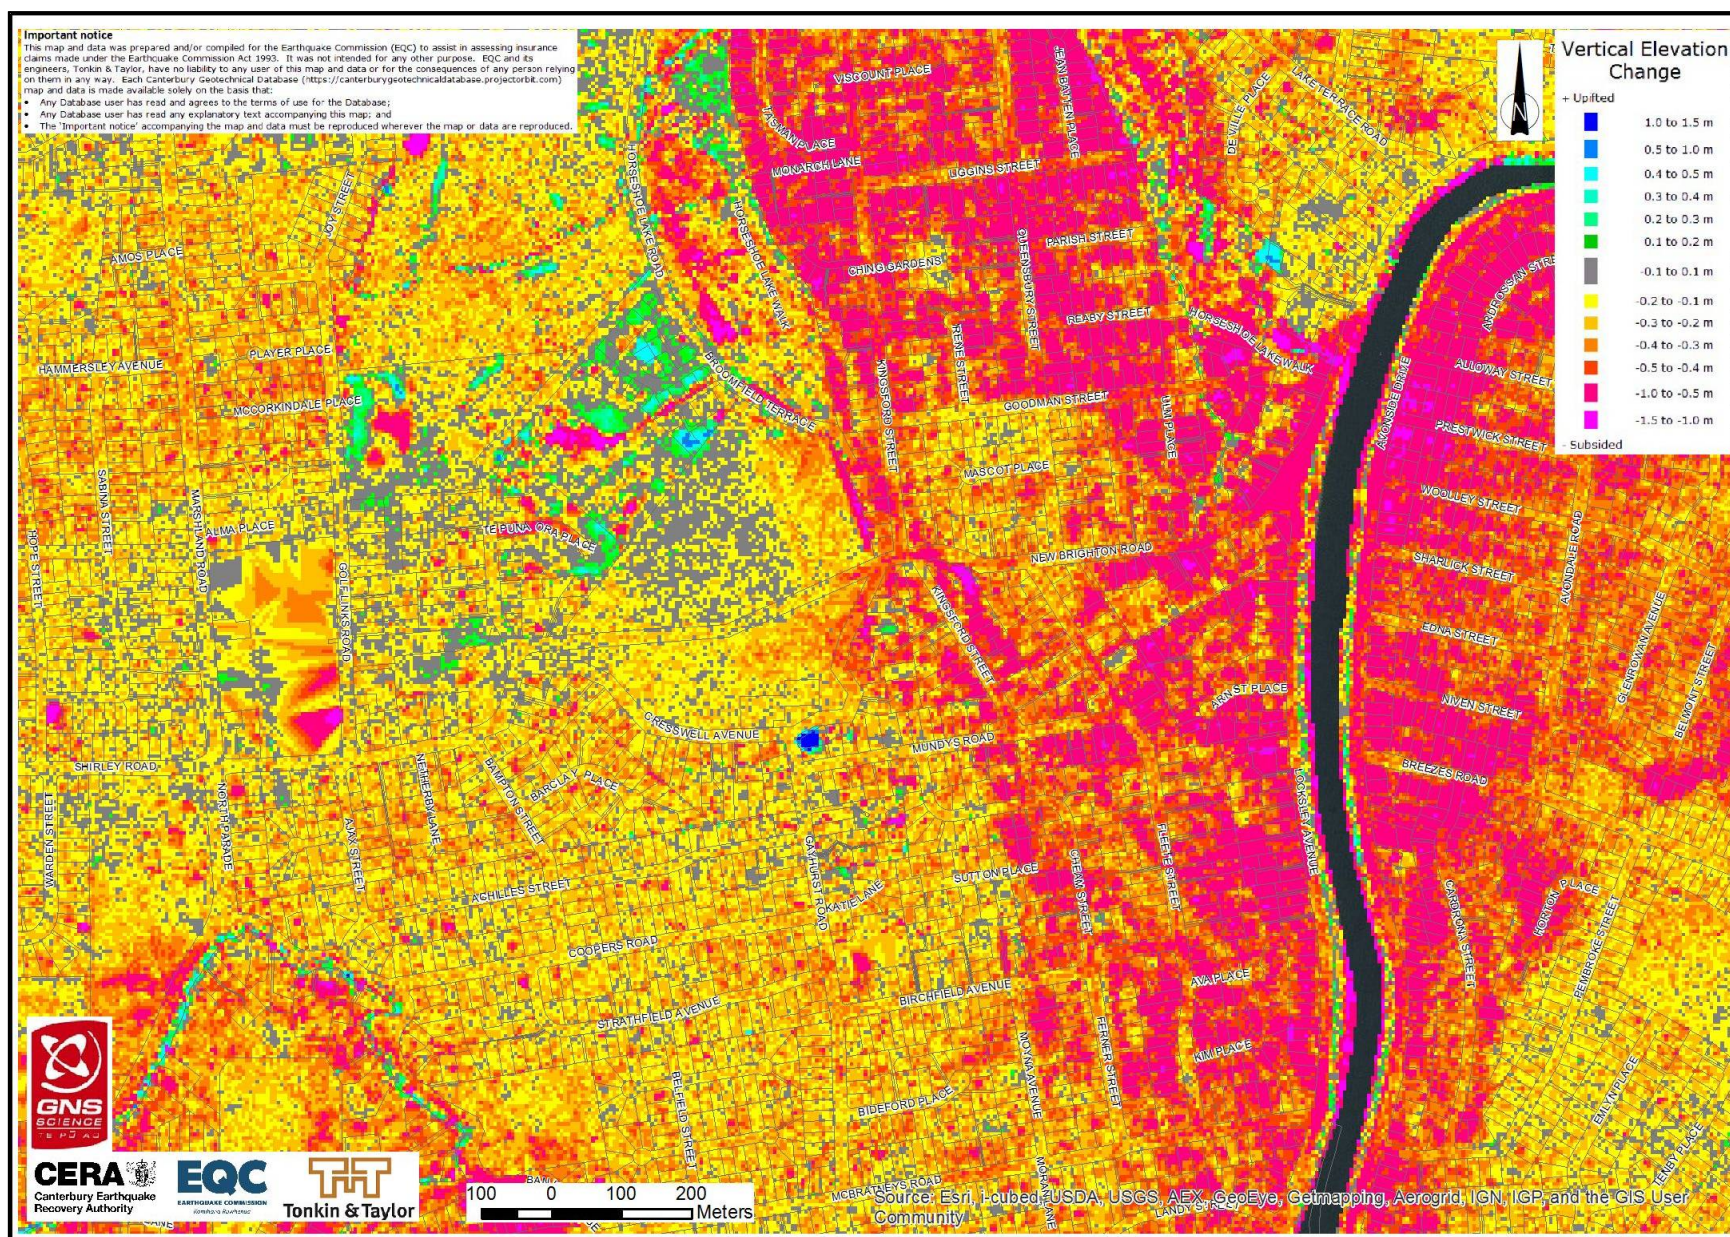
Figure 8 – Change in ground elevation between LiDAR in July 2003 and February 2012, with regional tectonic component of ground displacement removed

Vertical elevation changes between LiDAR sets that approximate the vertical ground movements during significant earthquakes. Elevation changes were calculated as differences between pairs of Digital Elevation Models (DEM). Local vertical movements were calculated as the differences between the 'observed' elevation differences and the regional tectonic displacement from GNS Science dislocation models of the vertical tectonic movements during each earthquake.

All of the movements are differences between DEMs and are inherently less accurate than their source DEM's. The pre-earthquake source DEM is less accurate than the post-earthquake DEMs. Some of the DEMs have visually distinguishable lines or ripples within the colour bands that are almost certainly artefacts from the data acquisition and subsequent processing rather than from physical vertical movements. Notable examples are several approximately NNE-SSW swathes visible in the Feb 2011 difference set and an almost E-W line at 43.48°S in the 13 Jun 2011 difference set.
