## Area-wide geotechnical information summary for CERA zoning review panel

Table 1 – Area-wide geotechnical and engineering considerations for South Dallington

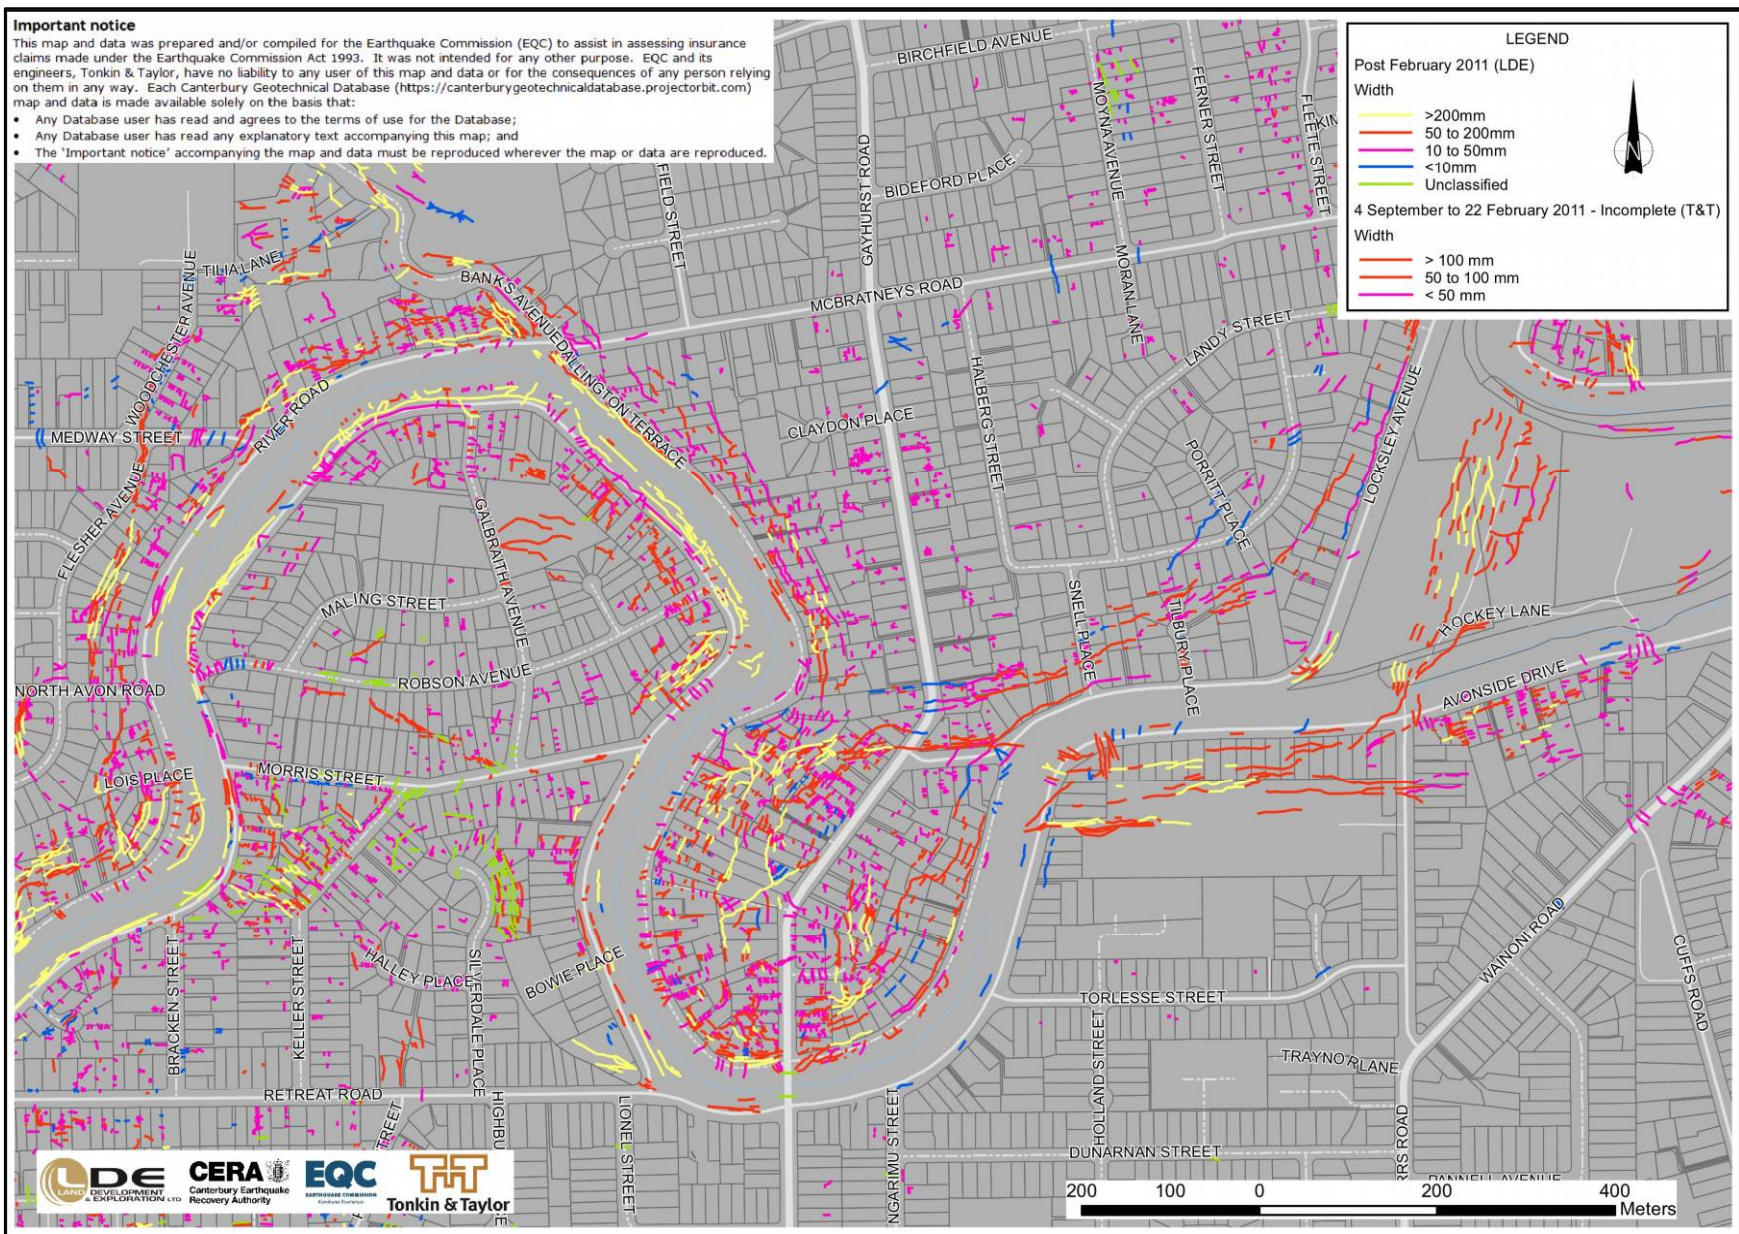
Figure 2 – Observed ground crack locations

Crack locations were mapped in order to infer the general direction, magnitude and extent of the lateral ground movements. The mapping objectives changed in response to the varying situation following the two earthquakes. Observations after the 4 Sept 2010 Earthquake were principally for insurance claim settlements. The crack widths were recorded in property-by-property observations, but cracks were not tracked across property boundaries and only a portion of properties were mapped before the 22 Feb 2011 Earthquake. Cracks were mapped at a scale of 1:5000 to 1:10000 for about two weeks following the 22 Feb 2011 Earthquake in order to rapidly identify the extent of lateral spreading following the earthquake. The individual crack widths were not recorded. From early March 2011, cracks were generally mapped at a scale of 1:2000 and classified according to their maximum width. Cracks were tracked through properties in order to identify regional patterns.

The crack mapping is incomplete and only observations made by the mapping teams are presented. In particular, the mapping following the 4 Sept 2010 Earthquake was incomplete before the 22 Feb 2011 Earthquake occurred and subsequent mapping remains incomplete within the residential 'red zone' areas. Also, cracks in roads were often not able to be mapped because many were filled and the roads resealed before a mapping team arrived.

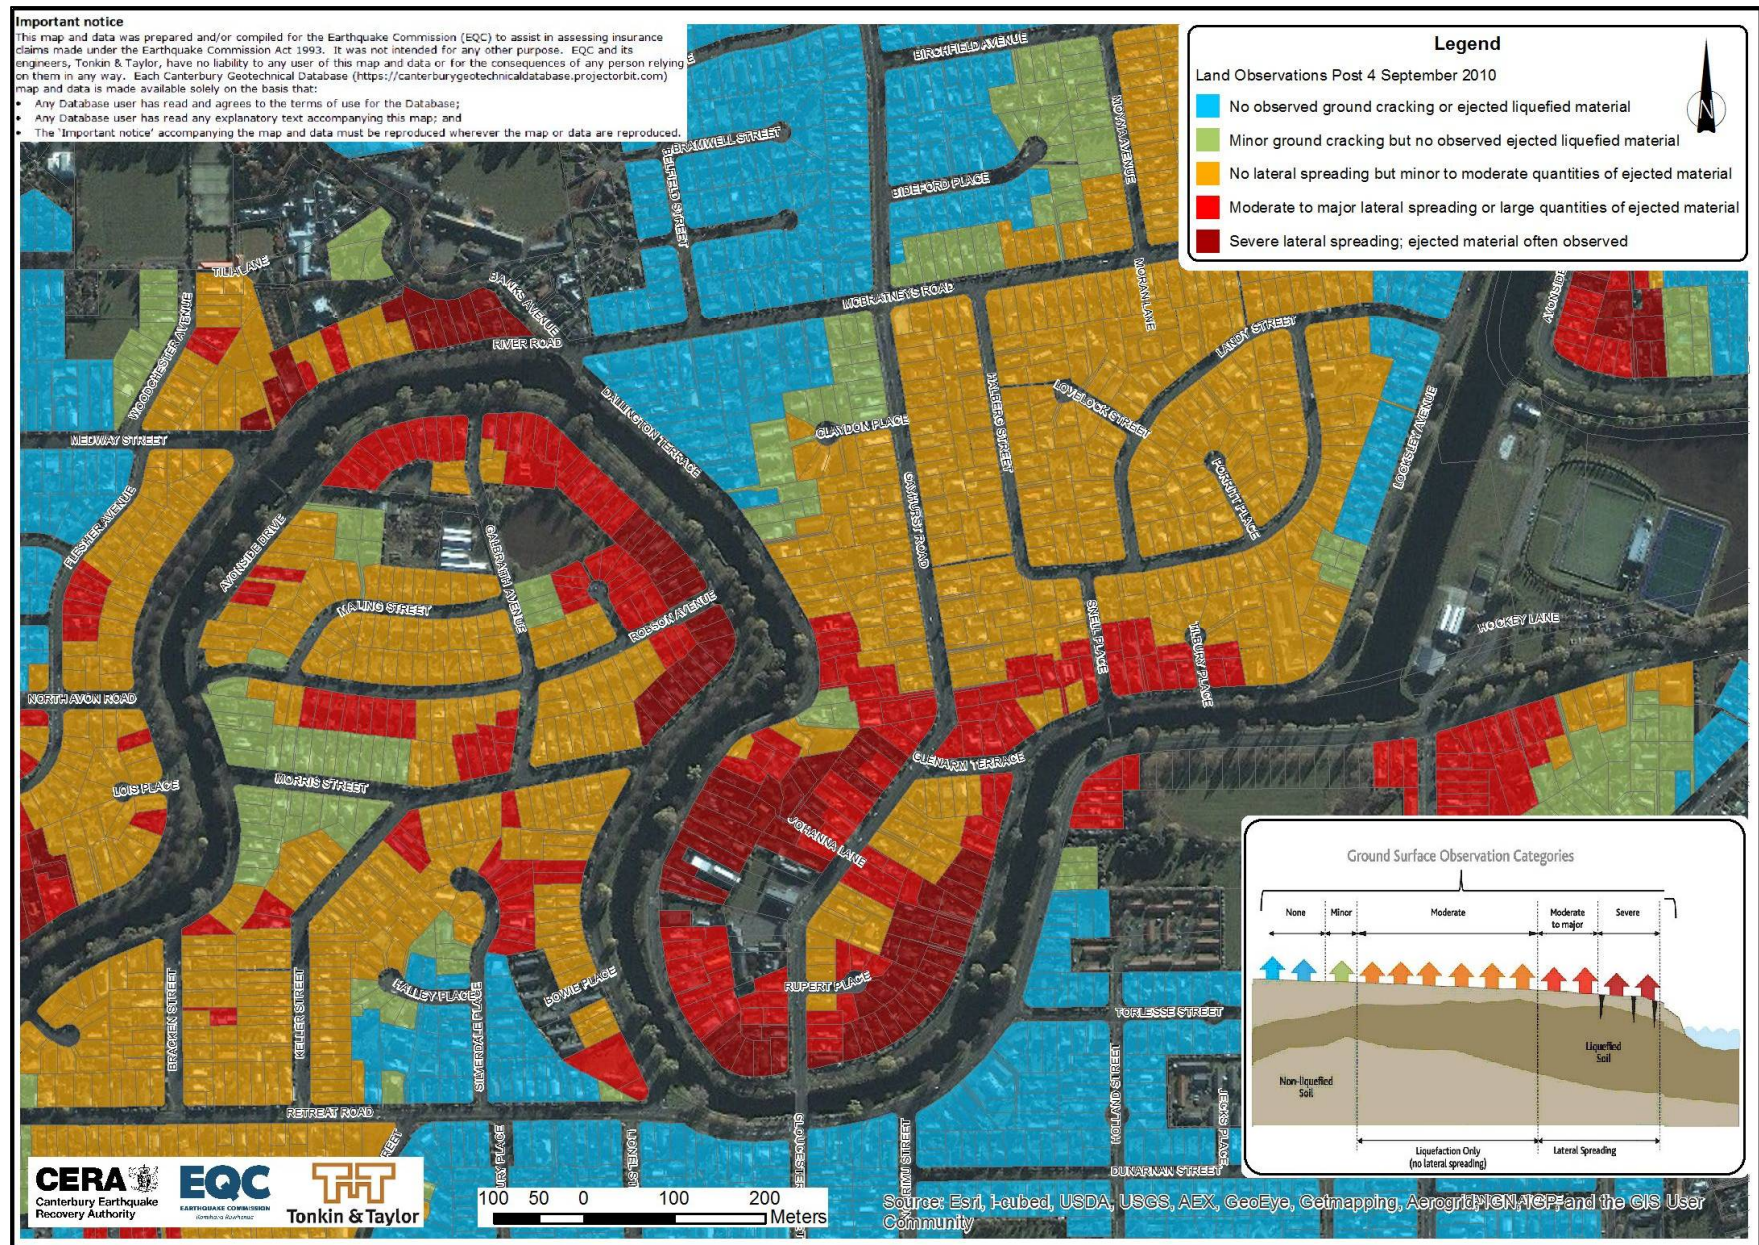
Figure 3 – Ground surface observations of liquefaction and lateral spreading following 4<sup>th</sup> September 2010 earthquake (from property-level ground mapping)

The quantities of material ejected due to liquefaction and observations of lateral spreading were collated from on-foot rapid inspection of individual properties following each significant earthquake. The observations were categorized according to the quantity of ejected material observed on the ground surface and according to the presence or absence of evidence of lateral spreading. Each of these three categories was further subdivided according to the severity. The colour coding used on these maps has completely different meaning to colours used by CERA for land zoning and DBH for technical categories.

The observations were collected for the Earthquake Commission and were only made in residential areas. The mapping only identified liquefaction and lateral spreading that was visible at the surface at the time of inspection. Liquefaction may have occurred at depth without obvious evidence at the surface and evidence of liquefaction may have been removed before the inspection. (Removed material may be identifiable within the aerial photographs that were taken within a day or two of the earthquake.)

The properties were not all inspected between each pair of consecutive earthquakes (e.g. between 4 Sept 2010 and 22 Feb 2011) so the extent of the land deformations is most likely incomplete. Also, some observations following the 22 Feb 2011 and 13 Jun 2011 earthquakes could have been induced by preceding earthquakes.

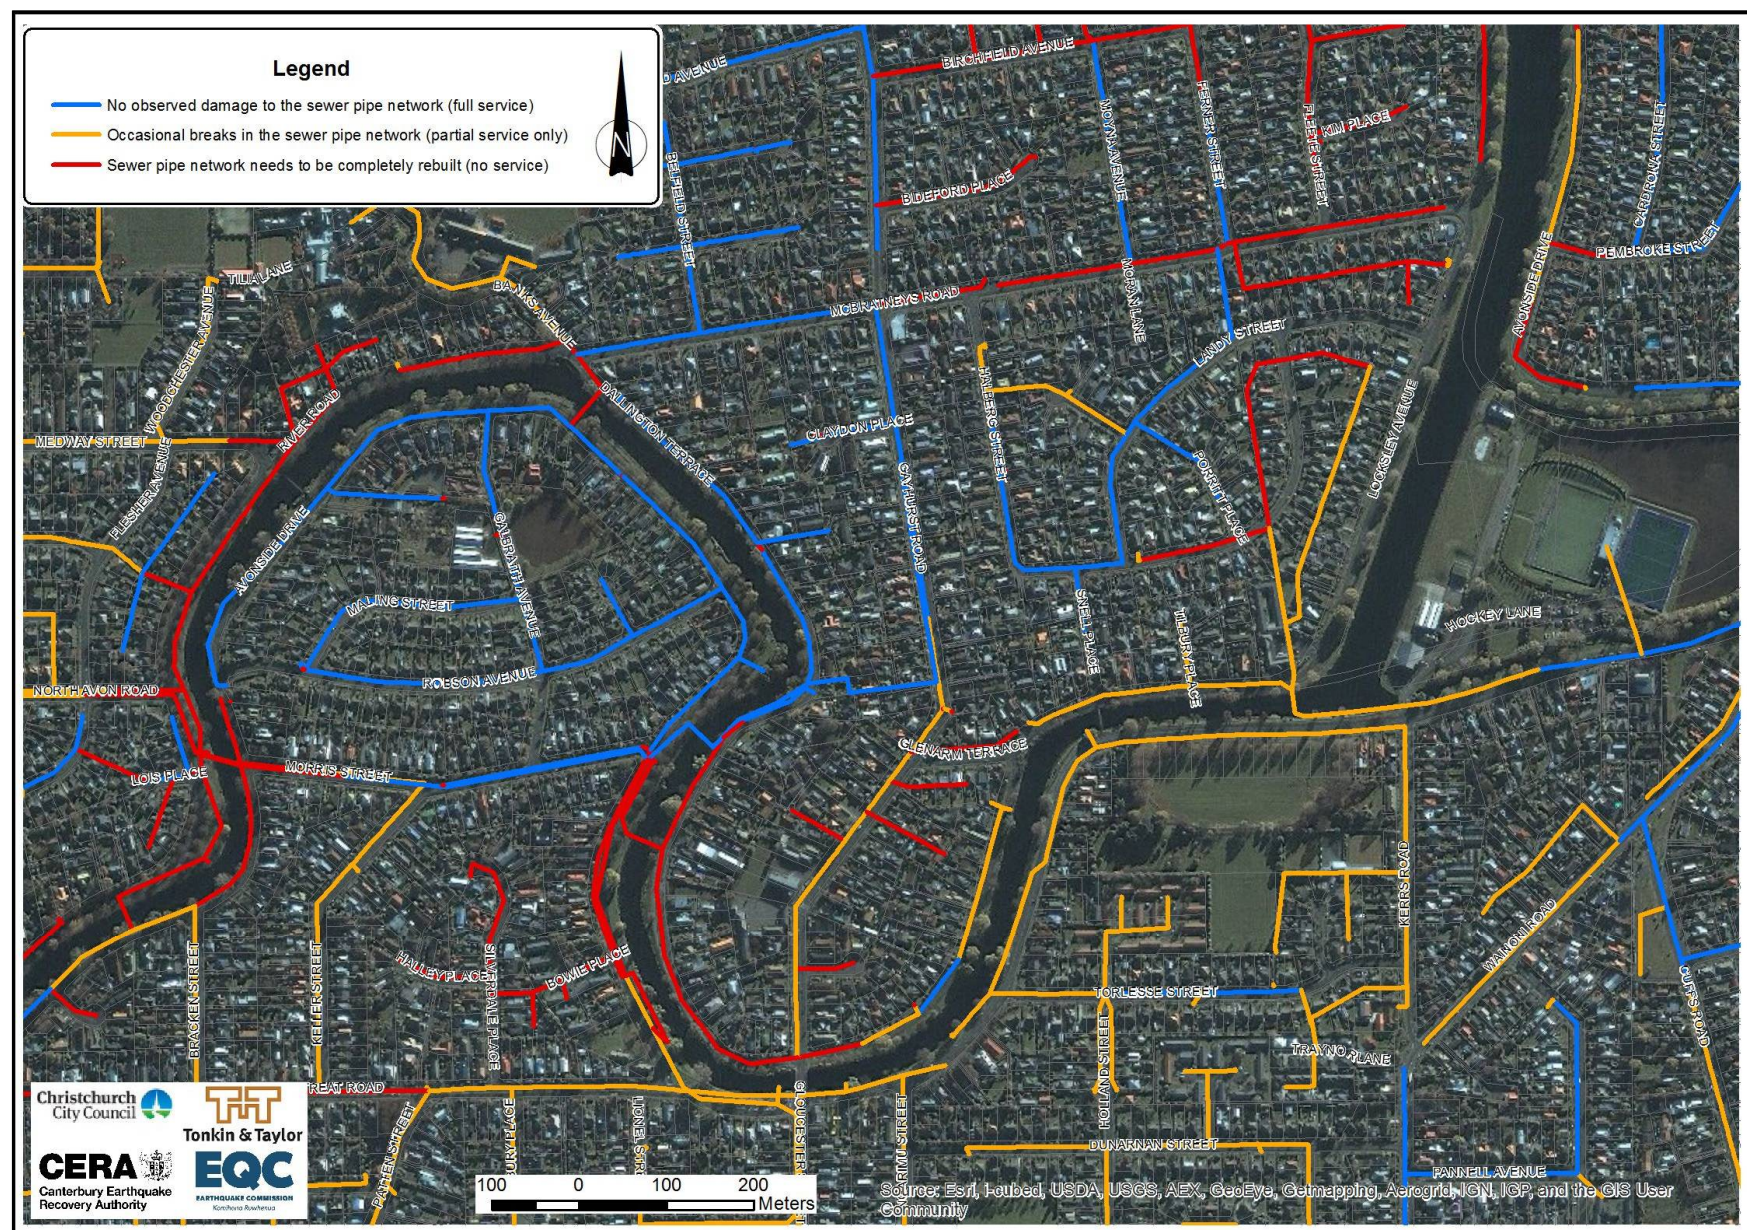
Figure 6 – Status of wastewater network as assessed at 20<sup>th</sup> April 2011 (NOW SUPERSEDED)

Since this map was compiled there has been significant additional assessment of the infrastructure network, so this map is now superseded. It is included only to show the best available information at the time of the zoning decisions. For an up to date assessment of the infrastructure network, SCIRT or the City Council should be consulted.

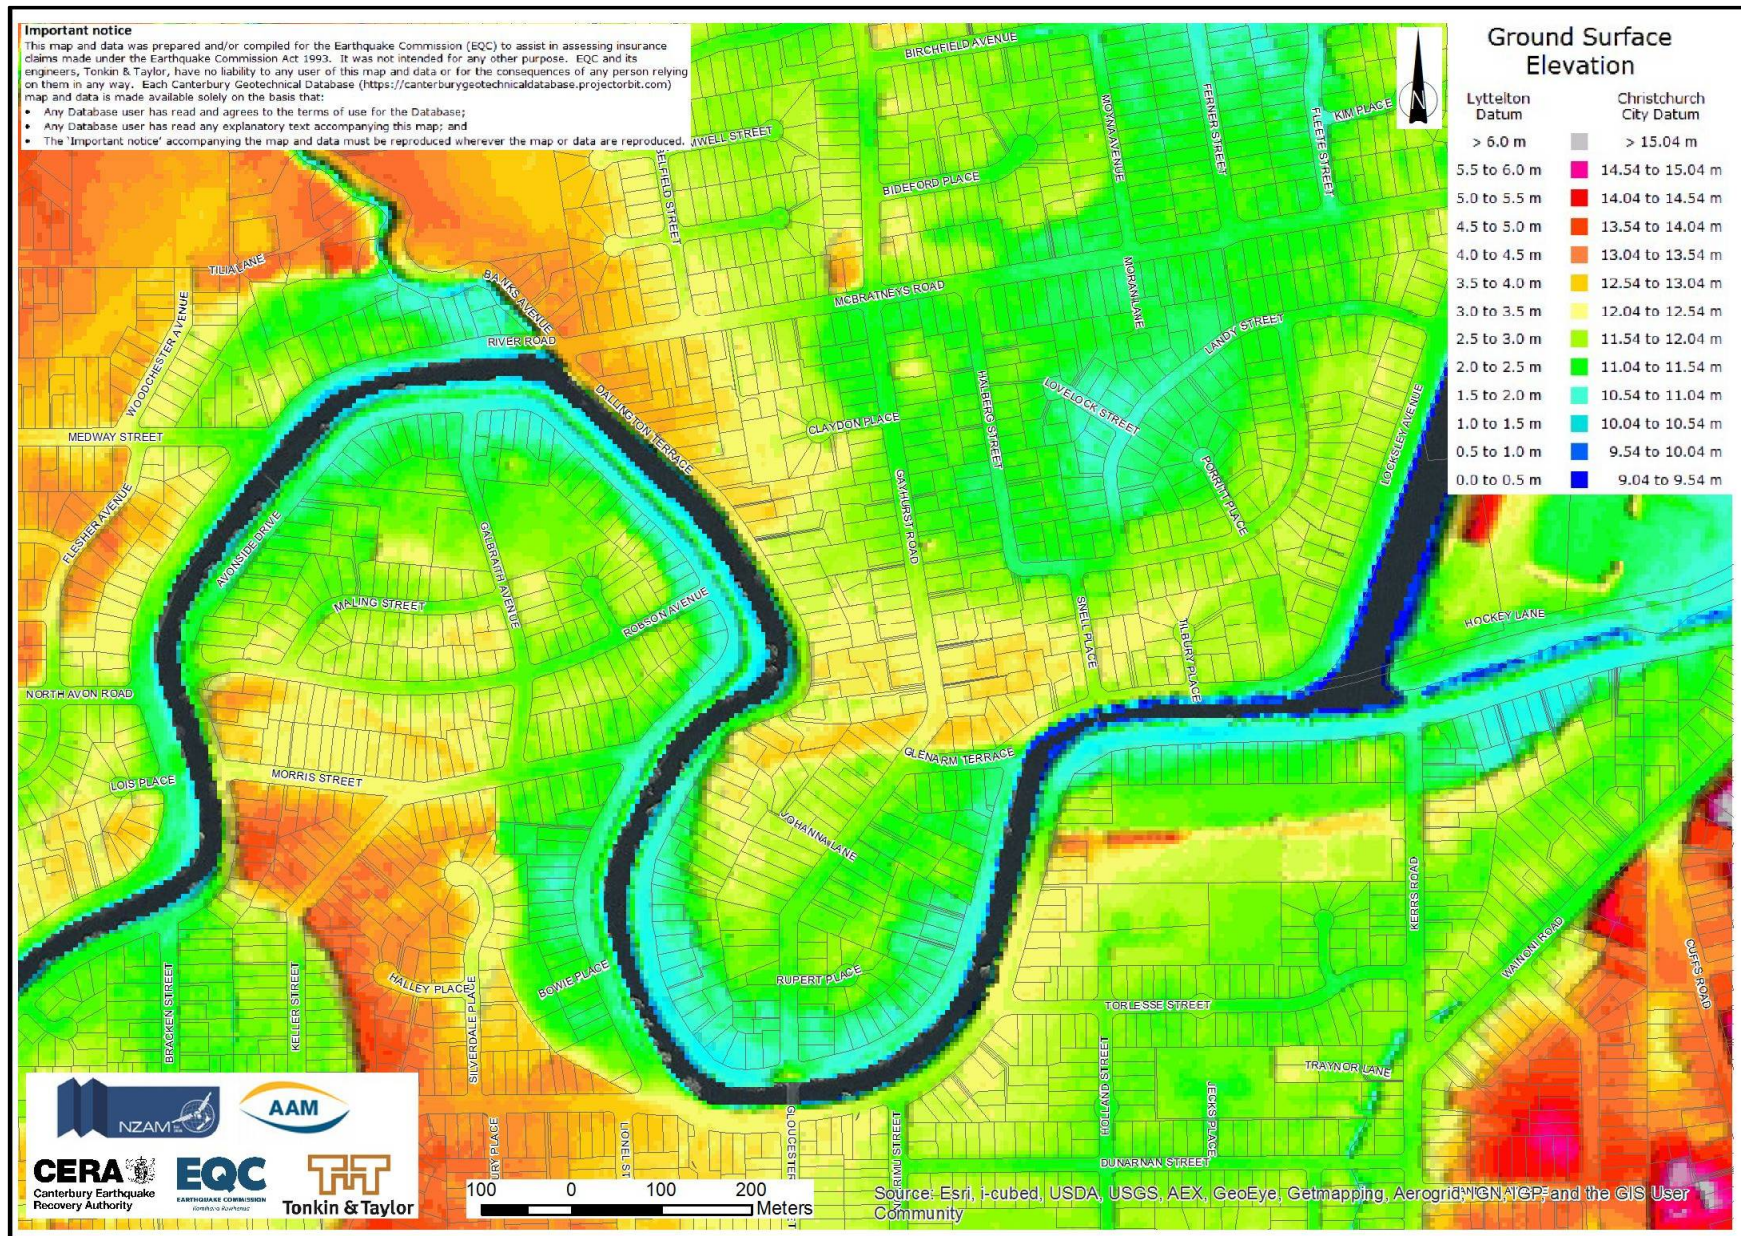
Figure 7 – Ground surface elevation from February 2012 survey

LiDAR was acquired following each of the significant earthquakes. A digital elevation model was developed from each supplied LiDAR set by averaging the ground-return elevations within a 10 m radius of each grid point. Metadata supplied with the source LiDAR indicates a vertical accuracy of  $\pm 0.07$  to  $\pm 0.15$  m (excluding GPS error and Geoid modelling error) and 0.40 to 0.55 m horizontal. The pre-earthquake LiDAR has lower accuracy and sparser LiDAR point sets than the post-earthquake sets.

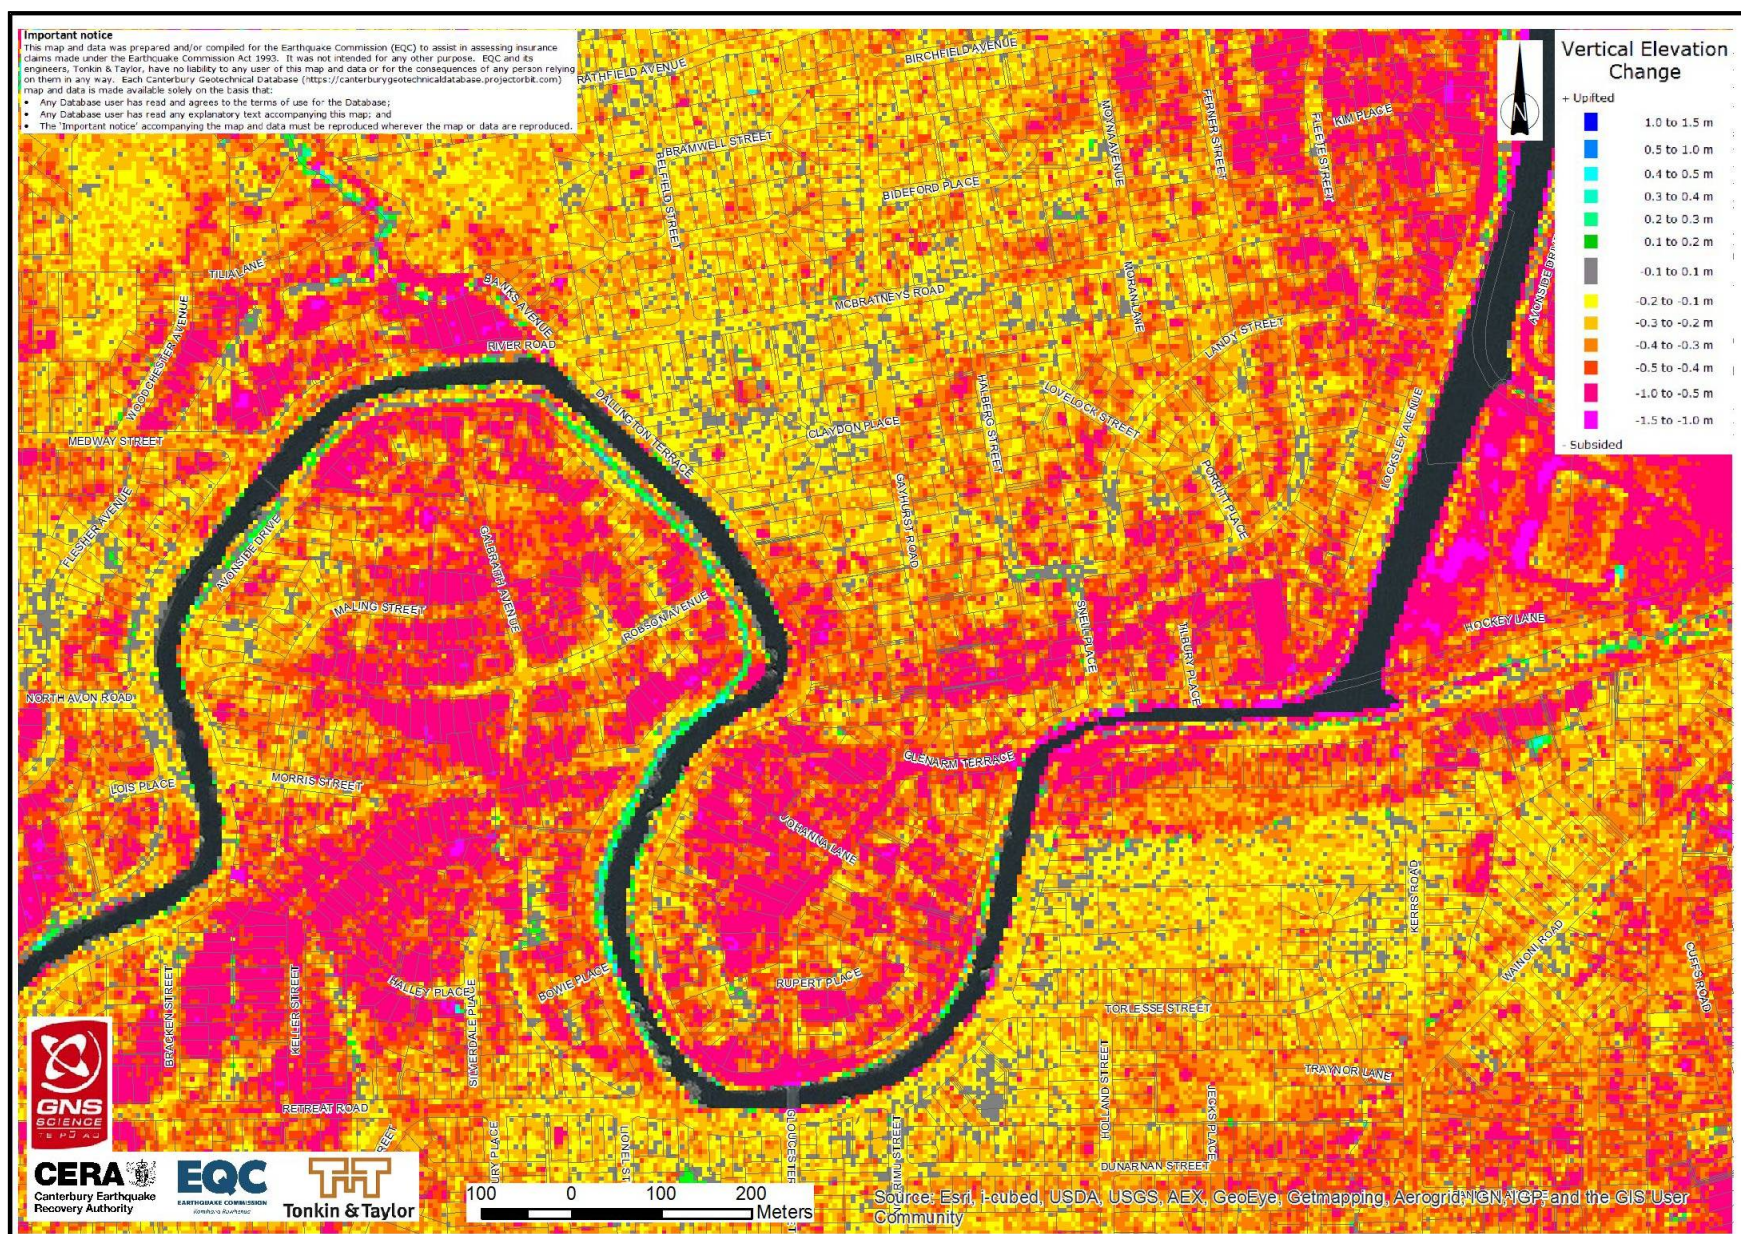
Figure 8 – Change in ground elevation between LiDAR in July 2003 and February 2012, with regional tectonic component of ground displacement removed

Vertical elevation changes between LiDAR sets that approximate the vertical ground movements during significant earthquakes. Elevation changes were calculated as differences between pairs of Digital Elevation Models (DEM). Local vertical movements were calculated as the differences between the 'observed' elevation differences and the regional tectonic displacement from GNS Science dislocation models of the vertical tectonic movements during each earthquake.

All of the movements are differences between DEMs and are inherently less accurate than their source DEM's. The pre-earthquake source DEM is less accurate than the post-earthquake DEMs. Some of the DEMs have visually distinguishable lines or ripples within the colour bands that are almost certainly artefacts from the data acquisition and subsequent processing rather than from physical vertical movements. Notable examples are several approximately NNE-SSW swathes visible in the Feb 2011 difference set and an almost E-W line at 43.48°S in the 13 Jun 2011 difference set.
