Area-wide geotechnical information summary for CERA zoning review panel

Table 1 – Area-wide geotechnical and engineering considerations for South New Brighton

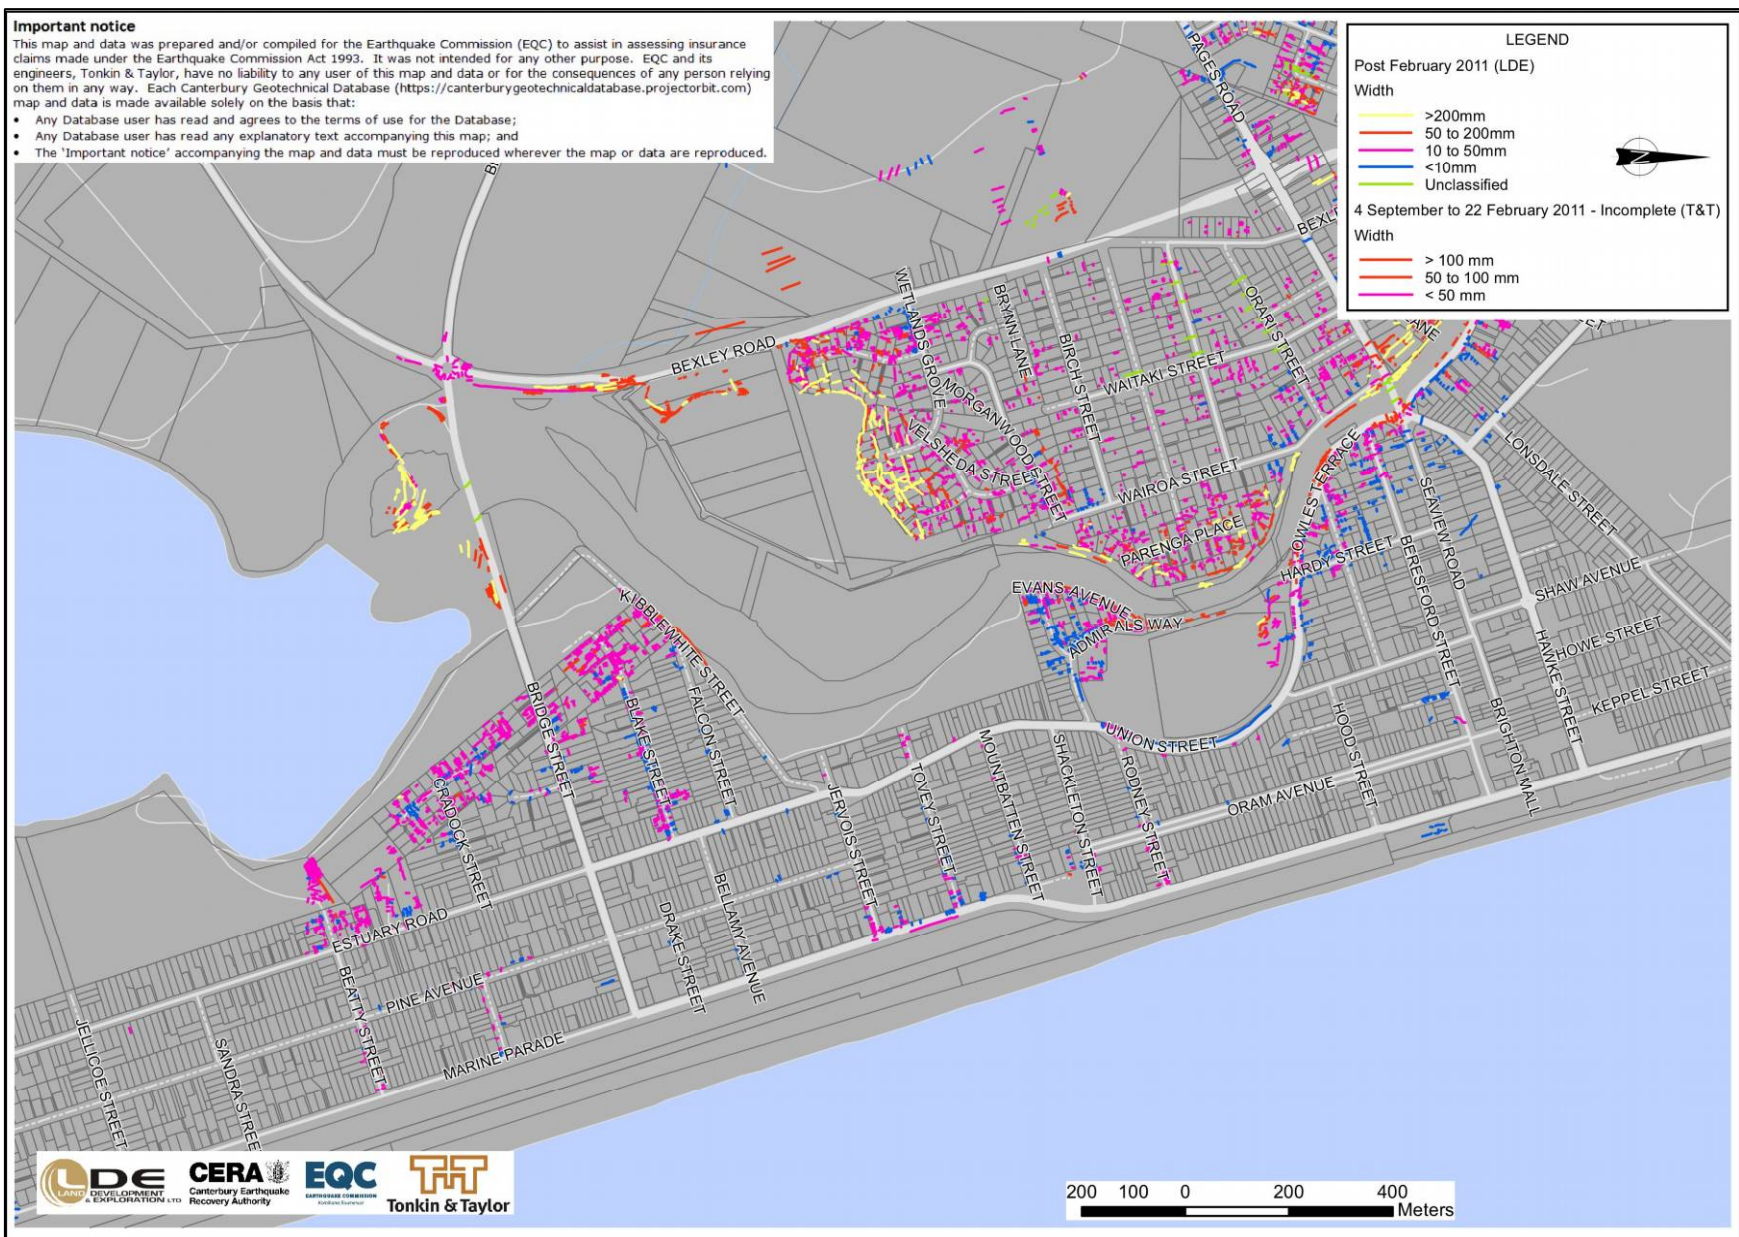
Figure 2 – Observed ground crack locations

Crack locations were mapped in order to infer the general direction, magnitude and extent of the lateral ground movements. The mapping objectives changed in response to the varying situation following the two earthquakes. Observations after the 4 Sept 2010 Earthquake were principally for insurance claim settlements. The crack widths were recorded in property-by-property observations, but cracks were not tracked across property boundaries and only a portion of properties were mapped before the 22 Feb 2011 Earthquake. Cracks were mapped at a scale of 1:5000 to 1:10000 for about two weeks following the 22 Feb 2011 Earthquake in order to rapidly identify the extent of lateral spreading following the earthquake. The individual crack widths were not recorded. From early March 2011, cracks were generally mapped at a scale of 1:2000 and classified according to their maximum width. Cracks were tracked through properties in order to identify regional patterns.

The crack mapping is incomplete and only observations made by the mapping teams are presented. In particular, the mapping following the 4 Sept 2010 Earthquake was incomplete before the 22 Feb 2011 Earthquake occurred and subsequent mapping remains incomplete within the residential 'red zone' areas. Also, cracks in roads were often not able to be mapped because many were filled and the roads resealed before a mapping team arrived.

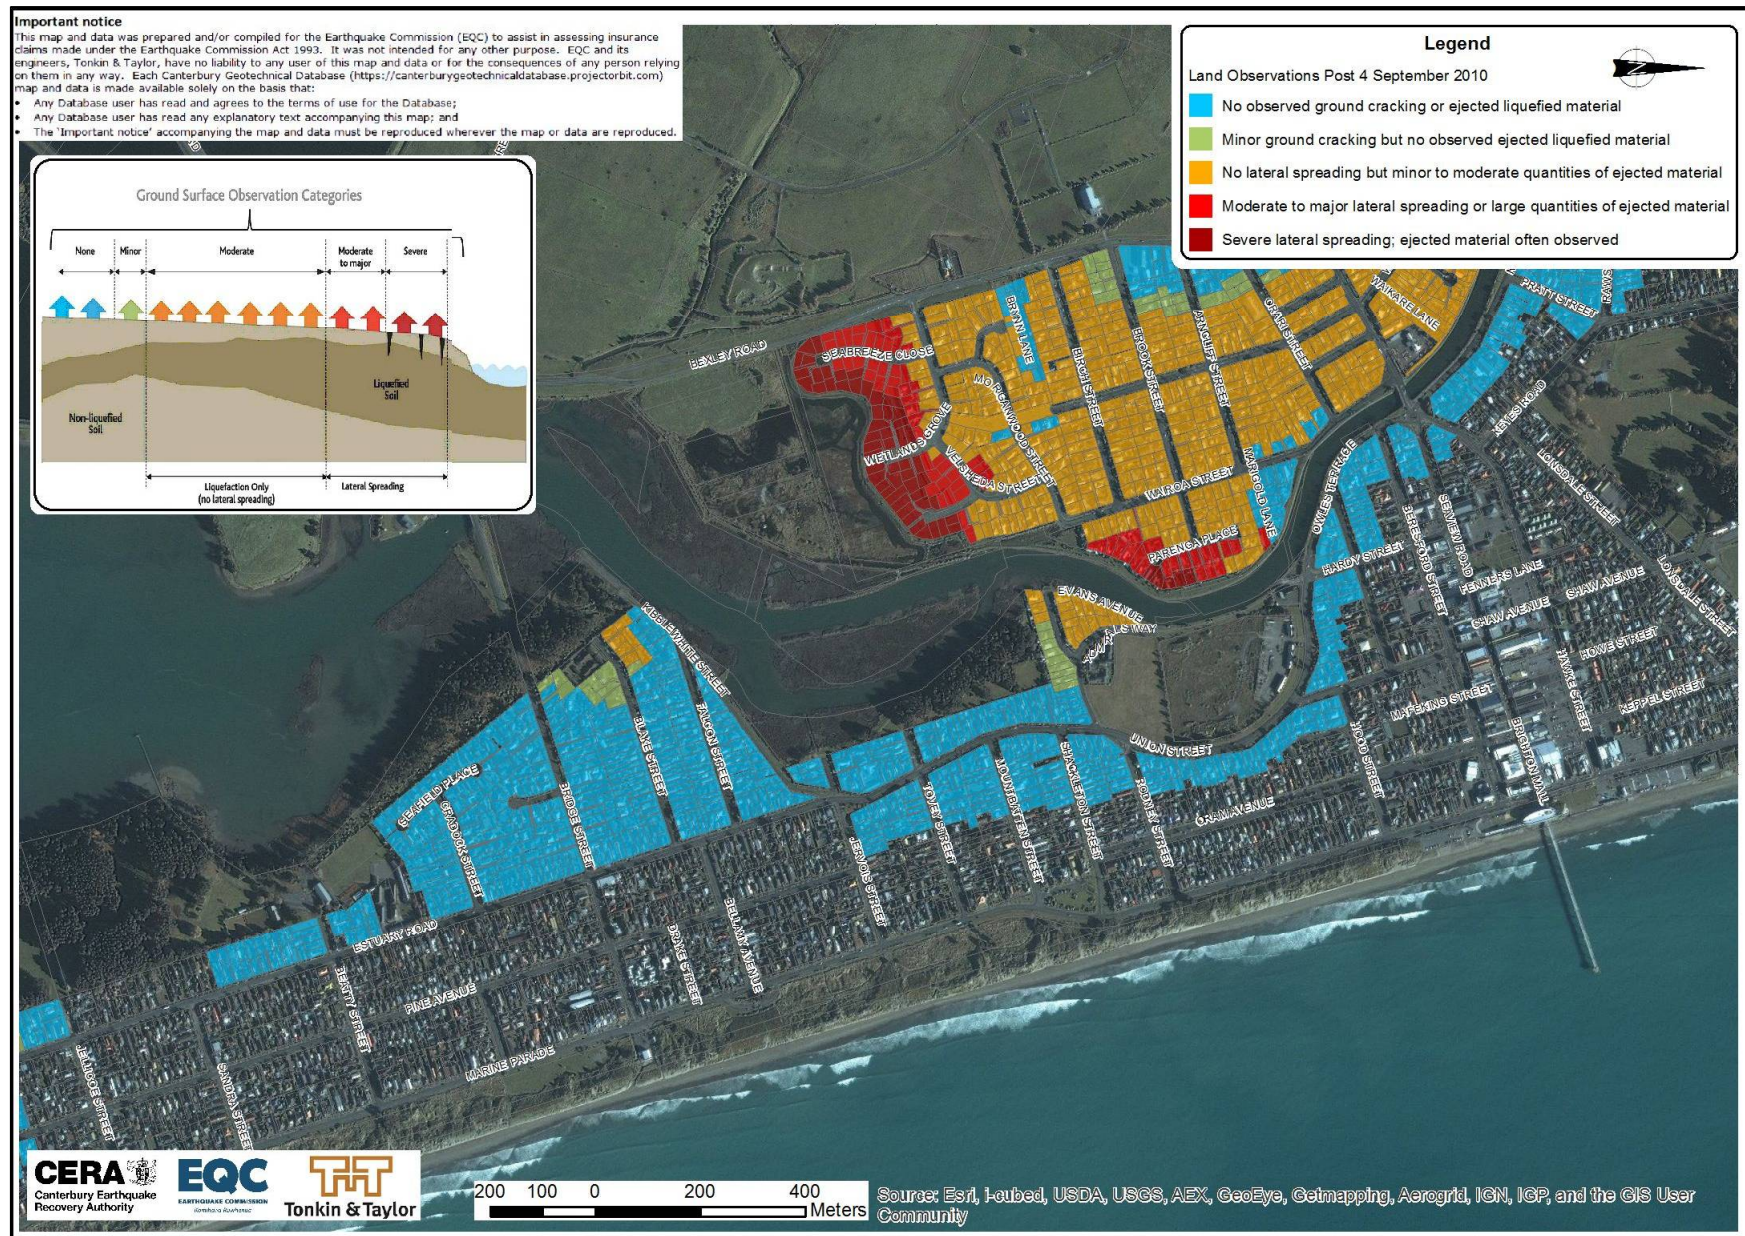
Figure 3 – Ground surface observations of liquefaction and lateral spreading following 4th September 2010 earthquake (from property-level ground mapping)

The quantities of material ejected due to liquefaction and observations of lateral spreading were collated from on-foot rapid inspection of individual properties following each significant earthquake. The observations were categorized according to the quantity of ejected material observed on the ground surface and according to the presence or absence of evidence of lateral spreading. Each of these three categories was further subdivided according to the severity. The colour coding used on these maps has completely different meaning to colours used by CERA for land zoning and DBH for technical categories.

The observations were collected for the Earthquake Commission and were only made in residential areas. The mapping only identified liquefaction and lateral spreading that was visible at the surface at the time of inspection. Liquefaction may have occurred at depth without obvious evidence at the surface and evidence of liquefaction may have been removed before the inspection. (Removed material may be identifiable within the aerial photographs that were taken within a day or two of the earthquake.)

The properties were not all inspected between each pair of consecutive earthquakes (e.g. between 4 Sept 2010 and 22 Feb 2011) so the extent of the land deformations is most likely incomplete. Also, some observations following the 22 Feb 2011 and 13 Jun 2011 earthquakes could have been induced by preceding earthquakes.

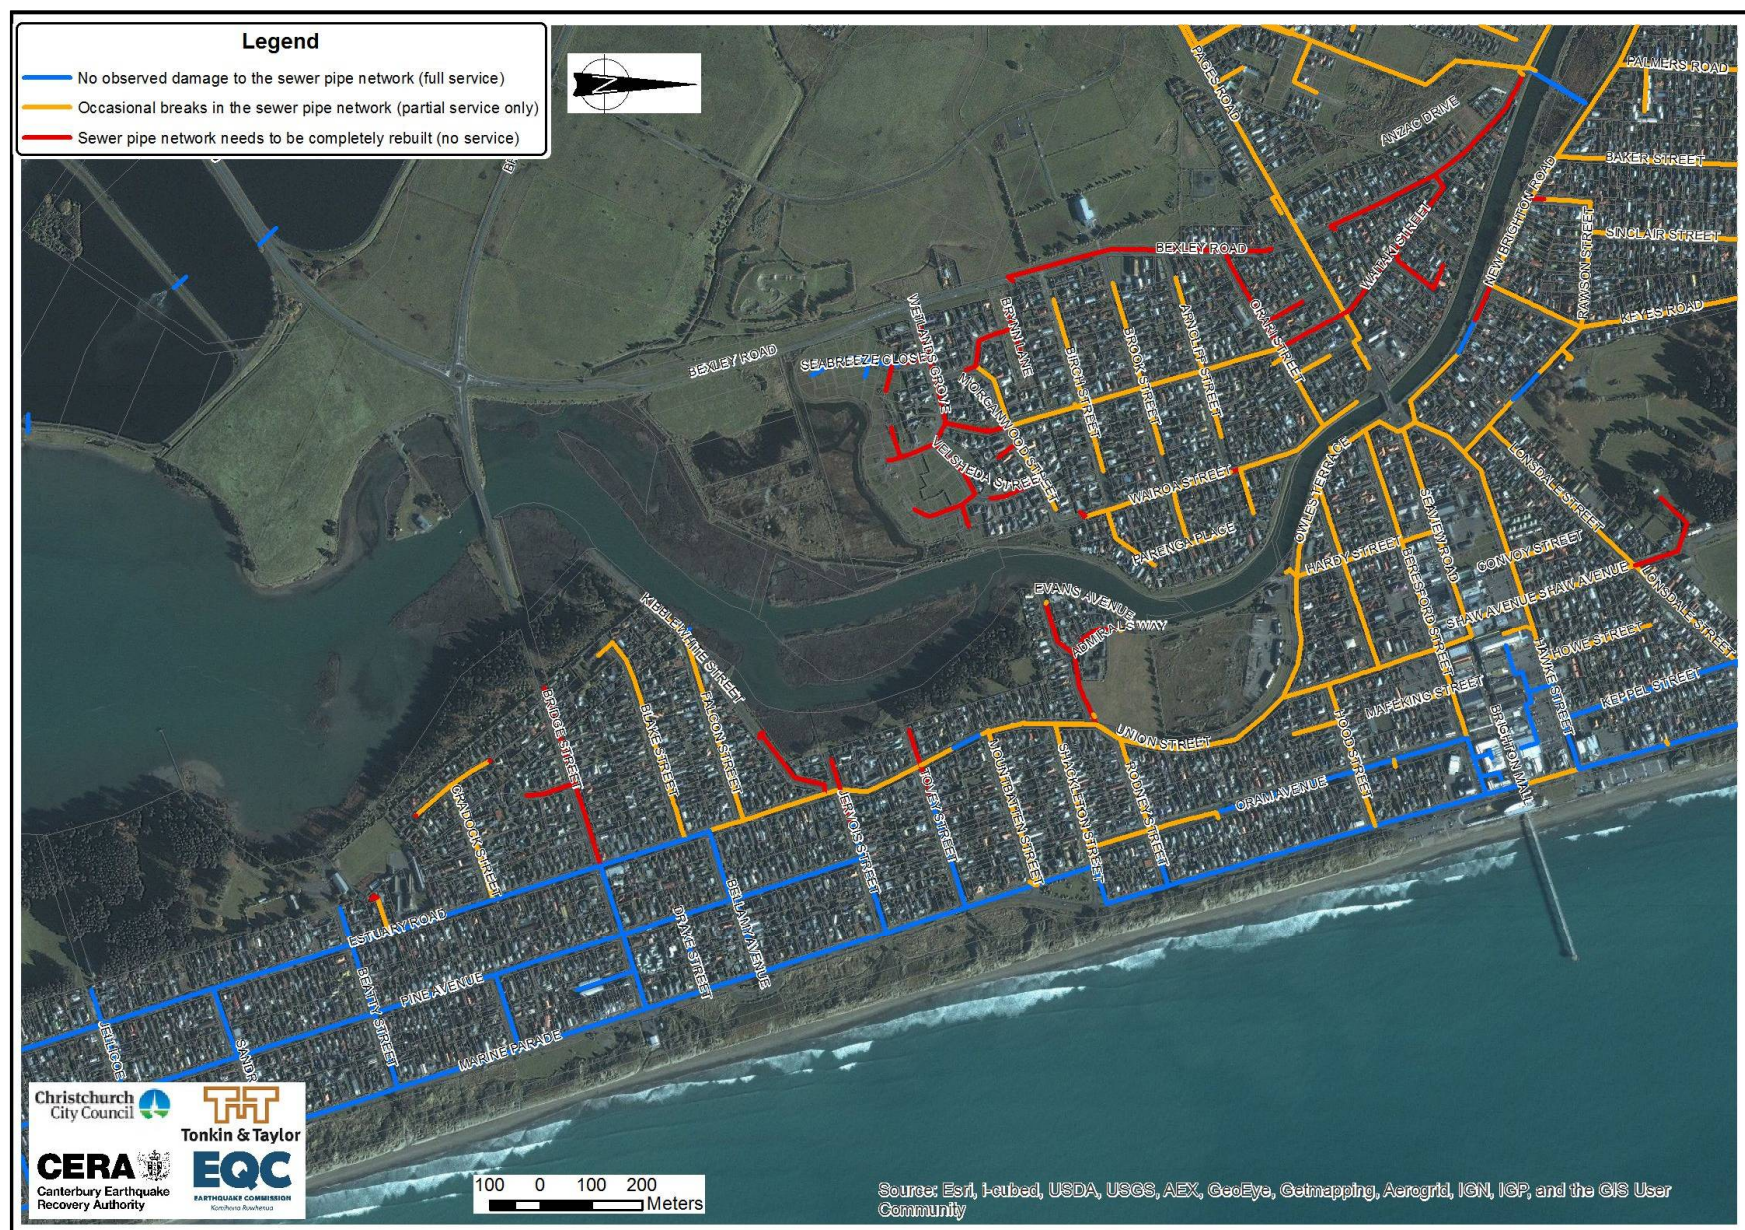
Figure 6 – Status of wastewater network as assessed at 20th April 2011 (NOW SUPERSEDED)

Since this map was compiled there has been significant additional assessment of the infrastructure network, so this map is now superseded. It is included only to show the best available information at the time of the zoning decisions. For an up to date assessment of the infrastructure network, SCIRT or the City Council should be consulted.

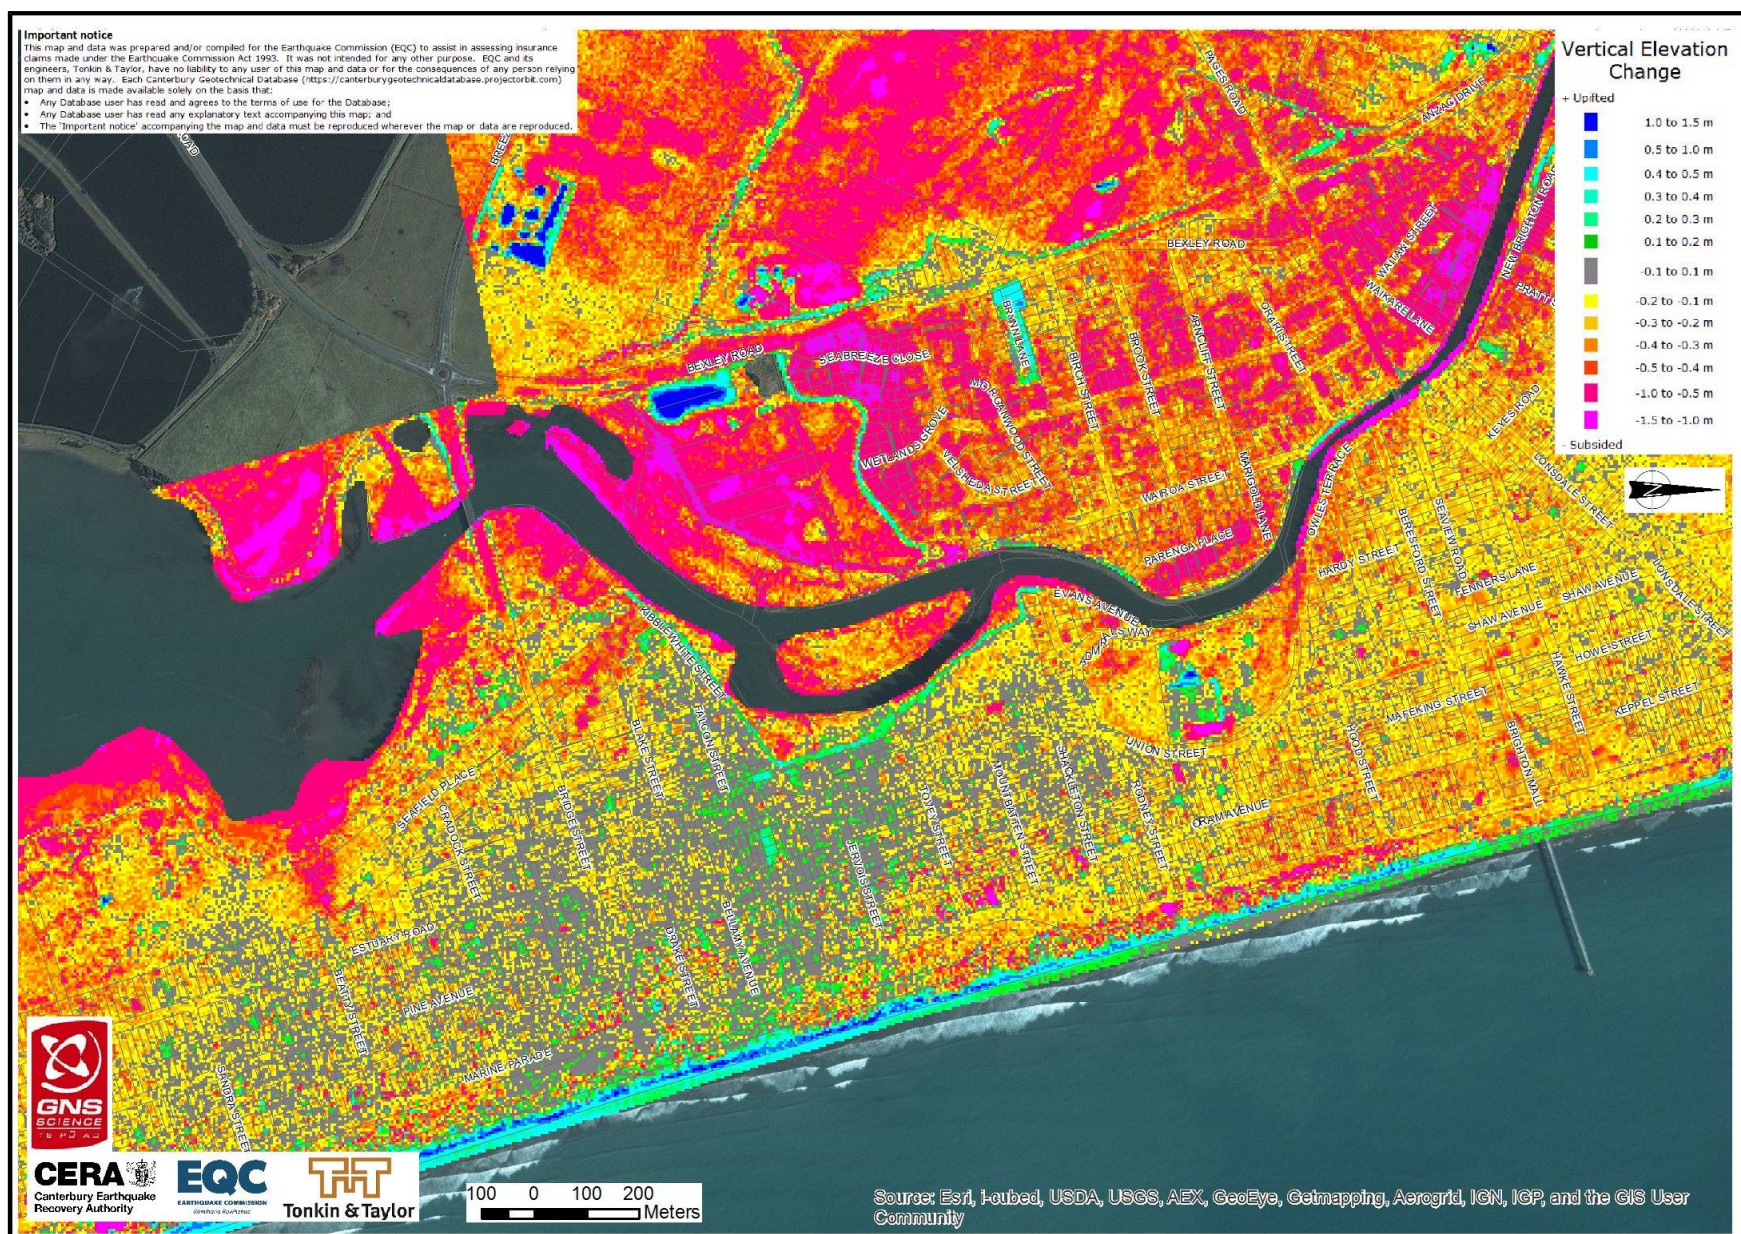
Figure 8 – Change in ground elevation between LiDAR in July 2003 and February 2012, with regional tectonic component of ground displacement removed

Vertical elevation changes between LiDAR sets that approximate the vertical ground movements during significant earthquakes. Elevation changes were calculated as differences between pairs of Digital Elevation Models (DEM). Local vertical movements were calculated as the differences between the 'observed' elevation differences and the regional tectonic displacement from GNS Science dislocation models of the vertical tectonic movements during each earthquake.

All of the movements are differences between DEMs and are inherently less accurate than their source DEM's. The pre-earthquake source DEM is less accurate than the post-earthquake DEMs. Some of the DEMs have visually distinguishable lines or ripples within the colour bands that are almost certainly artefacts from the data acquisition and subsequent processing rather than from physical vertical movements. Notable examples are several approximately NNE-SSW swathes visible in the Feb 2011 difference set and an almost E-W line at 43.48°S in the 13 Jun 2011 difference set.
