## Area-wide geotechnical information summary for CERA zoning review panel

This document contains all the area-wide geotechnical information which was considered by CERA as part of the process for making flat-land zoning decisions, and the subsequent zoning review.

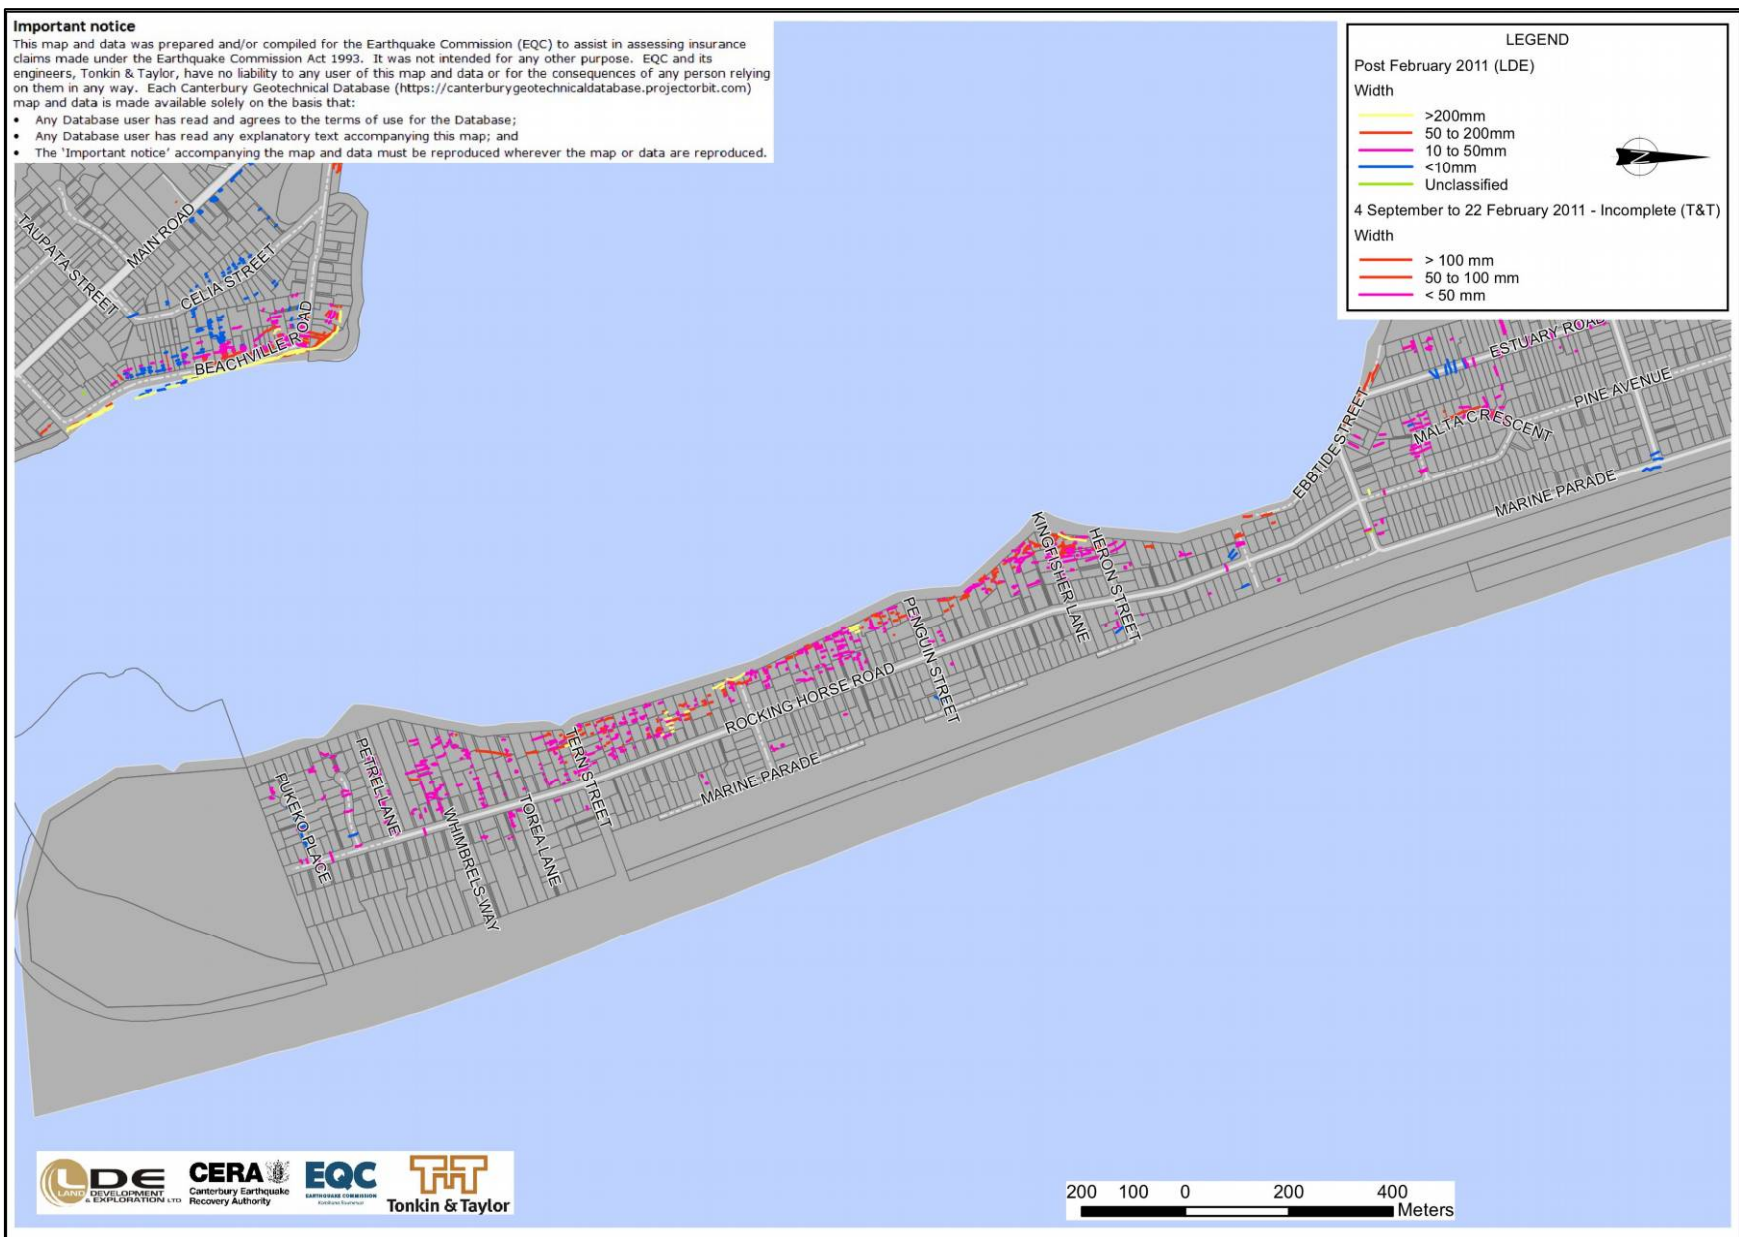
Figure 2 – Observed ground crack locations

Crack locations were mapped in order to infer the general direction, magnitude and extent of the lateral ground movements. The mapping objectives changed in response to the varying situation following the two earthquakes. Observations after the 4 Sept 2010 Earthquake were principally for insurance claim settlements. The crack widths were recorded in property-by-property observations, but cracks were not tracked across property boundaries and only a portion of properties were mapped before the 22 Feb 2011 Earthquake. Cracks were mapped at a scale of 1:5000 to 1:10000 for about two weeks following the 22 Feb 2011 Earthquake in order to rapidly identify the extent of lateral spreading following the earthquake. The individual crack widths were not recorded. From early March 2011, cracks were generally mapped at a scale of 1:2000 and classified according to their maximum width. Cracks were tracked through properties in order to identify regional patterns.

The crack mapping is incomplete and only observations made by the mapping teams are presented. In particular, the mapping following the 4 Sept 2010 Earthquake was incomplete before the 22 Feb 2011 Earthquake occurred and subsequent mapping remains incomplete within the residential 'red zone' areas. Also, cracks in roads were often not able to be mapped because many were filled and the roads resealed before a mapping team arrived.

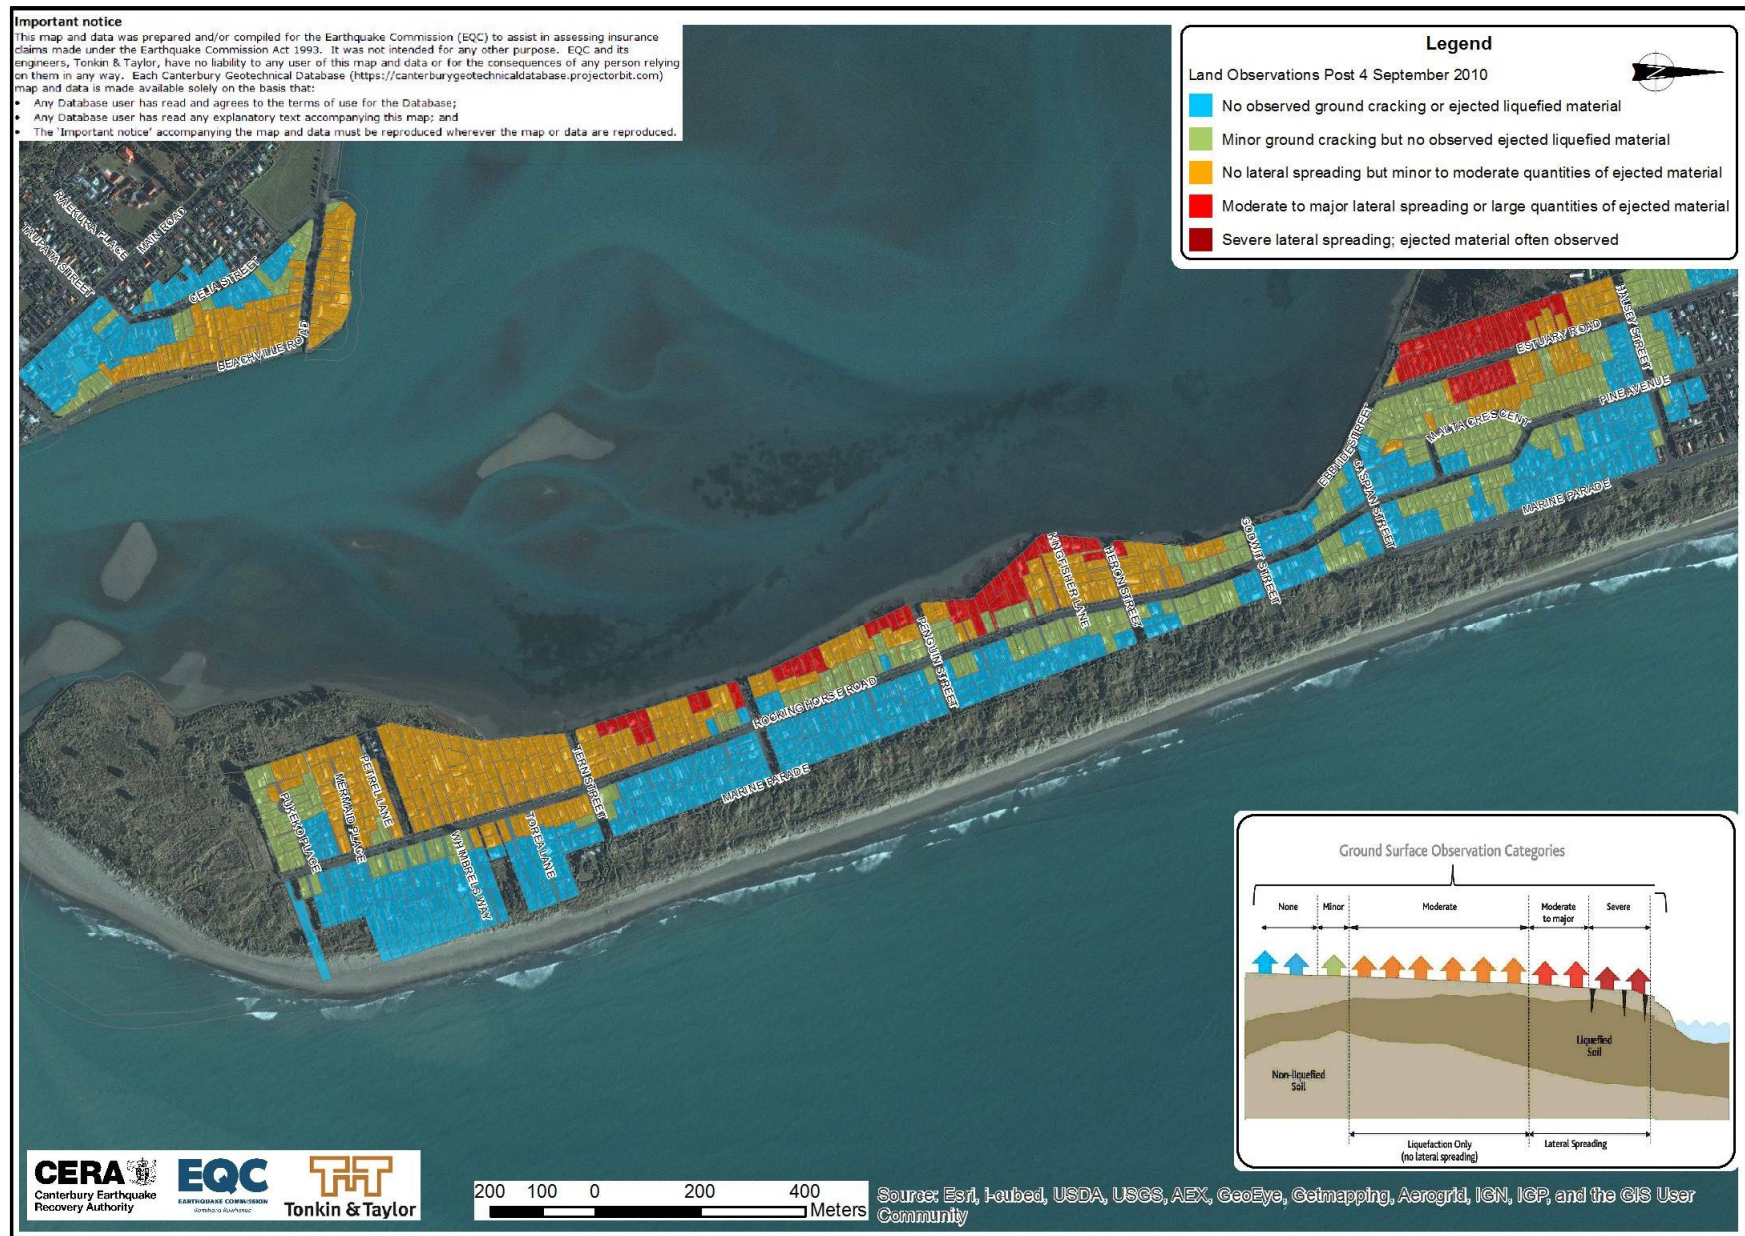
Figure 3 – Ground surface observations of liquefaction and lateral spreading following 4<sup>th</sup> September 2010 earthquake (from property-level ground mapping)

The quantities of material ejected due to liquefaction and observations of lateral spreading were collated from on-foot rapid inspection of individual properties following each significant earthquake. The observations were categorized according to the quantity of ejected material observed on the ground surface and according to the presence or absence of evidence of lateral spreading. Each of these three categories was further subdivided according to the severity. The colour coding used on these maps has completely different meaning to colours used by CERA for land zoning and DBH for technical categories.

The observations were collected for the Earthquake Commission and were only made in residential areas. The mapping only identified liquefaction and lateral spreading that was visible at the surface at the time of inspection. Liquefaction may have occurred at depth without obvious evidence at the surface and evidence of liquefaction may have been removed before the inspection. (Removed material may be identifiable within the aerial photographs that were taken within a day or two of the earthquake.)

The properties were not all inspected between each pair of consecutive earthquakes (e.g. between 4 Sept 2010 and 22 Feb 2011) so the extent of the land deformations is most likely incomplete. Also, some observations following the 22 Feb 2011 and 13 Jun 2011 earthquakes could have been induced by preceding earthquakes.

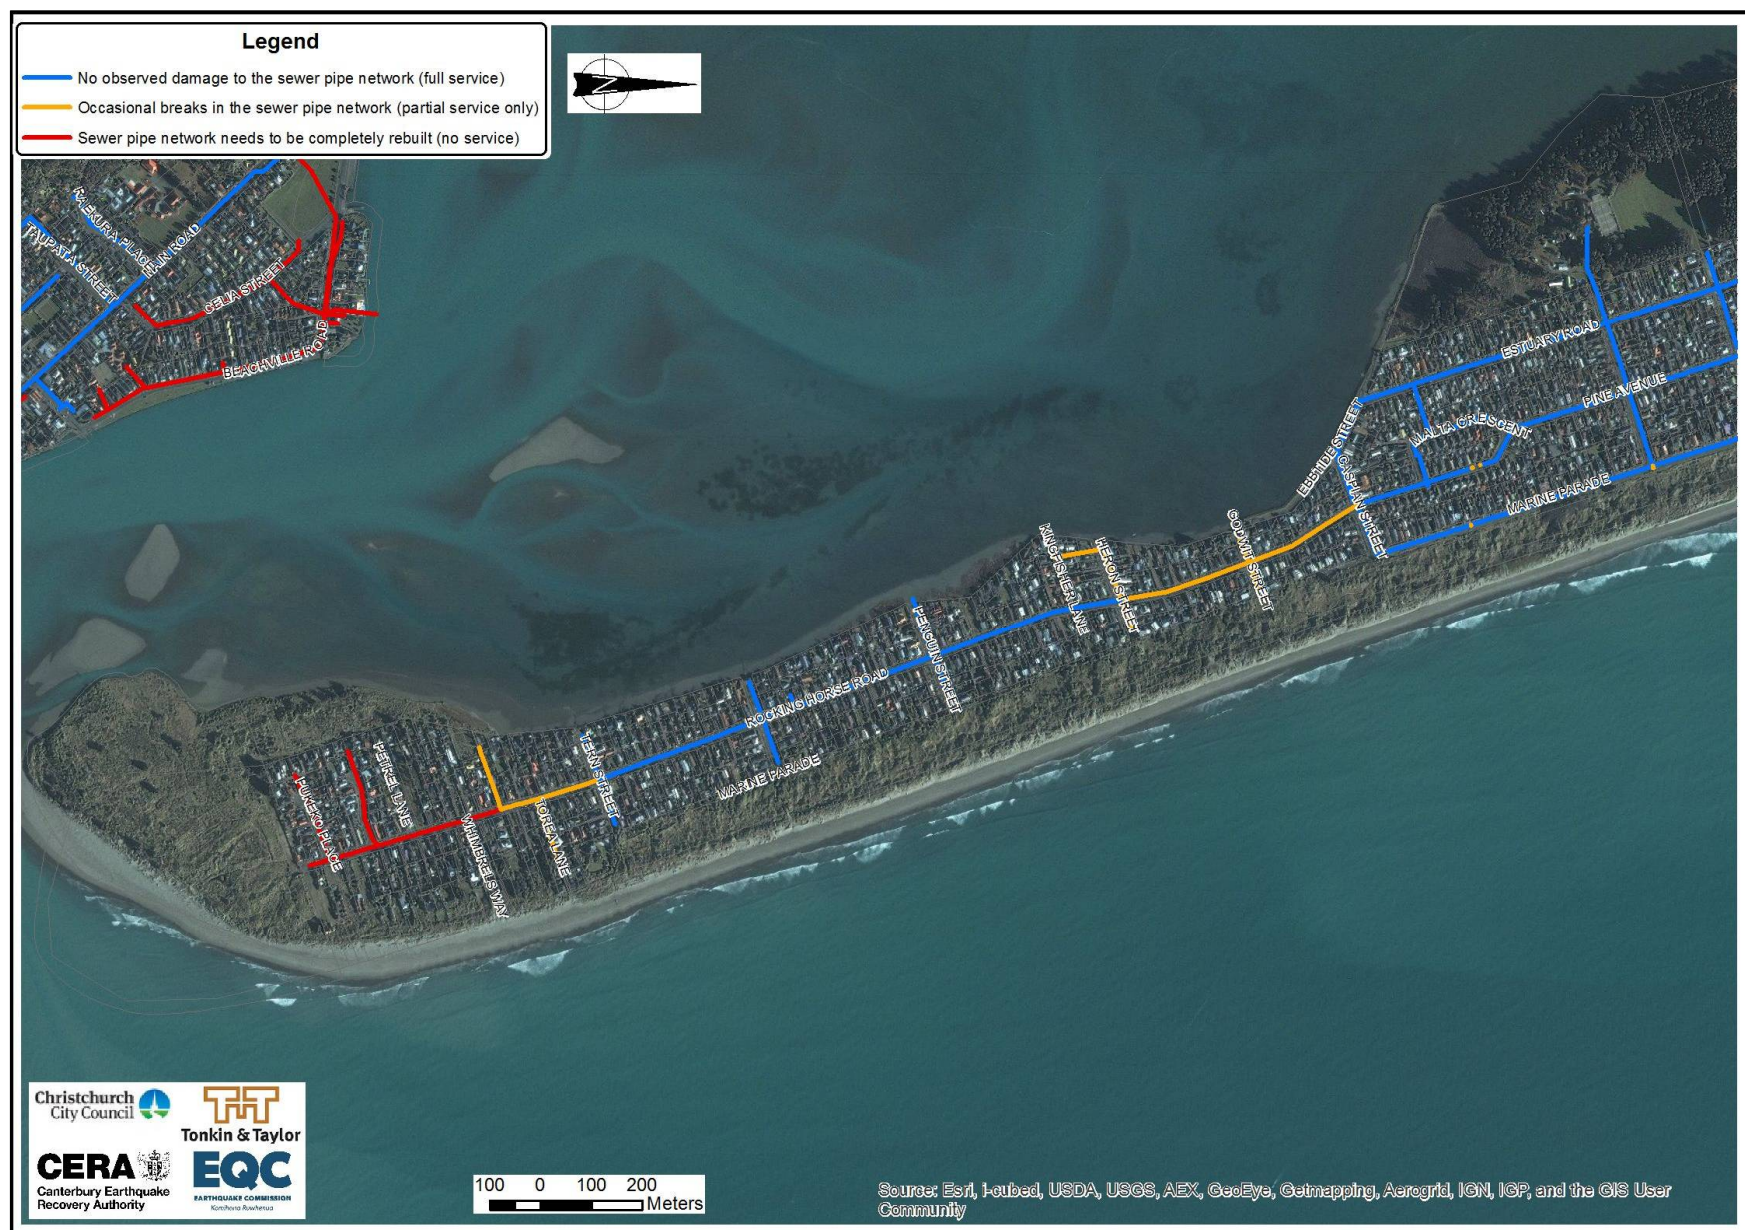
Figure 6 – Status of wastewater network as assessed at 20<sup>th</sup> April 2011 (NOW SUPERSEDED)

Since this map was compiled there has been significant additional assessment of the infrastructure network, so this map is now superseded. It is included only to show the best available information at the time of the zoning decisions. For an up to date assessment of the infrastructure network, SCIRT or the City Council should be consulted.

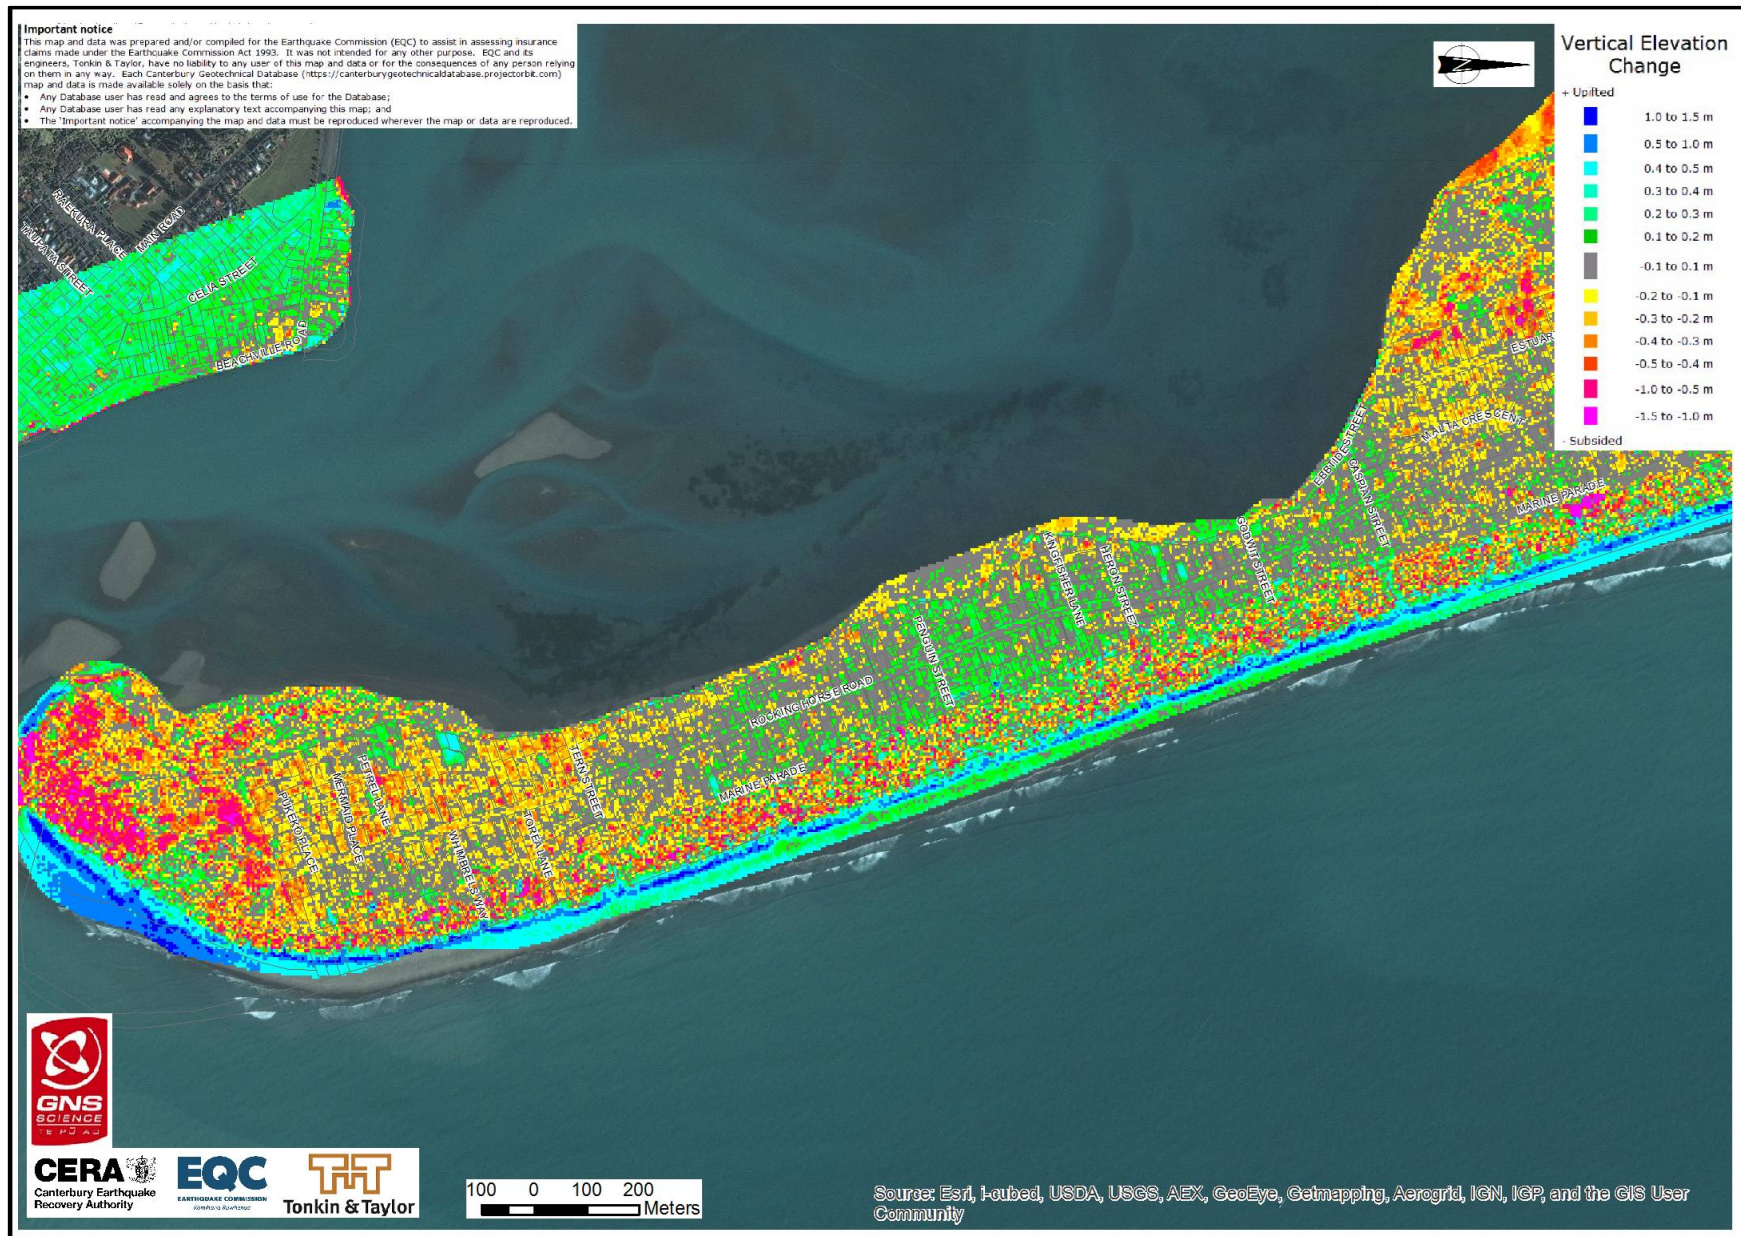
Figure 8b – Total change in ground elevation between LiDAR in Jul-03 and Feb-12 (i.e. without regional tectonic component of ground displacement removed)

Vertical elevation changes between LiDAR sets that approximate the vertical ground movements during significant earthquakes. Elevation changes were calculated as differences between pairs of Digital Elevation Models (DEM). Local vertical movements were calculated as the differences between the 'observed' elevation differences and the regional tectonic displacement from GNS Science dislocation models of the vertical tectonic movements during each earthquake.

All of the movements are differences between DEMs and are inherently less accurate than their source DEM's. The pre-earthquake source DEM is less accurate than the post-earthquake DEMs. Some of the DEMs have visually distinguishable lines or ripples within the colour bands that are almost certainly artefacts from the data acquisition and subsequent processing rather than from physical vertical movements. Notable examples are several approximately NNE-SSW swathes visible in the Feb 2011 difference set and an almost E-W line at 43.48°S in the 13 Jun 2011 difference set.

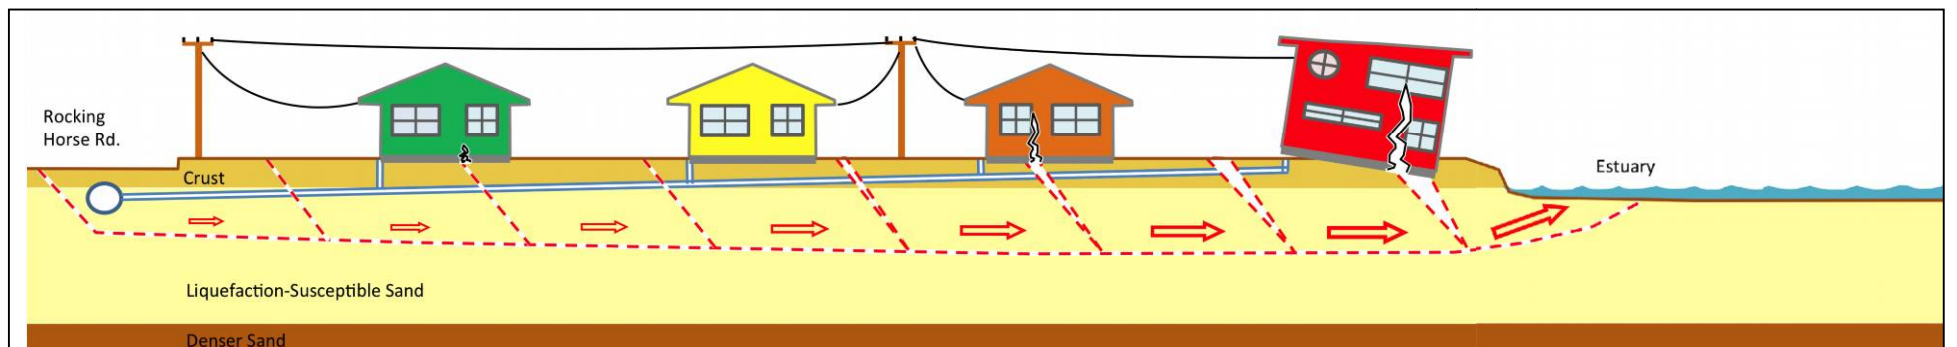
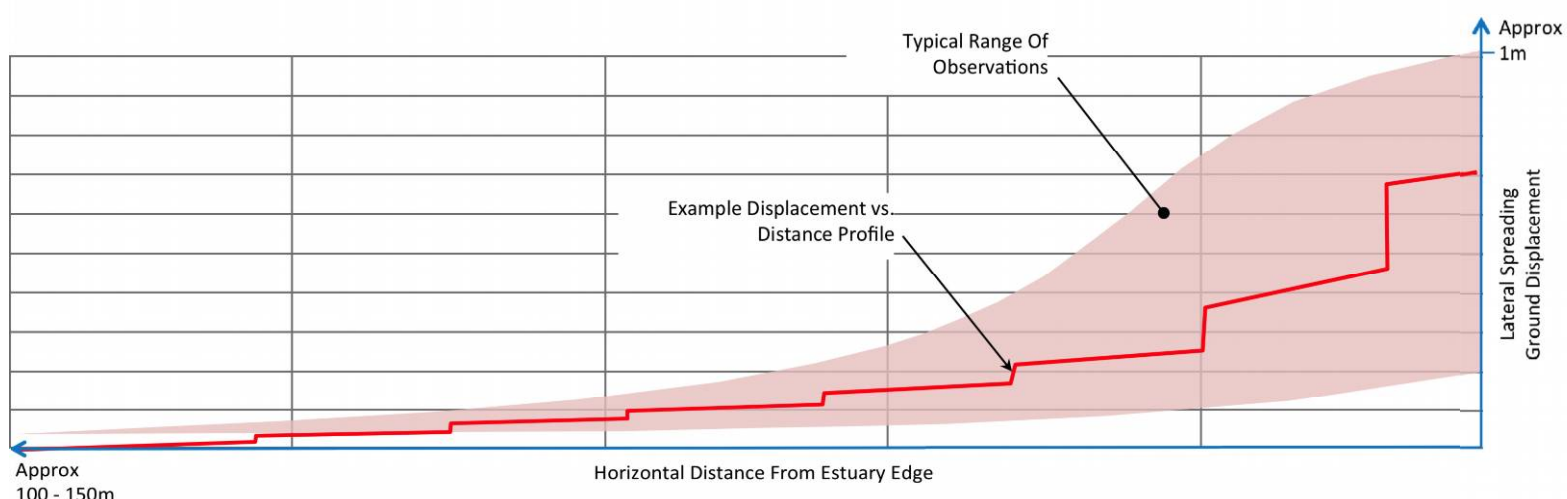
Figure 9 - Typical Post-Earthquake Observations - From Sep-10, Feb-11 & Jun-11 Earthquakes Combined

Observed land performance: Earthquake shaking between SLS and ULS design levels experienced, but with short duration of shaking (lateral spreading may be more severe in longer design EQ)

<b>Global Lateral Movement</b> (DBH Guidance C2.2.1)	Minor 0 - 100mm	Minor to Moderate 50 - 200mm	Moderate to Major 100 - 500mm	Major, with some Severe 600 - 1000mm in some areas 100 - 400mm in remaining areas
<b>Lateral Ground Stretching</b> (DBH Guidance C2.2.2)	Minor 0 - 50mm across footprint	Minor to Moderate 0 - 150mm across footprint	Moderate to Major 100 - 400mm across footprint	Major, with some Severe 200 - 500+ mm across footprint
<b>Building Damage - Old</b> (For existing old foundations)	Mostly minor to moderate damage, relatively simple repair	Moderate damage, generally repairable	High % with major damage, some able to be repaired	High % damaged beyond economic repair
<b>Infrastructure Damage</b>	Widespread major damage to trunk pipelines and lateral lines due to lateral stretching and general liquefaction. Moderate damage to roads due to stretching and general liquefaction. Localised stretching of powerlines.

<b>Post-EQ Habitability</b>	Most homes remain safe and habitable. Short-term loss of services due to damaged public trunk lines.		Some homes uninhabitable. Medium-term loss of services due to damaged private lateral lines.	Many homes unsafe.
