APPENDIX 5: THE STABILISATION AND REINSTATEMENT OF THE CATHEDRAL – CONCEPT REVIEW

ChristChurch Cathedral Working Group

The Stabilisation and Reinstatement of the Cathedral – Concept Review

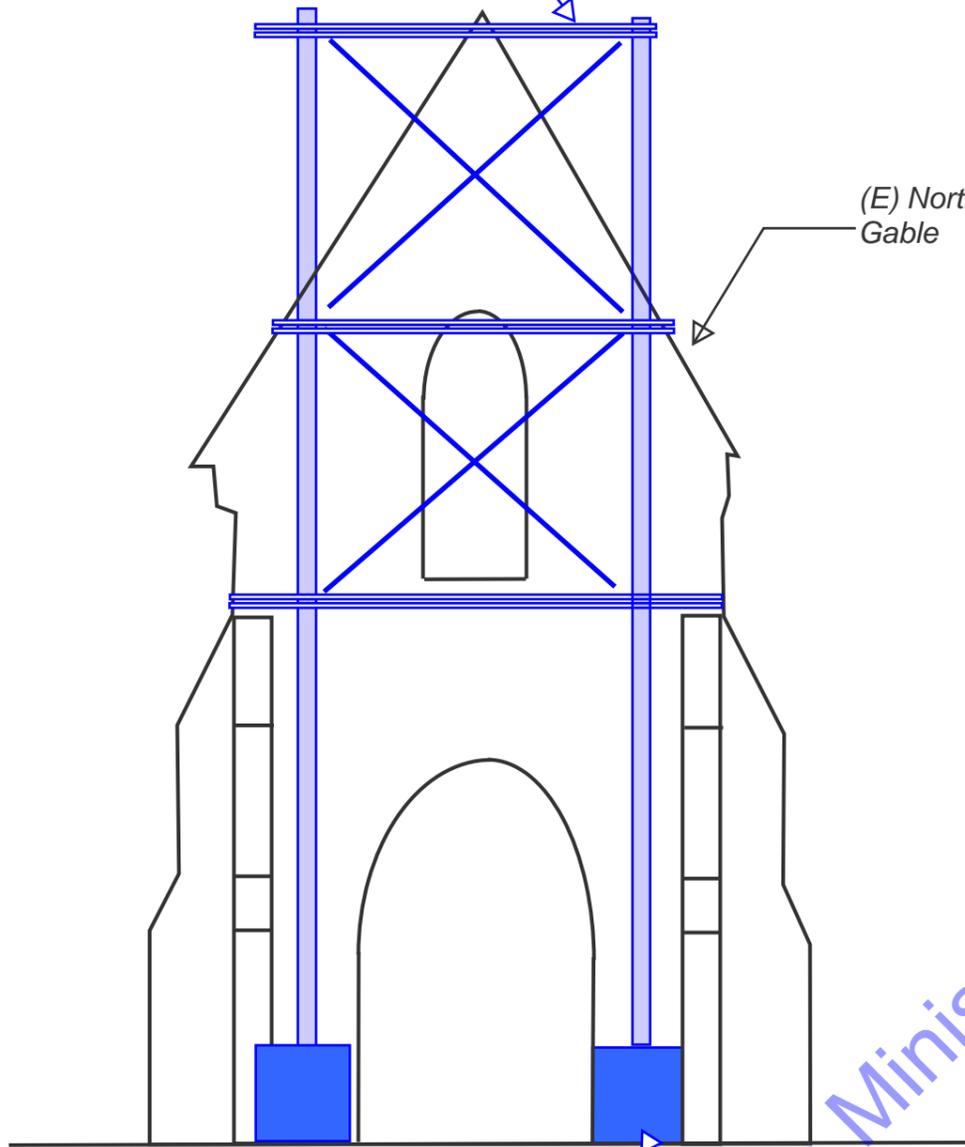
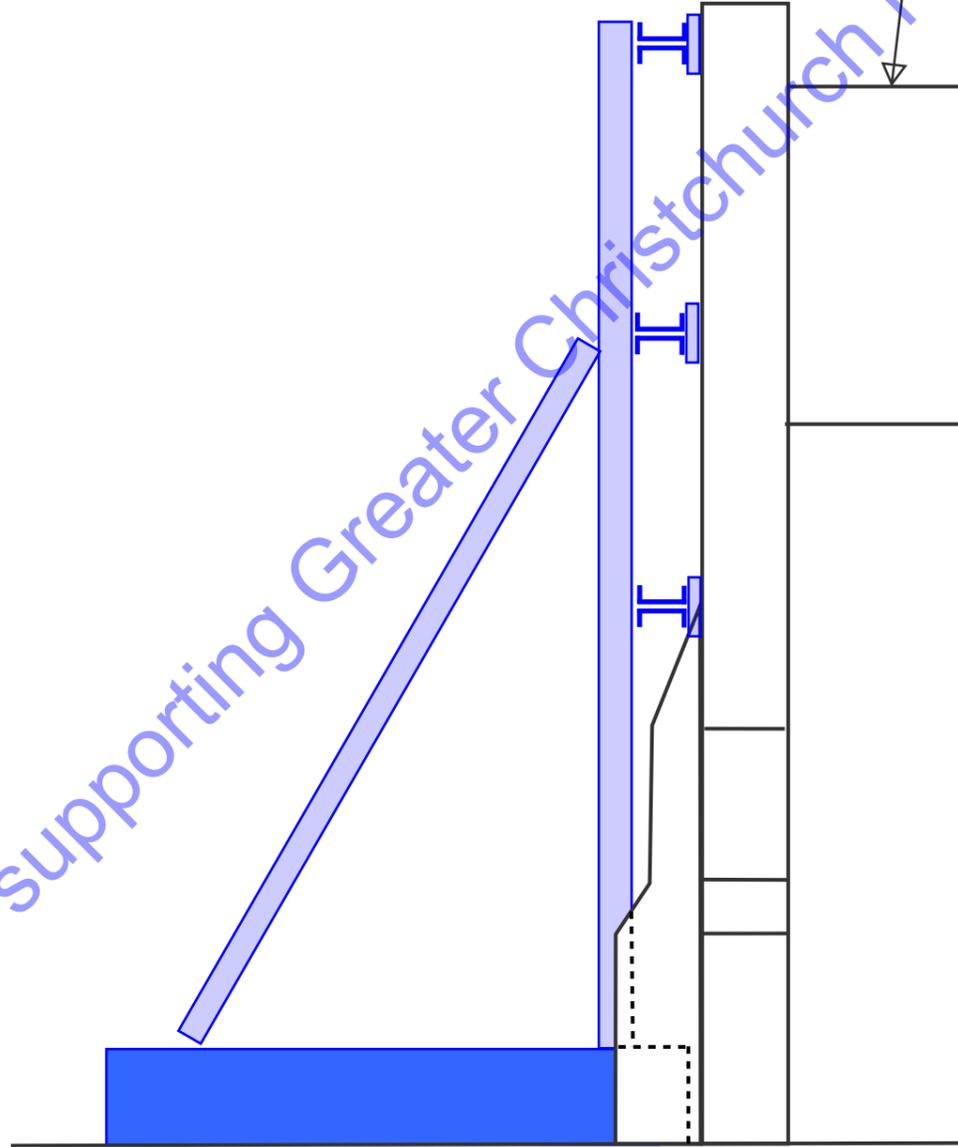
(E) North Porch
Gable

- 1.11. Remove loose masonry elements in the vicinity of the north porch. Lift in new precast concrete foundation blocks for the new temporary steel frame. North Porch Securing Frame is intended to stabilise the north gable of the North Porch.

Phase 1.12 (N) North
Porch Gable Securing
Frame

Phase 1.12 (N) North
Porch Gable Securing
Frame Foundation
Block
