Area-wide geotechnical information summary for CERA zoning review panel

This document contains all the area-wide geotechnical information which was considered by CERA as part of the process for making flat-land zoning decisions, and the subsequent zoning review.

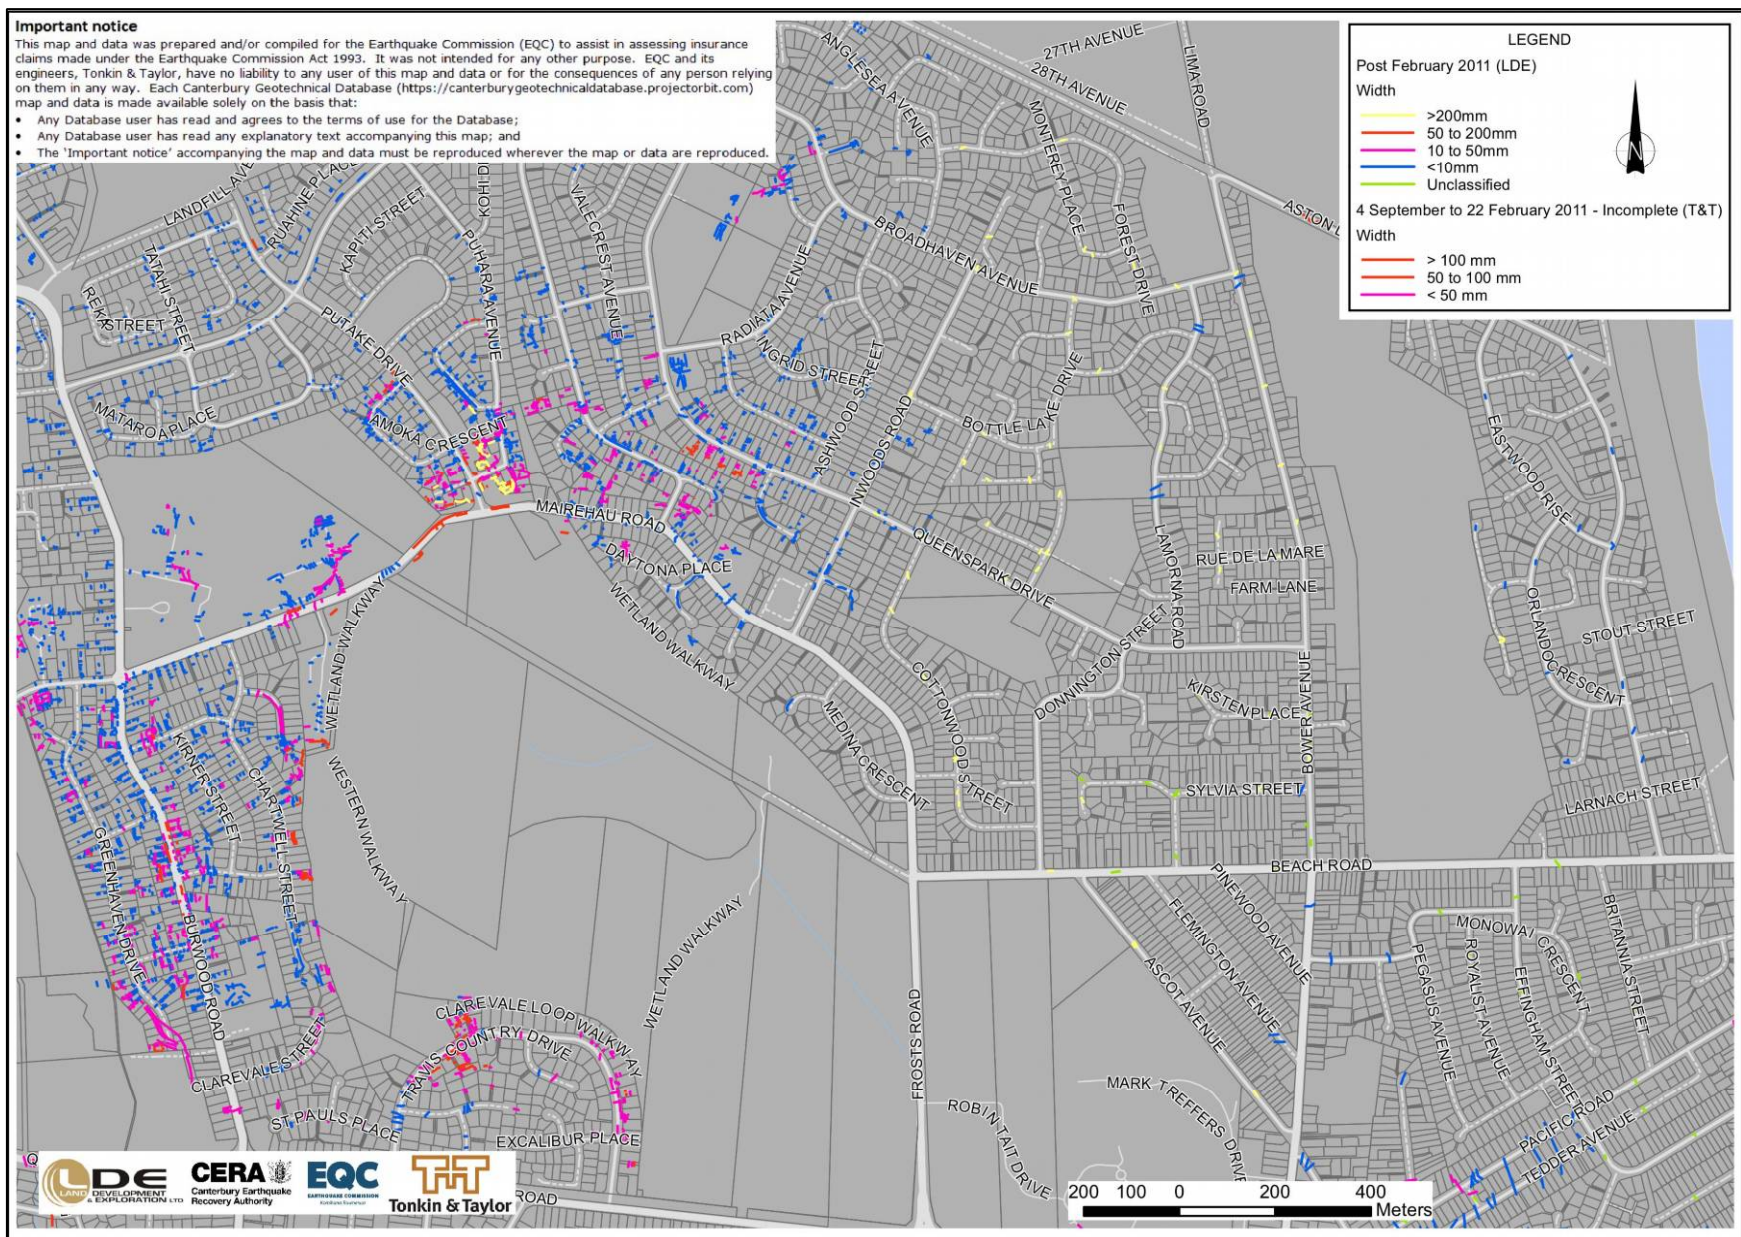
Figure 2 – Observed ground crack locations

Crack locations were mapped in order to infer the general direction, magnitude and extent of the lateral ground movements. The mapping objectives changed in response to the varying situation following the two earthquakes. Observations after the 4 Sept 2010 Earthquake were principally for insurance claim settlements. The crack widths were recorded in property-by-property observations, but cracks were not tracked across property boundaries and only a portion of properties were mapped before the 22 Feb 2011 Earthquake. Cracks were mapped at a scale of 1:5000 to 1:10000 for about two weeks following the 22 Feb 2011 Earthquake in order to rapidly identify the extent of lateral spreading following the earthquake. The individual crack widths were not recorded. From early March 2011, cracks were generally mapped at a scale of 1:2000 and classified according to their maximum width. Cracks were tracked through properties in order to identify regional patterns.

The crack mapping is incomplete and only observations made by the mapping teams are presented. In particular, the mapping following the 4 Sept 2010 Earthquake was incomplete before the 22 Feb 2011 Earthquake occurred and subsequent mapping remains incomplete within the residential 'red zone' areas. Also, cracks in roads were often not able to be mapped because many were filled and the roads resealed before a mapping team arrived.

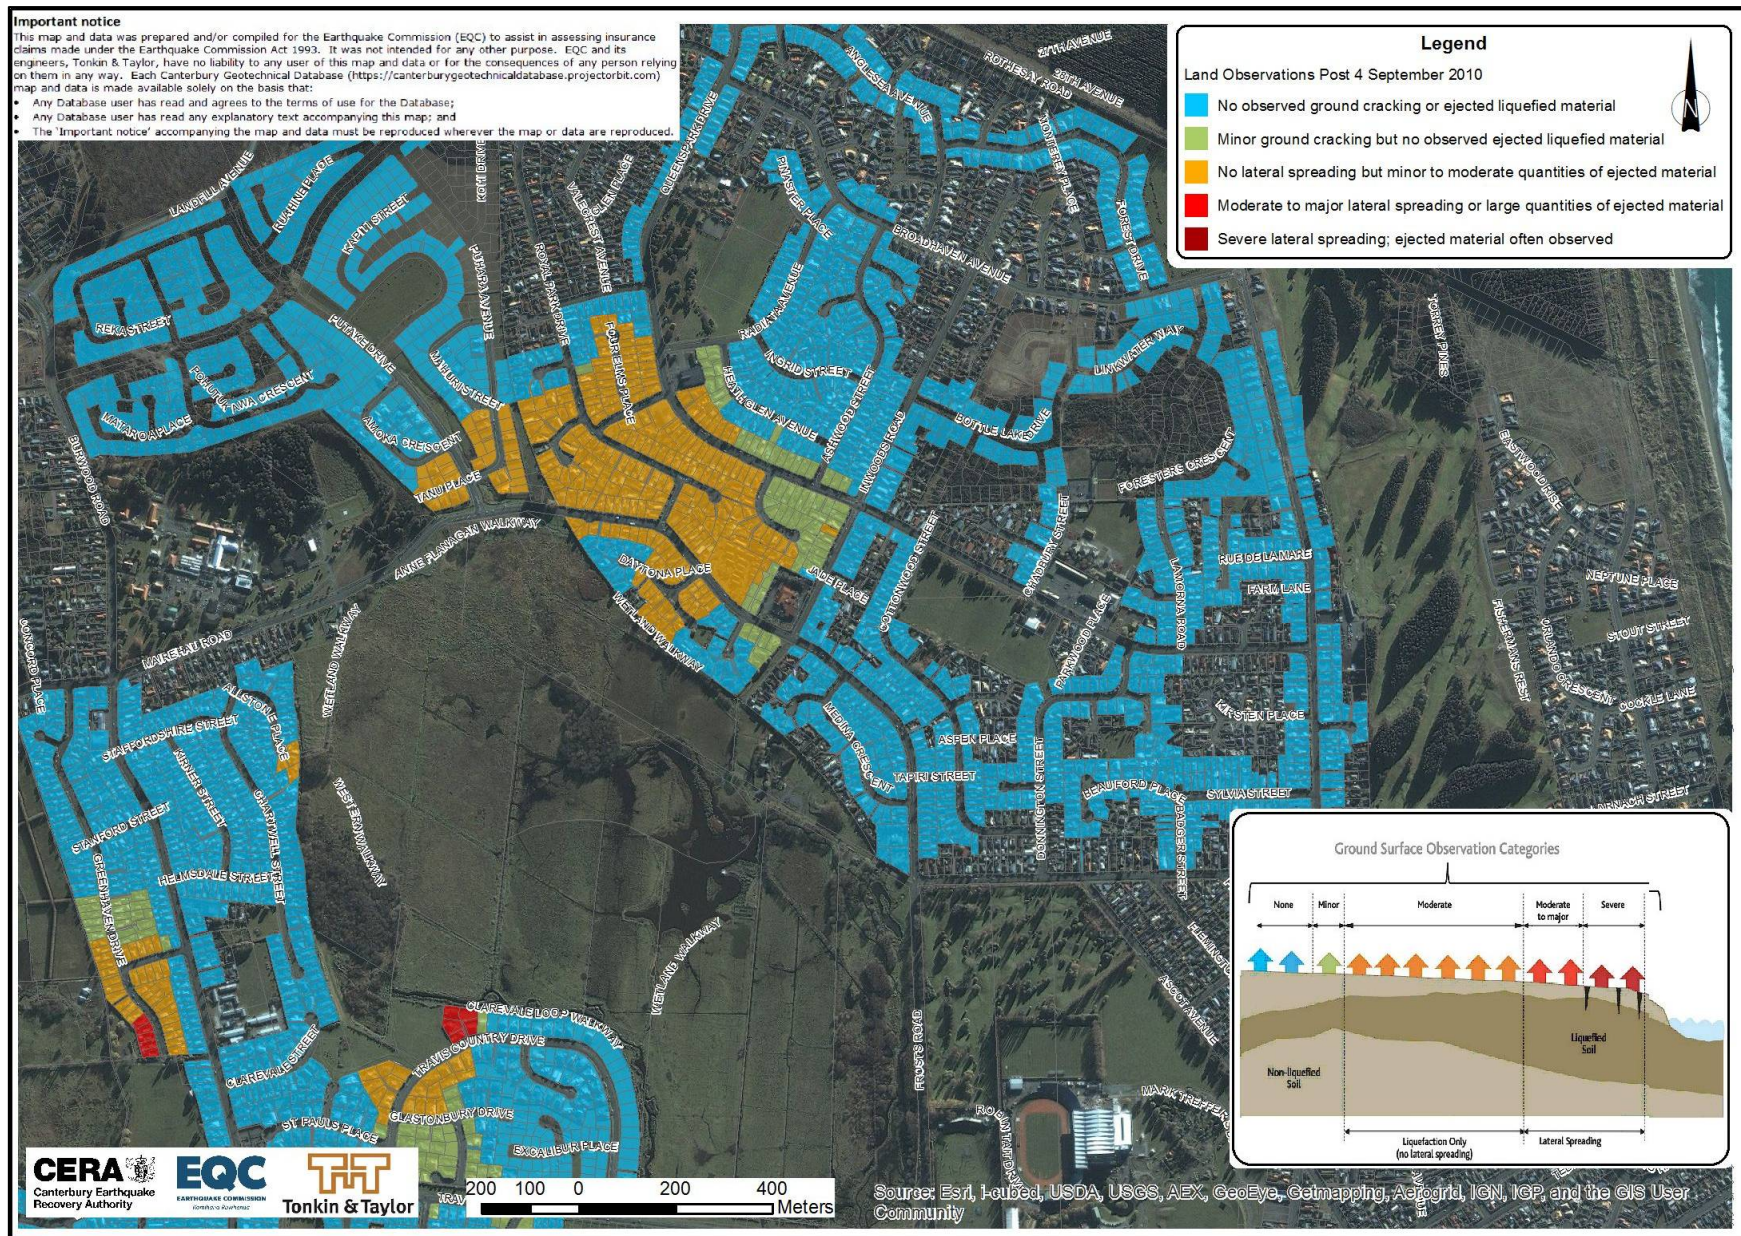
Figure 3 – Ground surface observations of liquefaction and lateral spreading following 4th September 2010 earthquake (from property-level ground mapping)

The quantities of material ejected due to liquefaction and observations of lateral spreading were collated from on-foot rapid inspection of individual properties following each significant earthquake. The observations were categorized according to the quantity of ejected material observed on the ground surface and according to the presence or absence of evidence of lateral spreading. Each of these three categories was further subdivided according to the severity. The colour coding used on these maps has completely different meaning to colours used by CERA for land zoning and DBH for technical categories.

The observations were collected for the Earthquake Commission and were only made in residential areas. The mapping only identified liquefaction and lateral spreading that was visible at the surface at the time of inspection. Liquefaction may have occurred at depth without obvious evidence at the surface and evidence of liquefaction may have been removed before the inspection. (Removed material may be identifiable within the aerial photographs that were taken within a day or two of the earthquake.)

The properties were not all inspected between each pair of consecutive earthquakes (e.g. between 4 Sept 2010 and 22 Feb 2011) so the extent of the land deformations is most likely incomplete. Also, some observations following the 22 Feb 2011 and 13 Jun 2011 earthquakes could have been induced by preceding earthquakes.

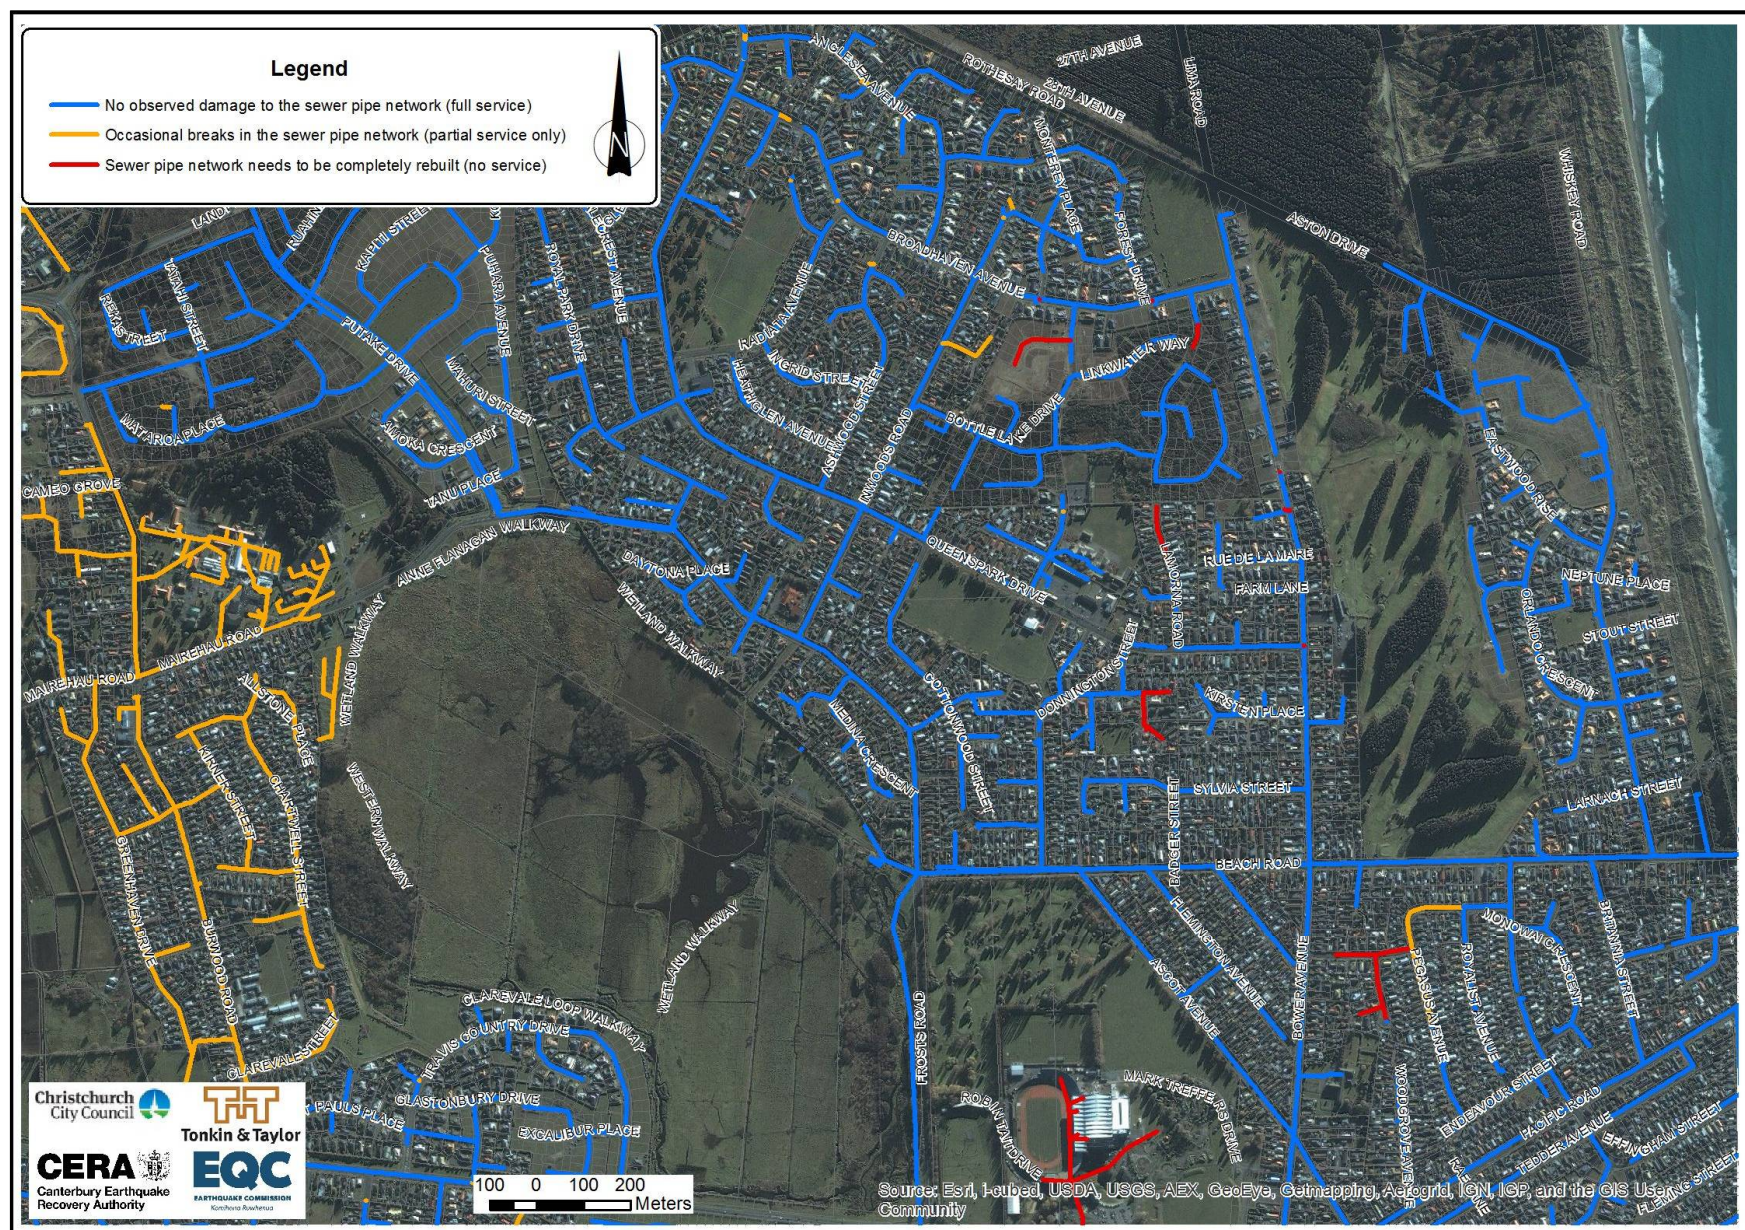
Figure 6 – Status of wastewater network as assessed at 20th April 2011 (NOW SUPERSEDED)

Since this map was compiled there has been significant additional assessment of the infrastructure network, so this map is now superseded. It is included only to show the best available information at the time of the zoning decisions. For an up to date assessment of the infrastructure network, SCIRT or the City Council should be consulted.

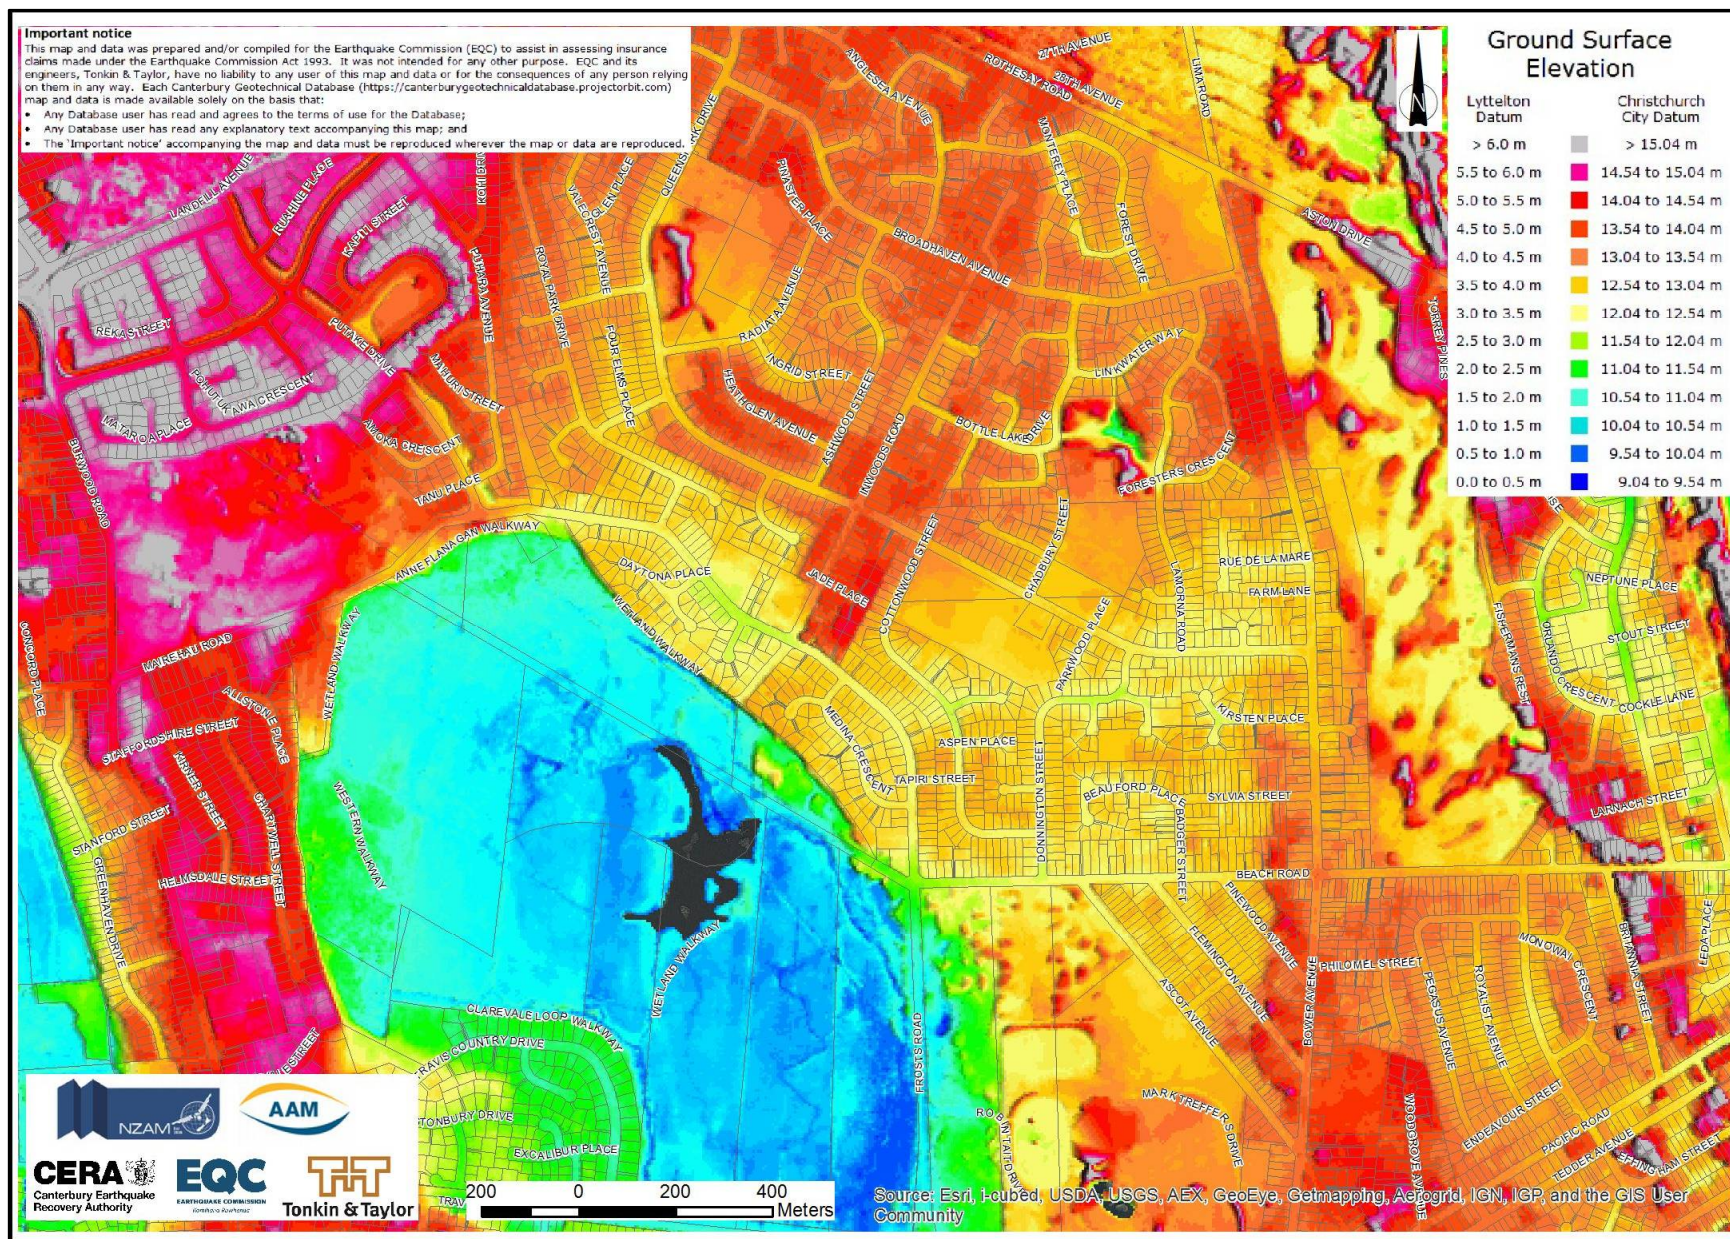
Figure 7 – Ground surface elevation from February 2012 LiDAR survey

LiDAR was acquired following each of the significant earthquakes. A digital elevation model was developed from each supplied LiDAR set by averaging the ground-return elevations within a 10 m radius of each grid point. Metadata supplied with the source LiDAR indicates a vertical accuracy of ± 0.07 to ± 0.15 m (excluding GPS error and Geoid modelling error) and 0.40 to 0.55 m horizontal. The pre-earthquake LiDAR has lower accuracy and sparser LiDAR point sets than the post-earthquake sets.

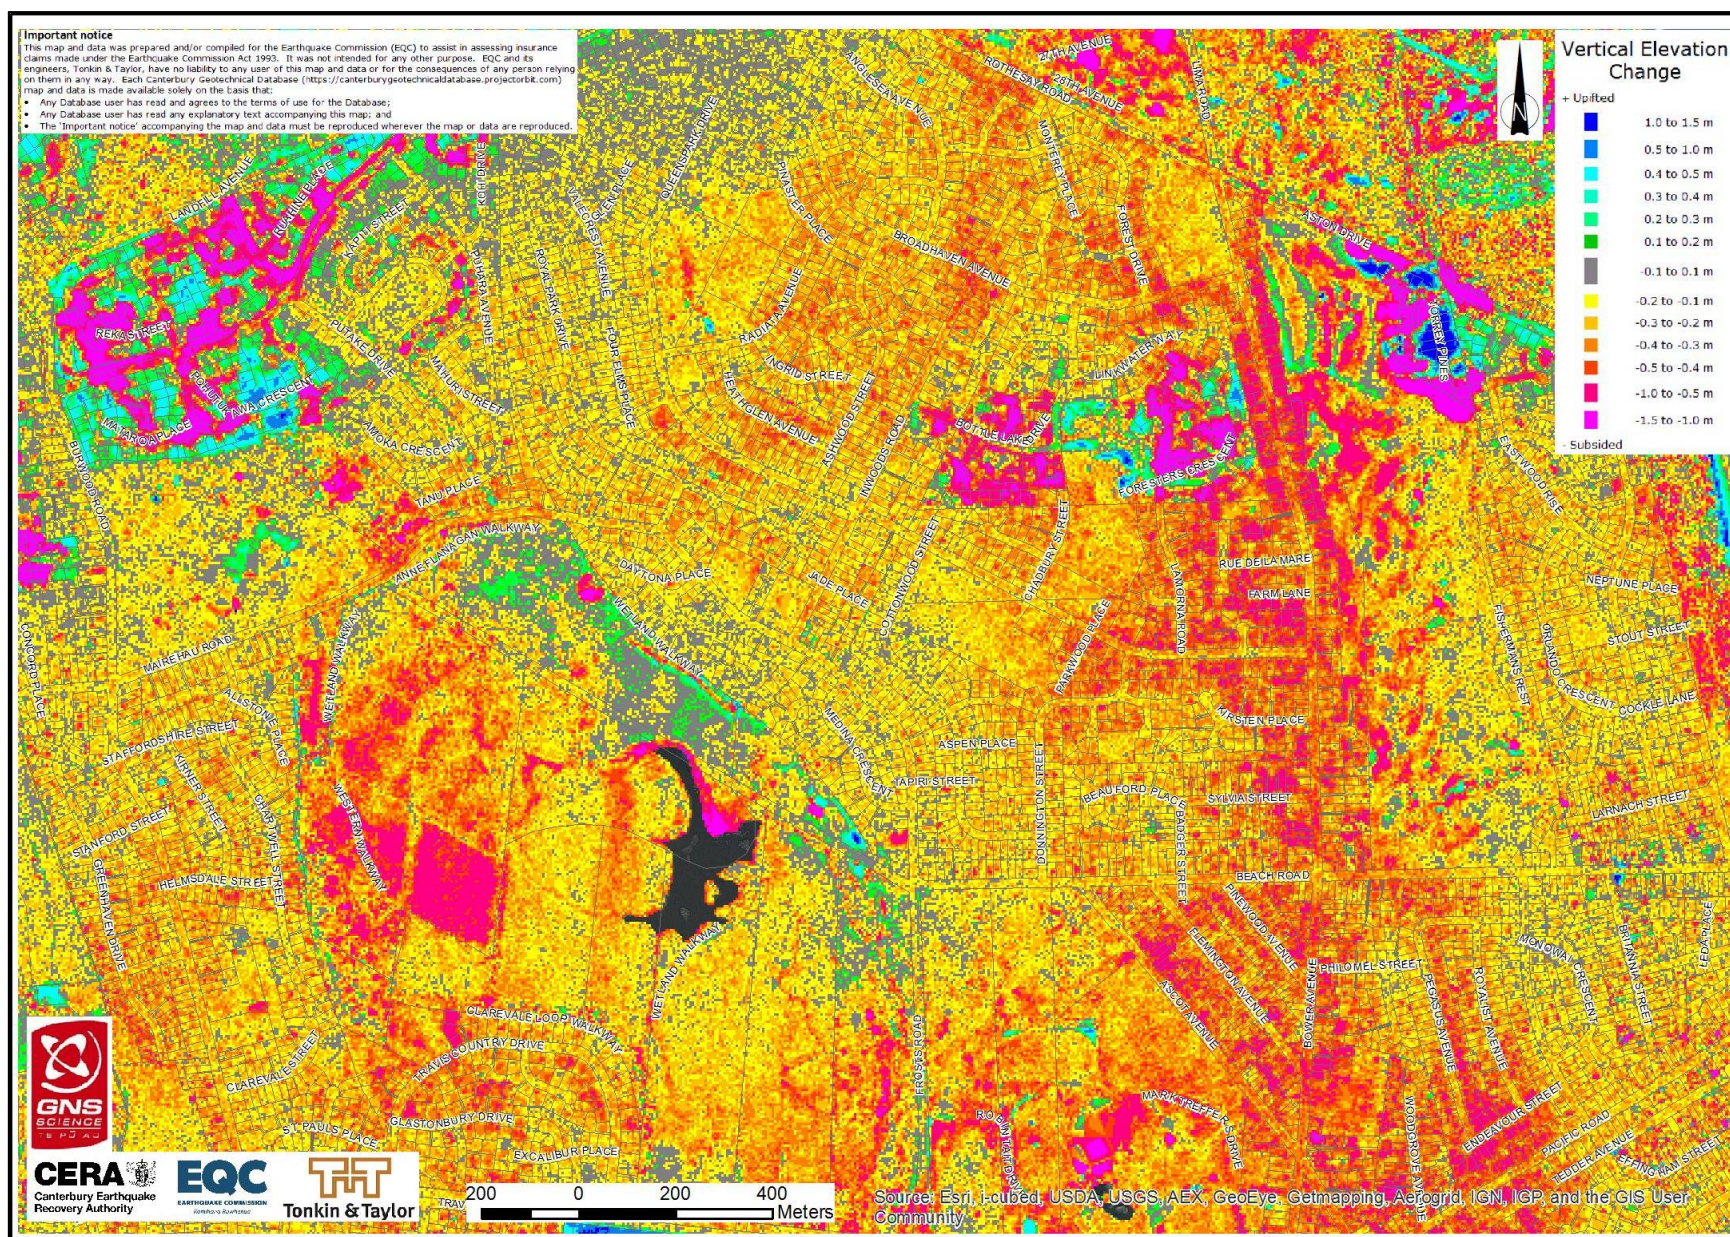
Figure 8 – Change in ground elevation between LiDAR in July 2003 and February 2012, with regional tectonic component of ground displacement removed

Vertical elevation changes between LiDAR sets that approximate the vertical ground movements during significant earthquakes. Elevation changes were calculated as differences between pairs of Digital Elevation Models (DEM). Local vertical movements were calculated as the differences between the 'observed' elevation differences and the regional tectonic displacement from GNS Science dislocation models of the vertical tectonic movements during each earthquake.

All of the movements are differences between DEMs and are inherently less accurate than their source DEM's. The pre-earthquake source DEM is less accurate than the post-earthquake DEMs. Some of the DEMs have visually distinguishable lines or ripples within the colour bands that are almost certainly artefacts from the data acquisition and subsequent processing rather than from physical vertical movements. Notable examples are several approximately NNE-SSW swathes visible in the Feb 2011 difference set and an almost E-W line at 43.48°S in the 13 Jun 2011 difference set.
