## Area-wide geotechnical information summary for CERA zoning review panel

Table 1 – Area-wide geotechnical and engineering considerations for West New Brighton

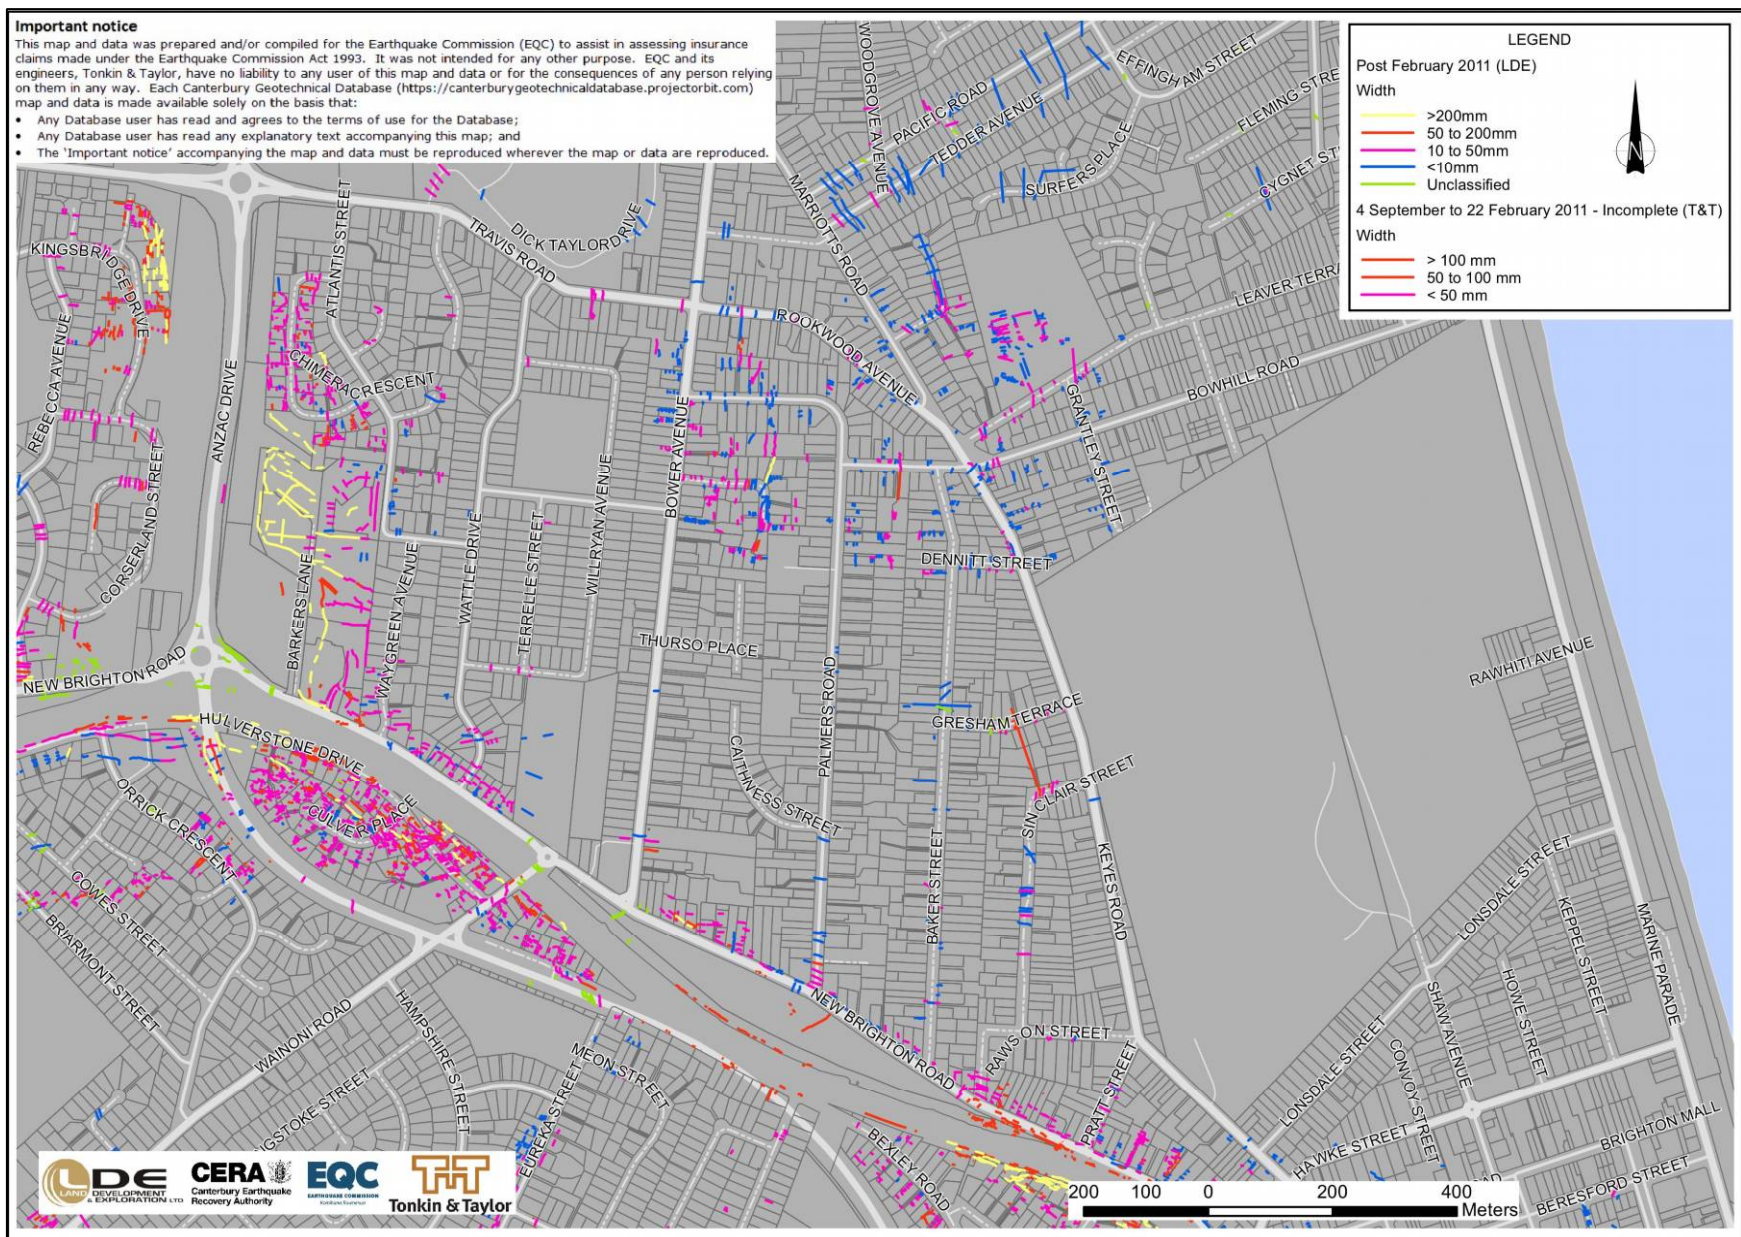
Figure 2 – Observed ground crack locations

Crack locations were mapped in order to infer the general direction, magnitude and extent of the lateral ground movements. The mapping objectives changed in response to the varying situation following the two earthquakes. Observations after the 4 Sept 2010 Earthquake were principally for insurance claim settlements. The crack widths were recorded in property-by-property observations, but cracks were not tracked across property boundaries and only a portion of properties were mapped before the 22 Feb 2011 Earthquake. Cracks were mapped at a scale of 1:5000 to 1:10000 for about two weeks following the 22 Feb 2011 Earthquake in order to rapidly identify the extent of lateral spreading following the earthquake. The individual crack widths were not recorded. From early March 2011, cracks were generally mapped at a scale of 1:2000 and classified according to their maximum width. Cracks were tracked through properties in order to identify regional patterns.

The crack mapping is incomplete and only observations made by the mapping teams are presented. In particular, the mapping following the 4 Sept 2010 Earthquake was incomplete before the 22 Feb 2011 Earthquake occurred and subsequent mapping remains incomplete within the residential 'red zone' areas. Also, cracks in roads were often not able to be mapped because many were filled and the roads resealed before a mapping team arrived.

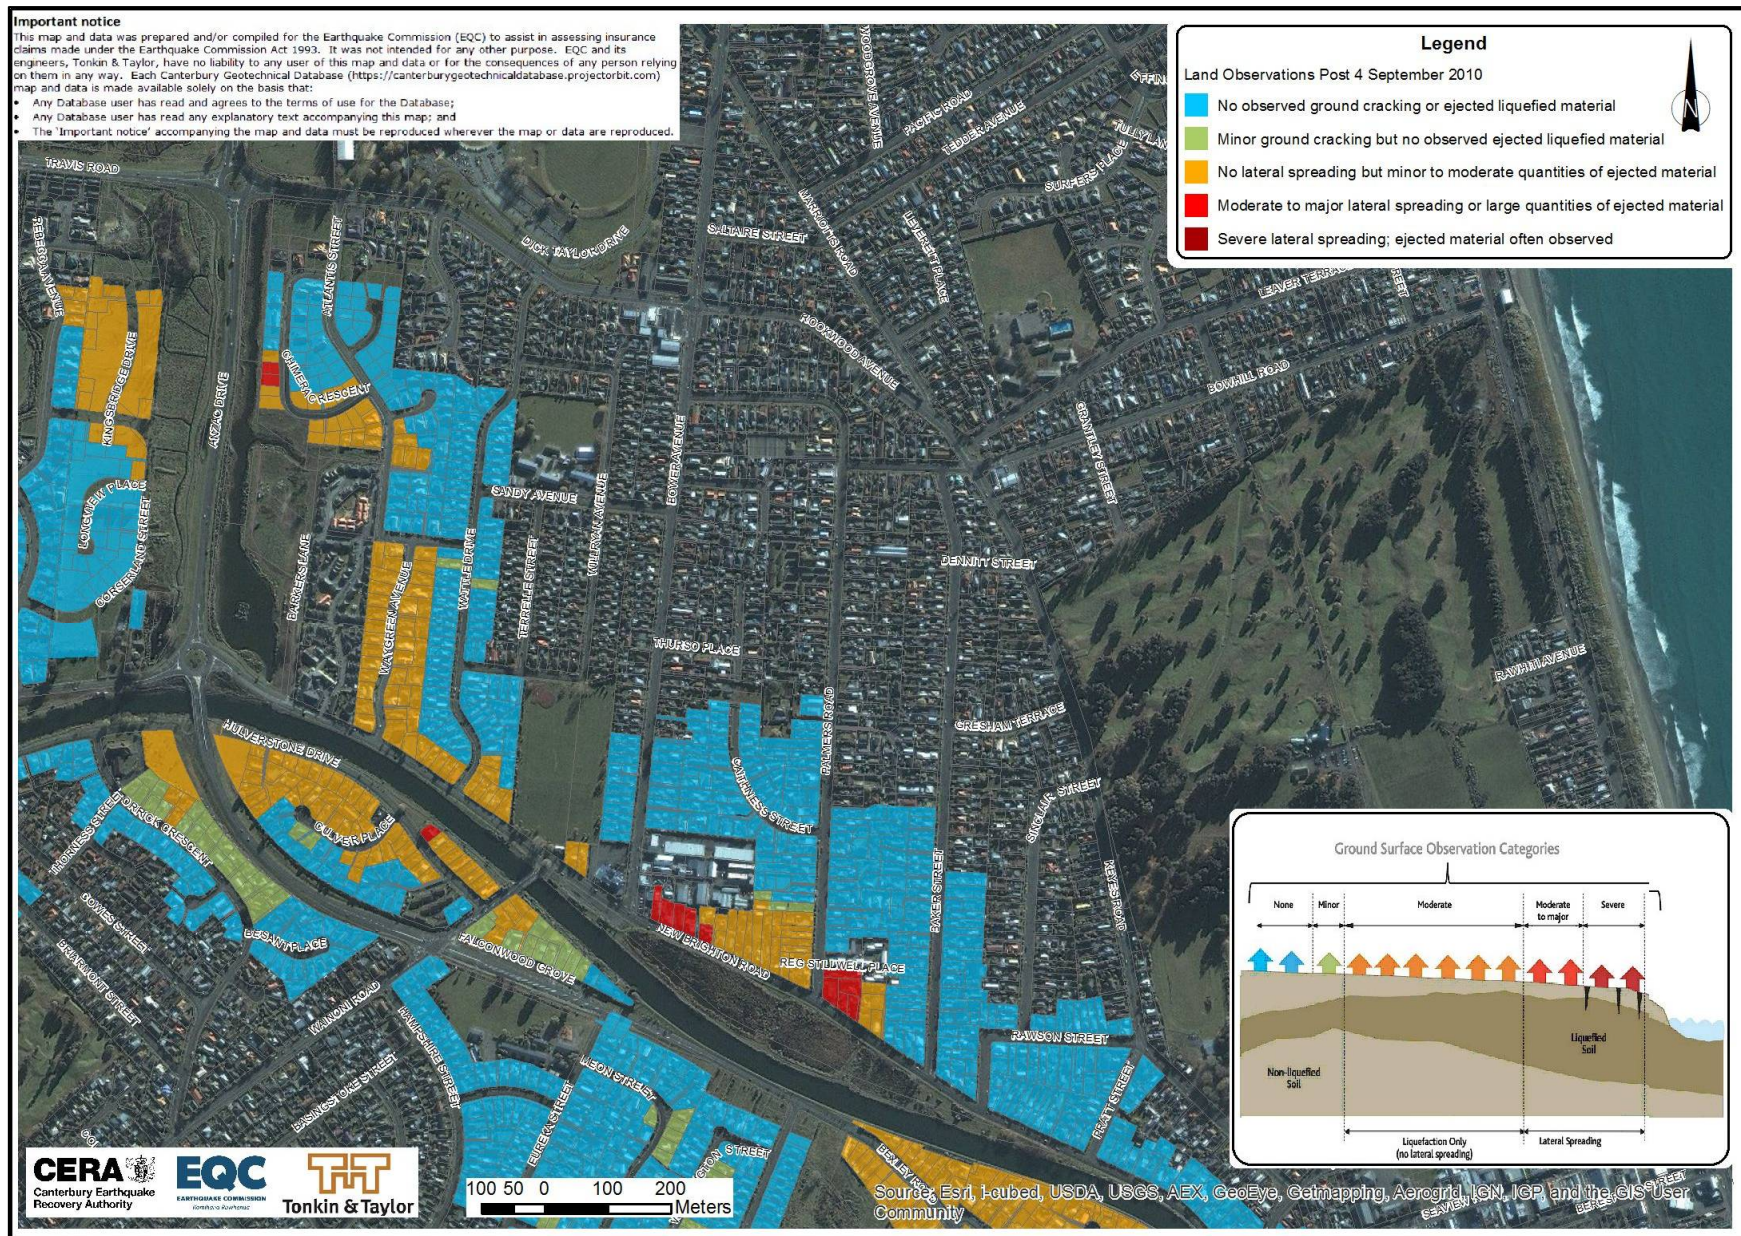
Figure 3 – Ground surface observations of liquefaction and lateral spreading following 4<sup>th</sup> September 2010 earthquake (from property-level ground mapping)

The quantities of material ejected due to liquefaction and observations of lateral spreading were collated from on-foot rapid inspection of individual properties following each significant earthquake. The observations were categorized according to the quantity of ejected material observed on the ground surface and according to the presence or absence of evidence of lateral spreading. Each of these three categories was further subdivided according to the severity. The colour coding used on these maps has completely different meaning to colours used by CERA for land zoning and DBH for technical categories.

The observations were collected for the Earthquake Commission and were only made in residential areas. The mapping only identified liquefaction and lateral spreading that was visible at the surface at the time of inspection. Liquefaction may have occurred at depth without obvious evidence at the surface and evidence of liquefaction may have been removed before the inspection. (Removed material may be identifiable within the aerial photographs that were taken within a day or two of the earthquake.)

The properties were not all inspected between each pair of consecutive earthquakes (e.g. between 4 Sept 2010 and 22 Feb 2011) so the extent of the land deformations is most likely incomplete. Also, some observations following the 22 Feb 2011 and 13 Jun 2011 earthquakes could have been induced by preceding earthquakes.

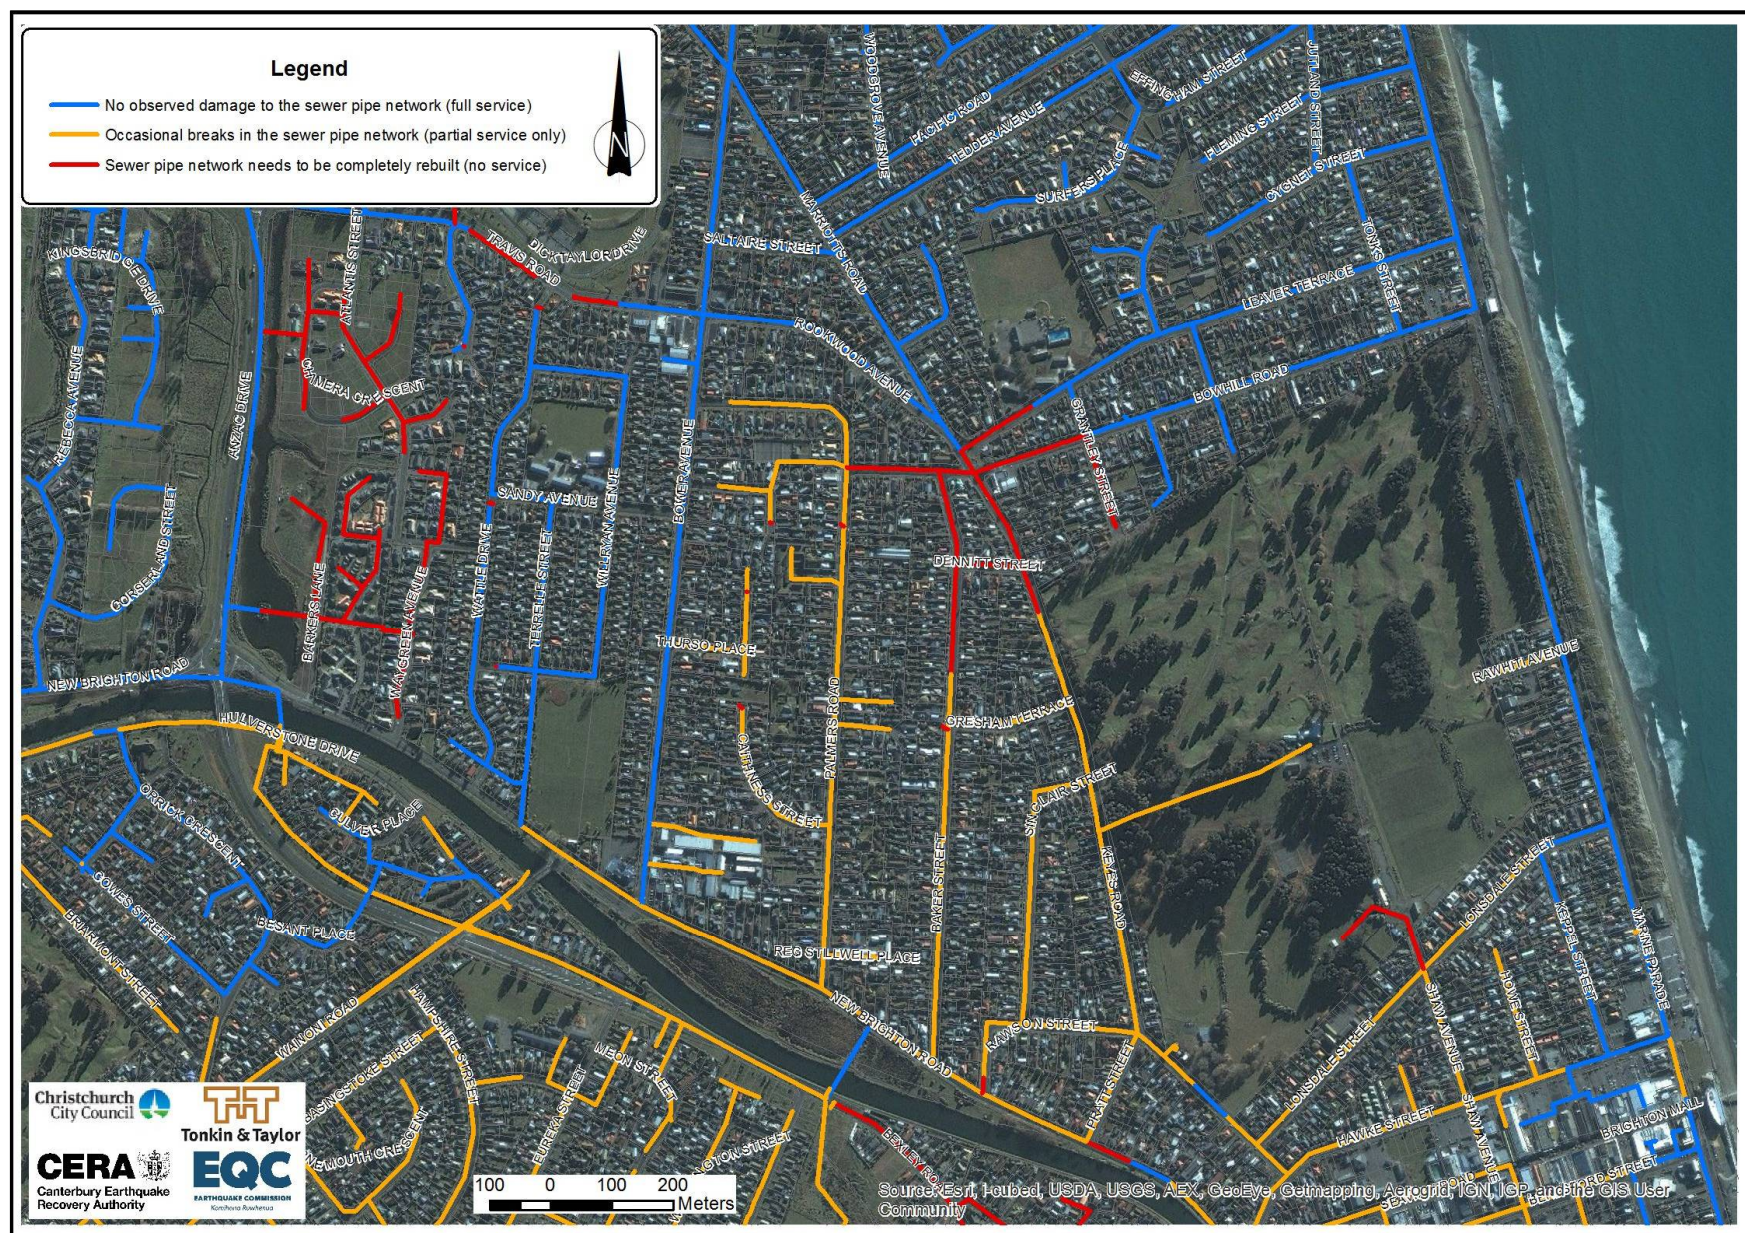
Figure 6 – Status of wastewater network as assessed at 20<sup>th</sup> April 2011 (NOW SUPERSEDED)

Since this map was compiled there has been significant additional assessment of the infrastructure network, so this map is now superseded. It is included only to show the best available information at the time of the zoning decisions. For an up to date assessment of the infrastructure network, SCIRT or the City Council should be consulted.

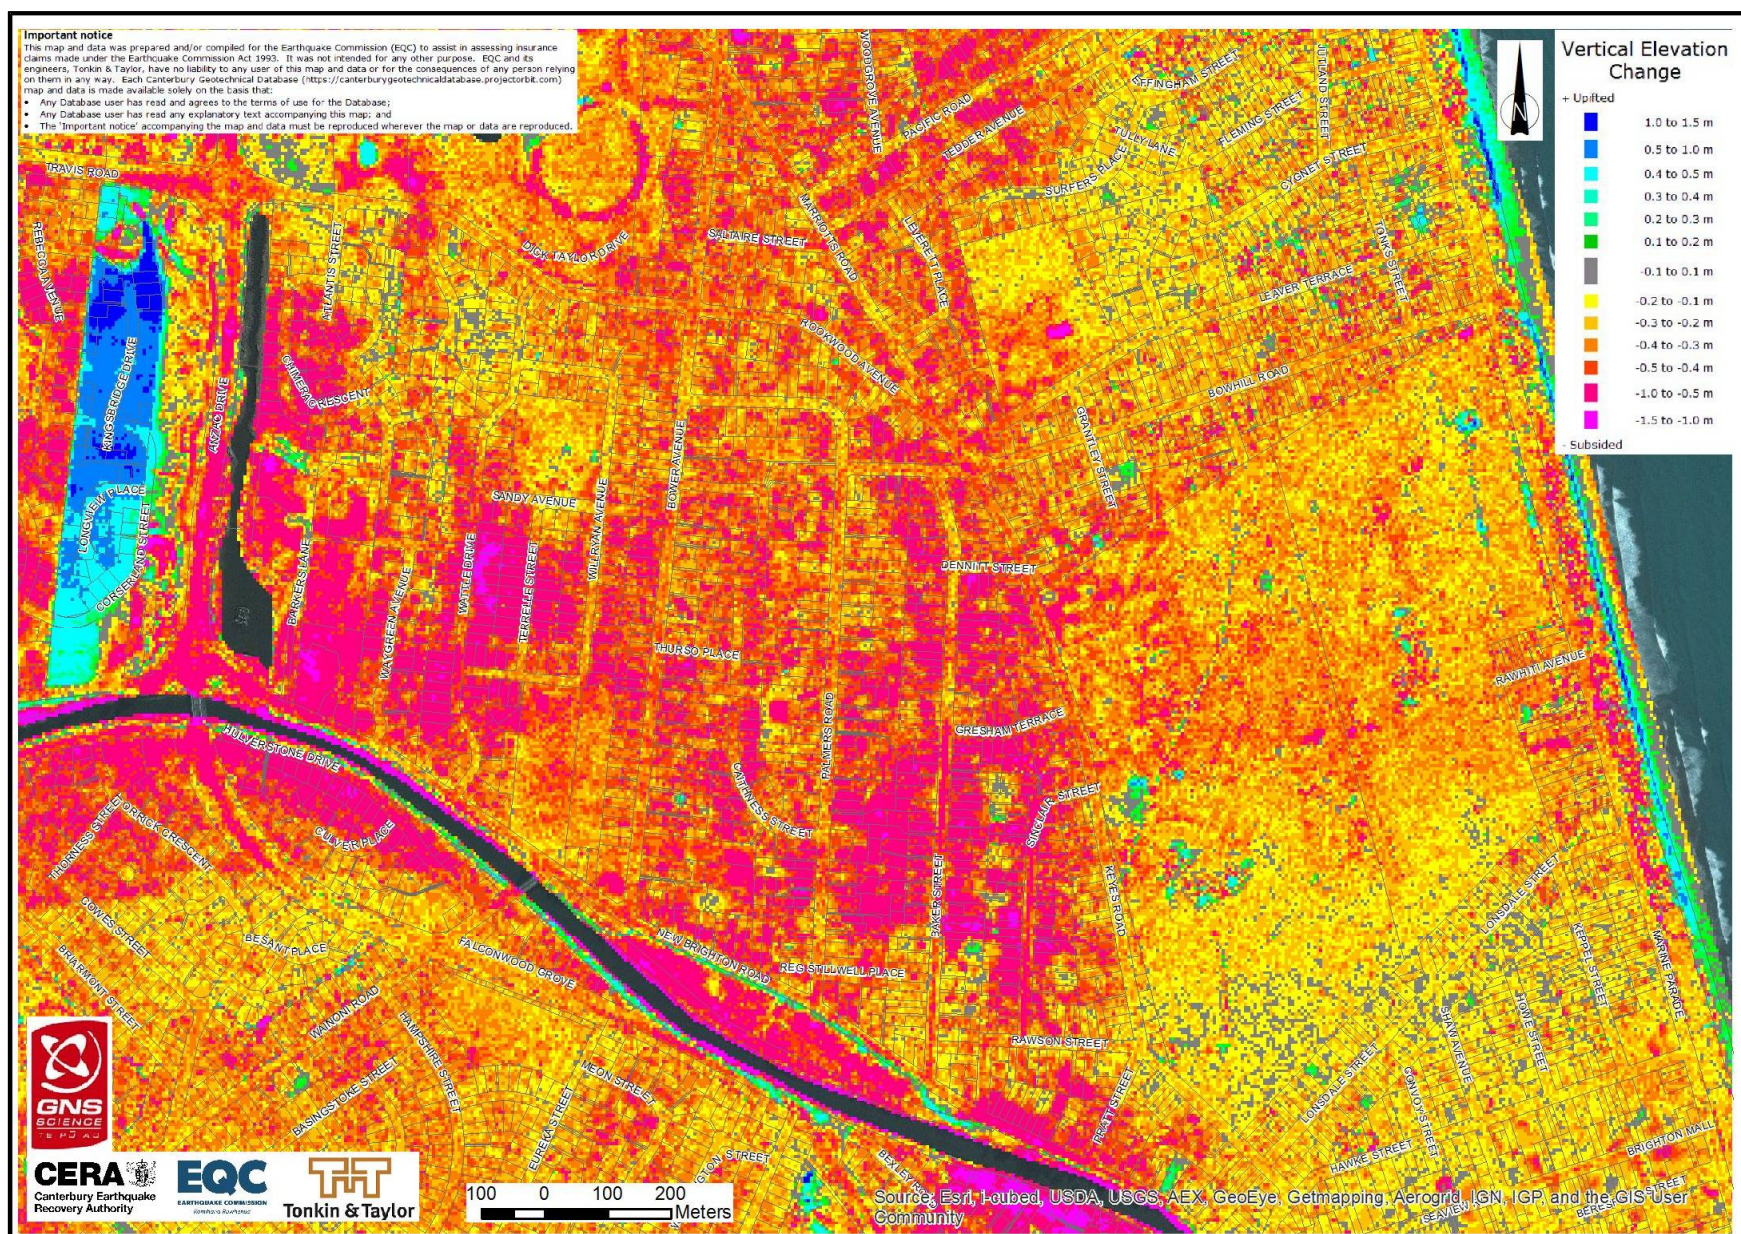
Figure 8 – Change in ground elevation between LiDAR in July 2003 and February 2012, with regional tectonic component of ground displacement removed

The areas coloured as blue above are where fill was placed as part of subdivision development after the first LiDAR survey was undertaken in 2003.

Vertical elevation changes between LiDAR sets that approximate the vertical ground movements during significant earthquakes. Elevation changes were calculated as differences between pairs of Digital Elevation Models (DEM). Local vertical movements were calculated as the differences between the 'observed' elevation differences and the regional tectonic displacement from GNS Science dislocation models of the vertical tectonic movements during each earthquake.

All of the movements are differences between DEMs and are inherently less accurate than their source DEM's. The pre-earthquake source DEM is less accurate than the post-earthquake DEMs. Some of the DEMs have visually distinguishable lines or ripples within the colour bands that are almost certainly artefacts from the data acquisition and subsequent processing rather than from physical vertical movements. Notable examples are several approximately NNE-SSW swathes visible in the Feb 2011 difference set and an almost E-W line at 43.48°S in the 13 Jun 2011 difference set.
