Appendix C – Sector 3 Modeling Results

Sector 3 Redcliffs

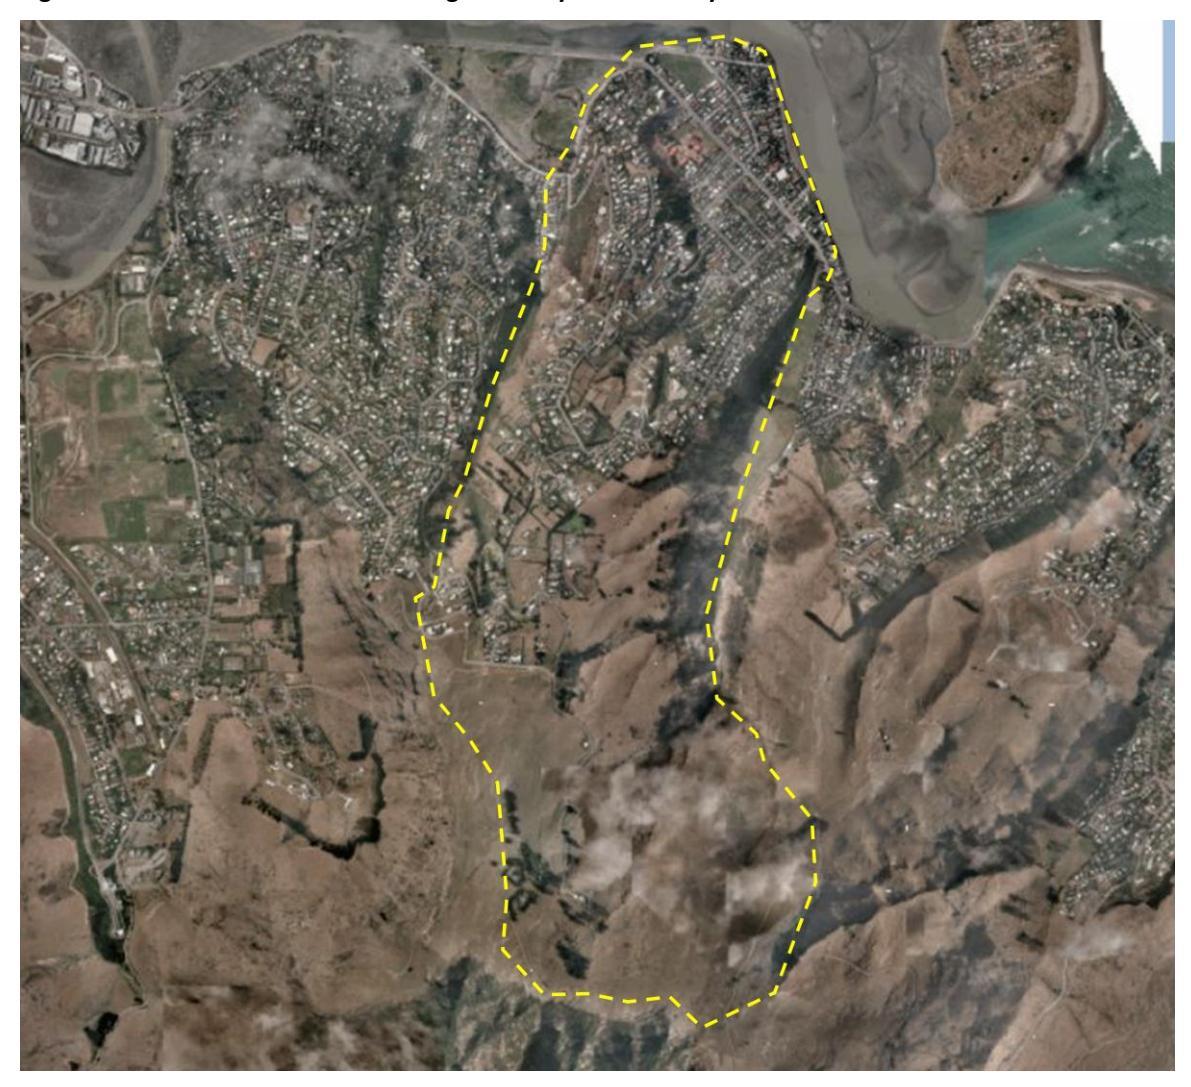
Figure 1 - Sector 3 site location showing the study area within yellow outline
