Cyclone Gabrielle Recovery Report | 21 September 2023

Weekly update on Cyclone Gabrielle recovery activity

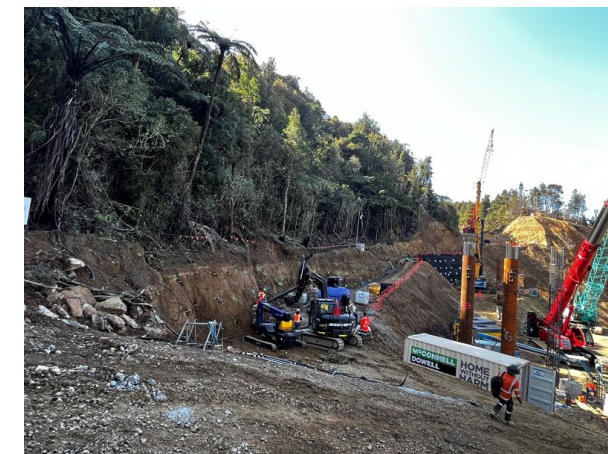
Taparahi Bridge works SH25A, Coromandel

- Remains on programme with fabrication of the girders complete and 5 out of 15 coated.
- Piling work at Pier C continues
- Work has commenced on the abutment formwork and reinforcing cages.
- Coordination meetings with SH25A wider corridor works are underway.

Taparahi is a 124m three span composite bridge

With a concrete substructure, steel superstructure and pre-cast concrete deck.
