# Appendix B – Sector 2 Modeling Results

#### **Sector 2 Wakefield Avenue**

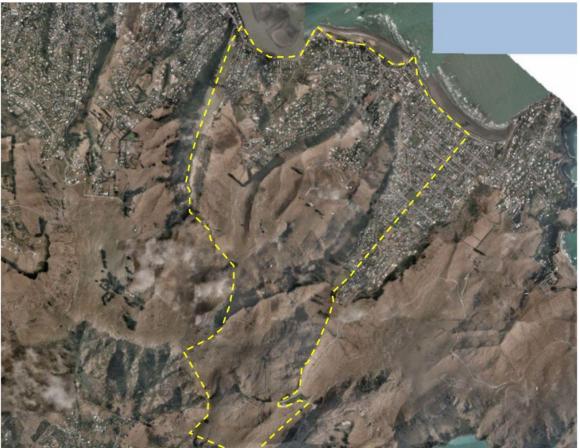
The area considered in this report for both sites (eastern and western) is shown in Figure 1 below, an area in excess of 4km<sup>2</sup>.

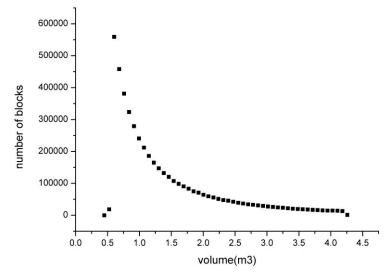
Table 1 - Boulder size distribution used for modeling

For the modeling an exponential boulder size distribution was used with a minimum boulder size of 0.3 m<sup>3</sup> and a maximum boulder size of 4.25 m<sup>3</sup>. This distribution curve is represented below in Table 1.

Note - this distribution covers all Sectors on the Port Hills. Individual Sectors may vary.

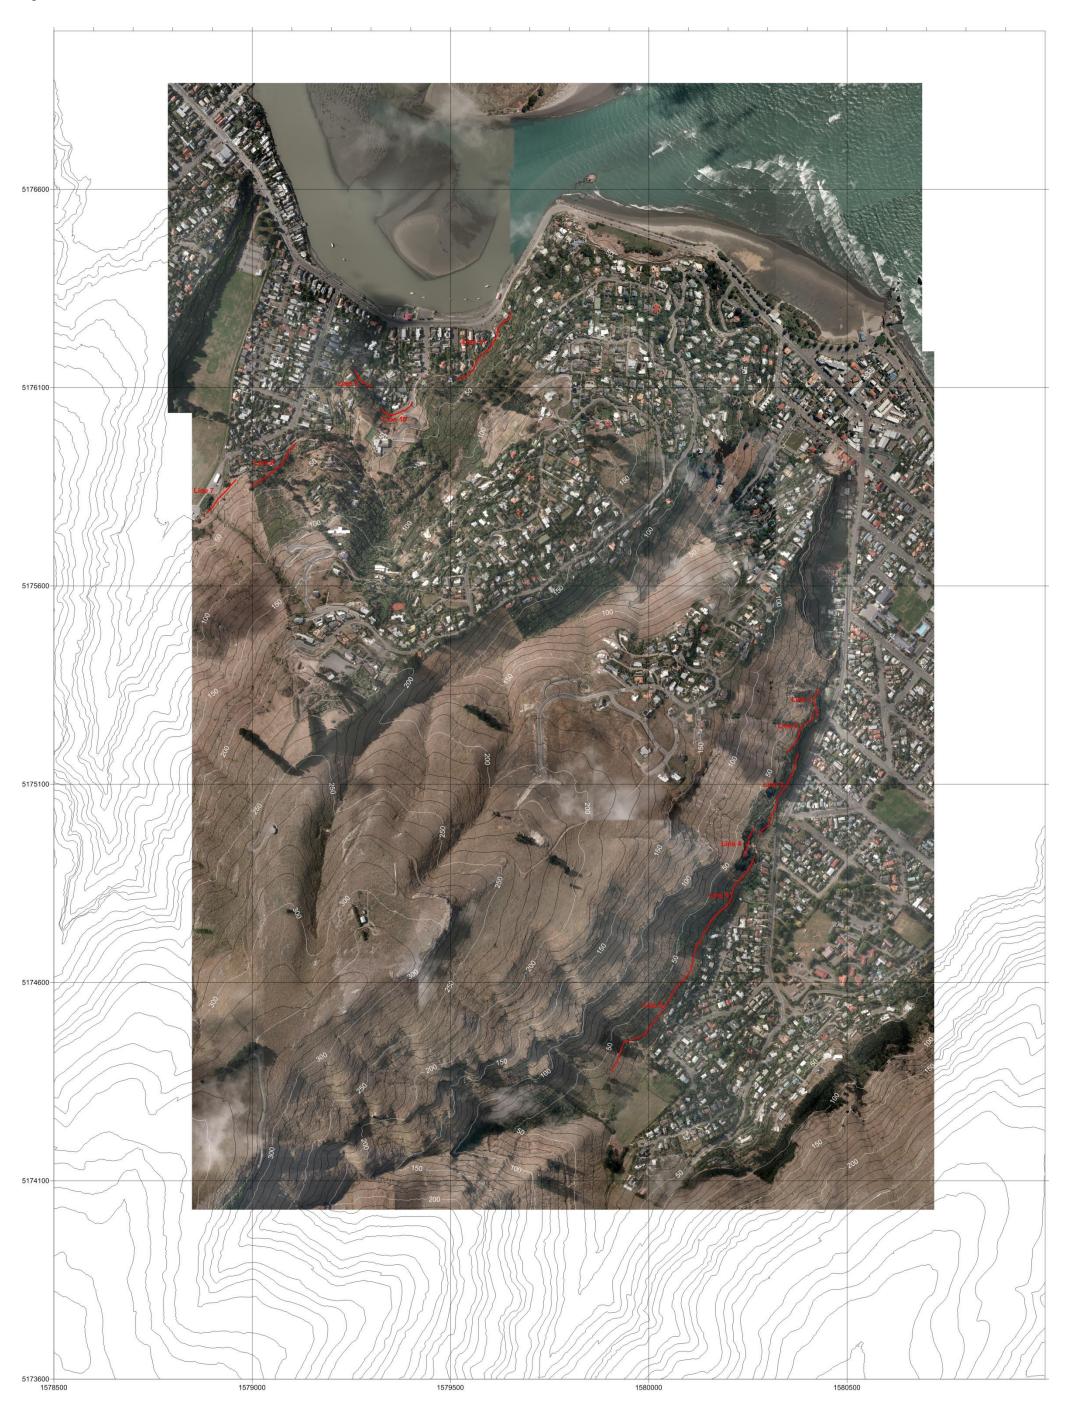
Figure 2 - Recommended Location of Rockfall Barriers

In accordance with Option 4 in the main report text it is recommended that the installation of rockfall barriers is the most suitable means of remediating the rockfall hazard in Sector 2. The size and lengths of the barriers are outlined in Table 2 below while the locations are shown in Figure 2. The results of the modelling are presented in the following graphics.

Sector	Barrier	Rating	Height	Length
(#)	(ETAG27)	(kJ)	(m)	(m)
2	1	2000	4	40
		1000	3	32
	2	1000	3	100
		2000	4	27
	3	2000	4	50
		1000	3	60
		300	7	100
		2000	4	21
	4	2000	4	76
	5	2000	4	50
		5000	6	70
		2000	4	110
		1000	3	36
	6	2000	4	60
		1000	3	190
		2000	4	110
		1000	3	48
	7	2000	4	113
	8	1000	3	60
	9	2000	4	50
	10	1000	3	47
	11	5000	7	30
		5000	7	100
		2000	5	99

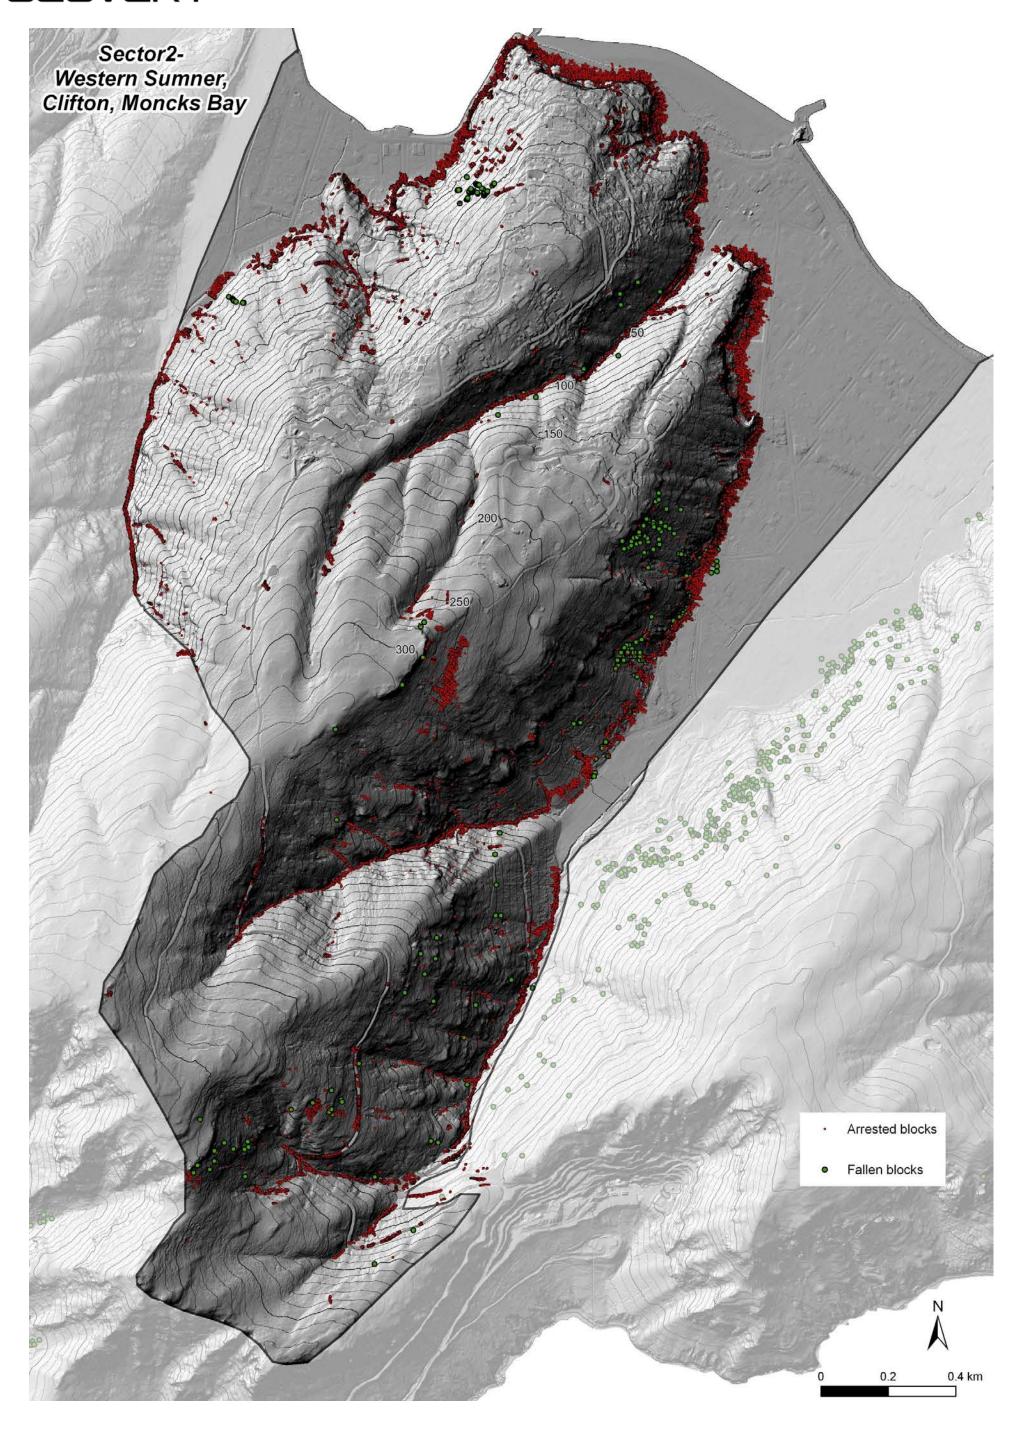
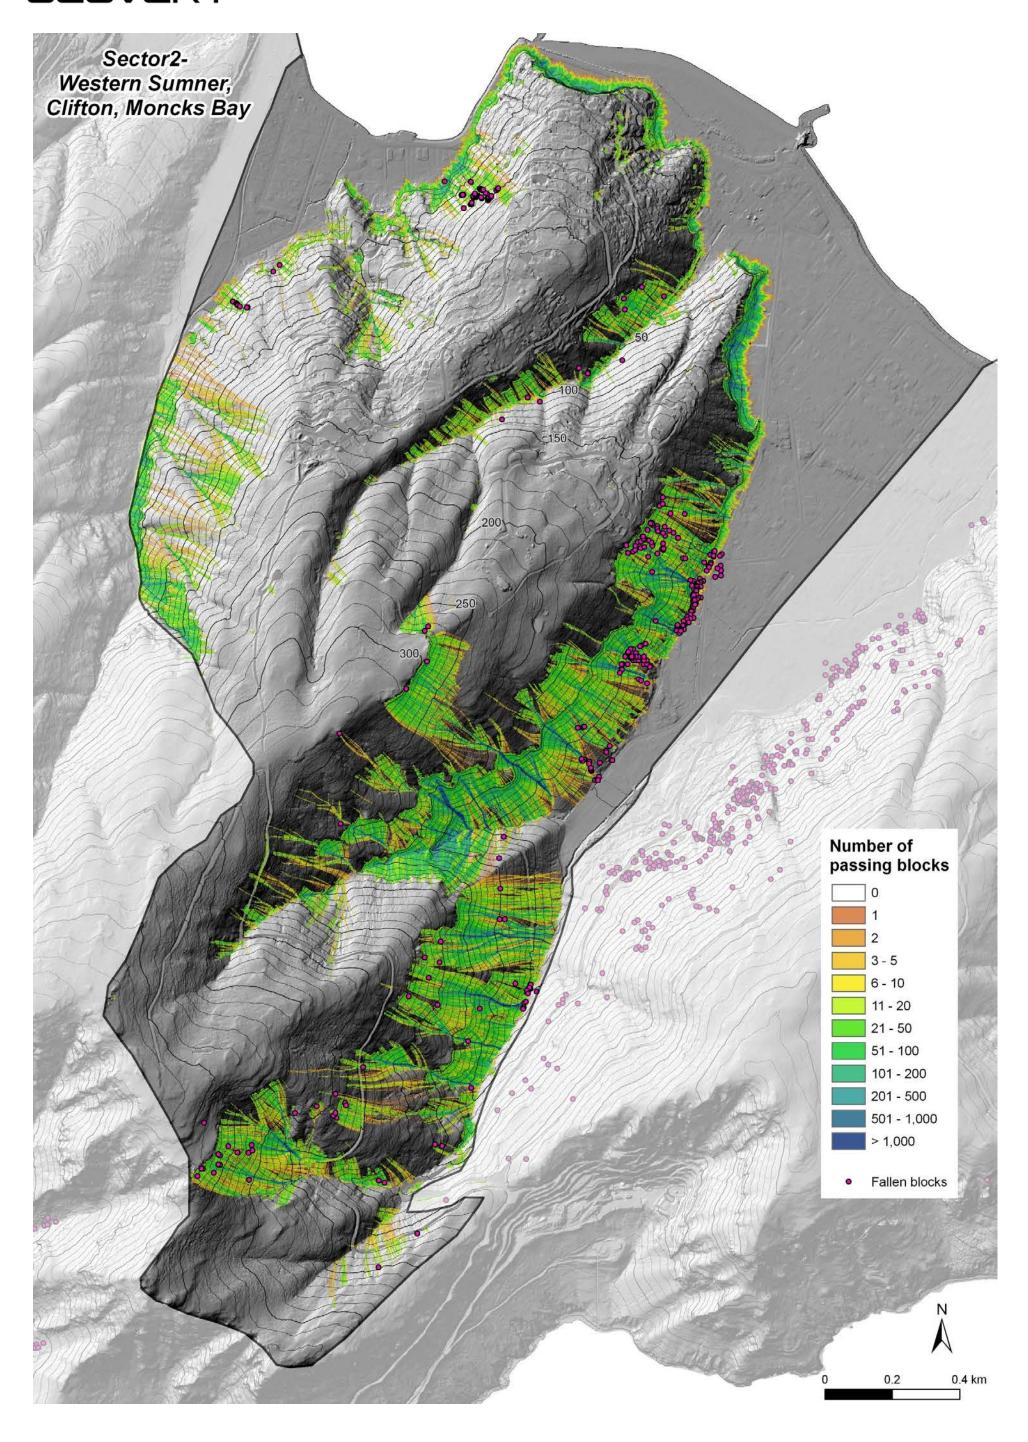
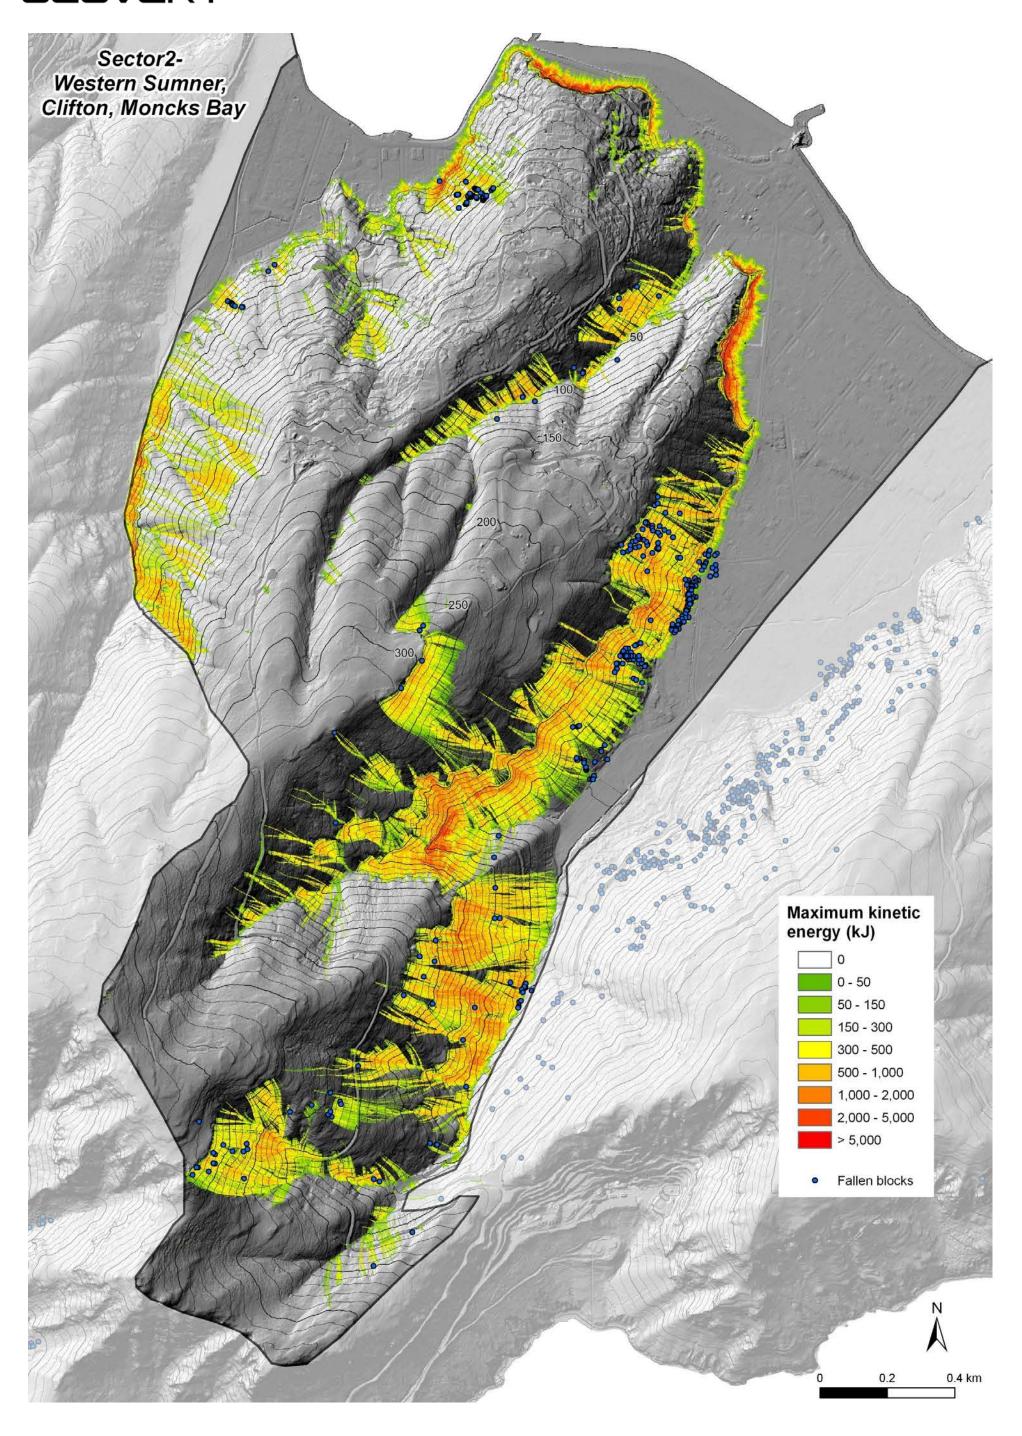
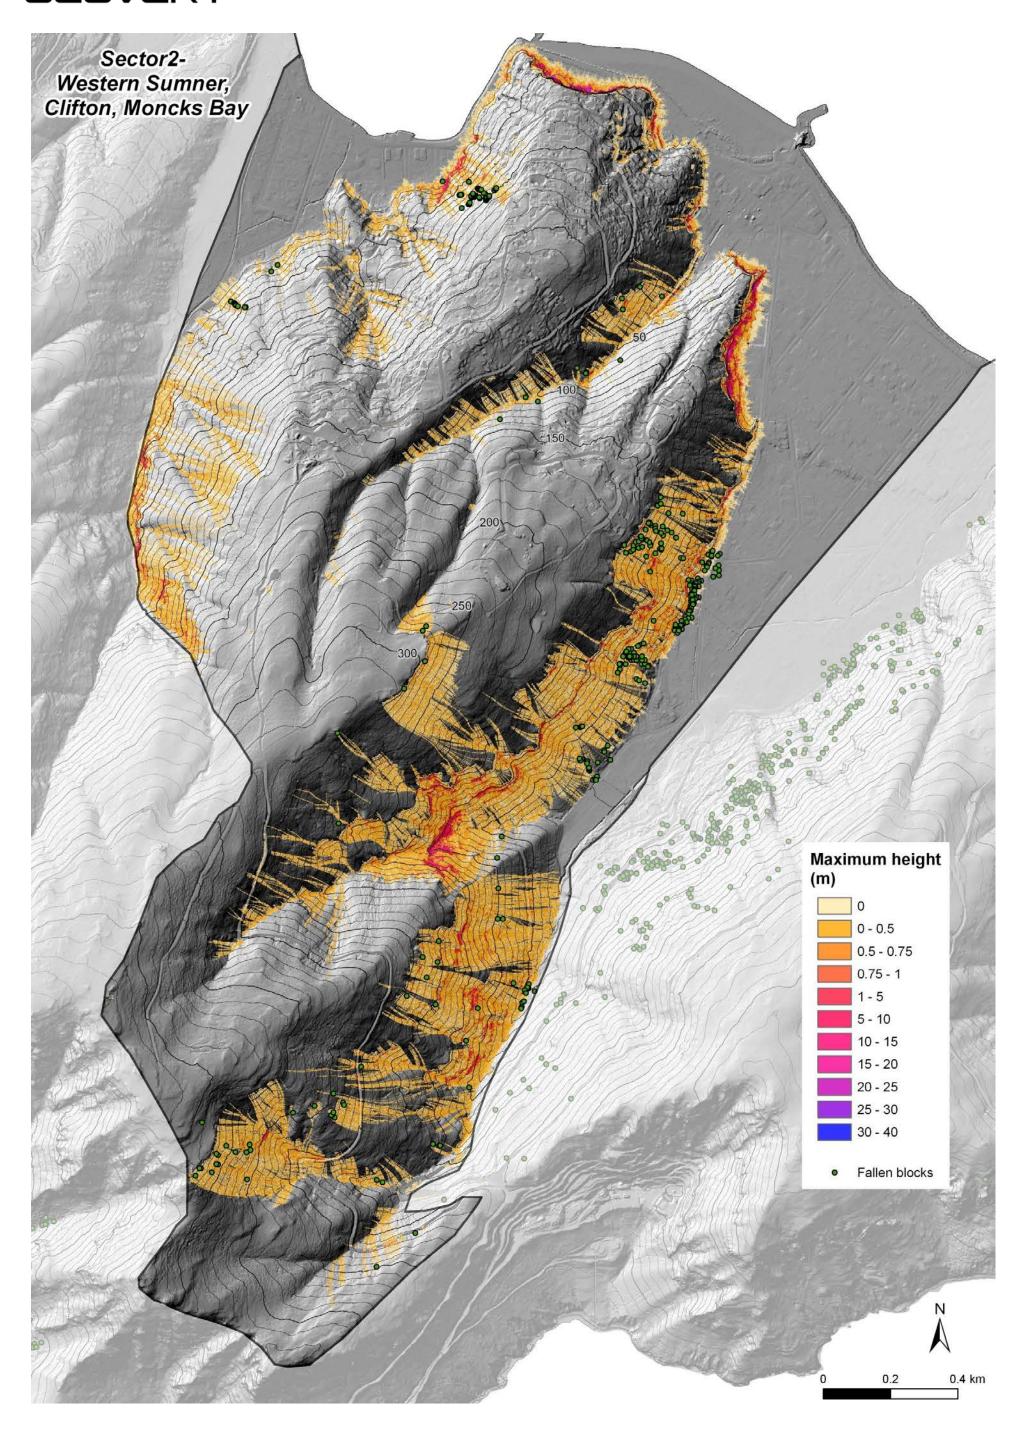
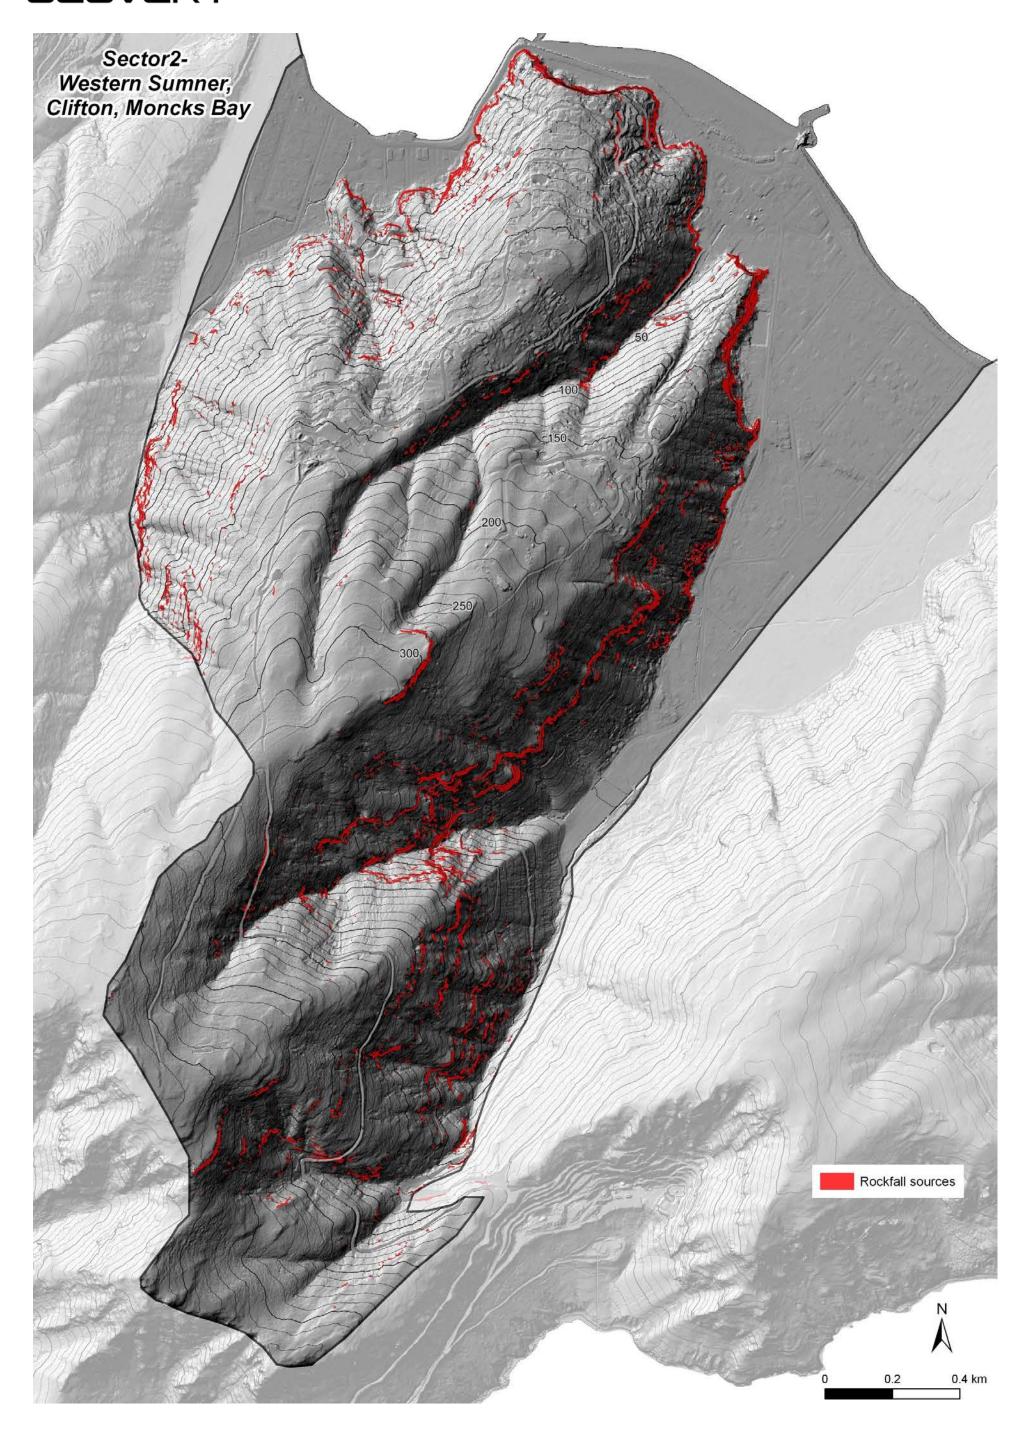
Analysis of the results show that bounce heights nowhere across the study site exceeded 2.0m in height, other than a few areas where they exceed 5m however this is likely the model showing boulders falling over vertical bluffs. The relatively low bounce heights are likely due to the surface conditions and shape of the boulders. While large vegetation has been removed from the model the light vegetation cover, predominantly tussock, contributes to reduced bounce heights.

Impact velocities for Wakefield Ave vary along the length of the study site and range between 100kJ to 2000kJ with one short section of 5000kJ. The highest velocities are recorded around Duncan, Truro and Paisley Streets. For Moncks Bay the highest velocities and bounce heights have been recorded between Cliff Street and Main Road.

An interesting output from the modeling is the extent of gullying that has occurred, that is the amount of boulders which come from multiple or wide source areas and flow into narrow gully features. This can be seen in the Total Number of Boulders image shown below. The gullying has a positive effect on remedial option design as the highest concentrations of boulders occur in very localized areas. Mitigation structures can be located in these areas meaning smaller (shorter) structures, while outside these areas lower levels of treatment, in some cases none, are required. However the effects of these concentrations may impact on design loadings if they occur in short time spans, e.g. following an earthquake.
