## Area-wide geotechnical information summary for CERA zoning review panel

Table 1 – Area-wide geotechnical and engineering considerations for Brooklands to Spencerville

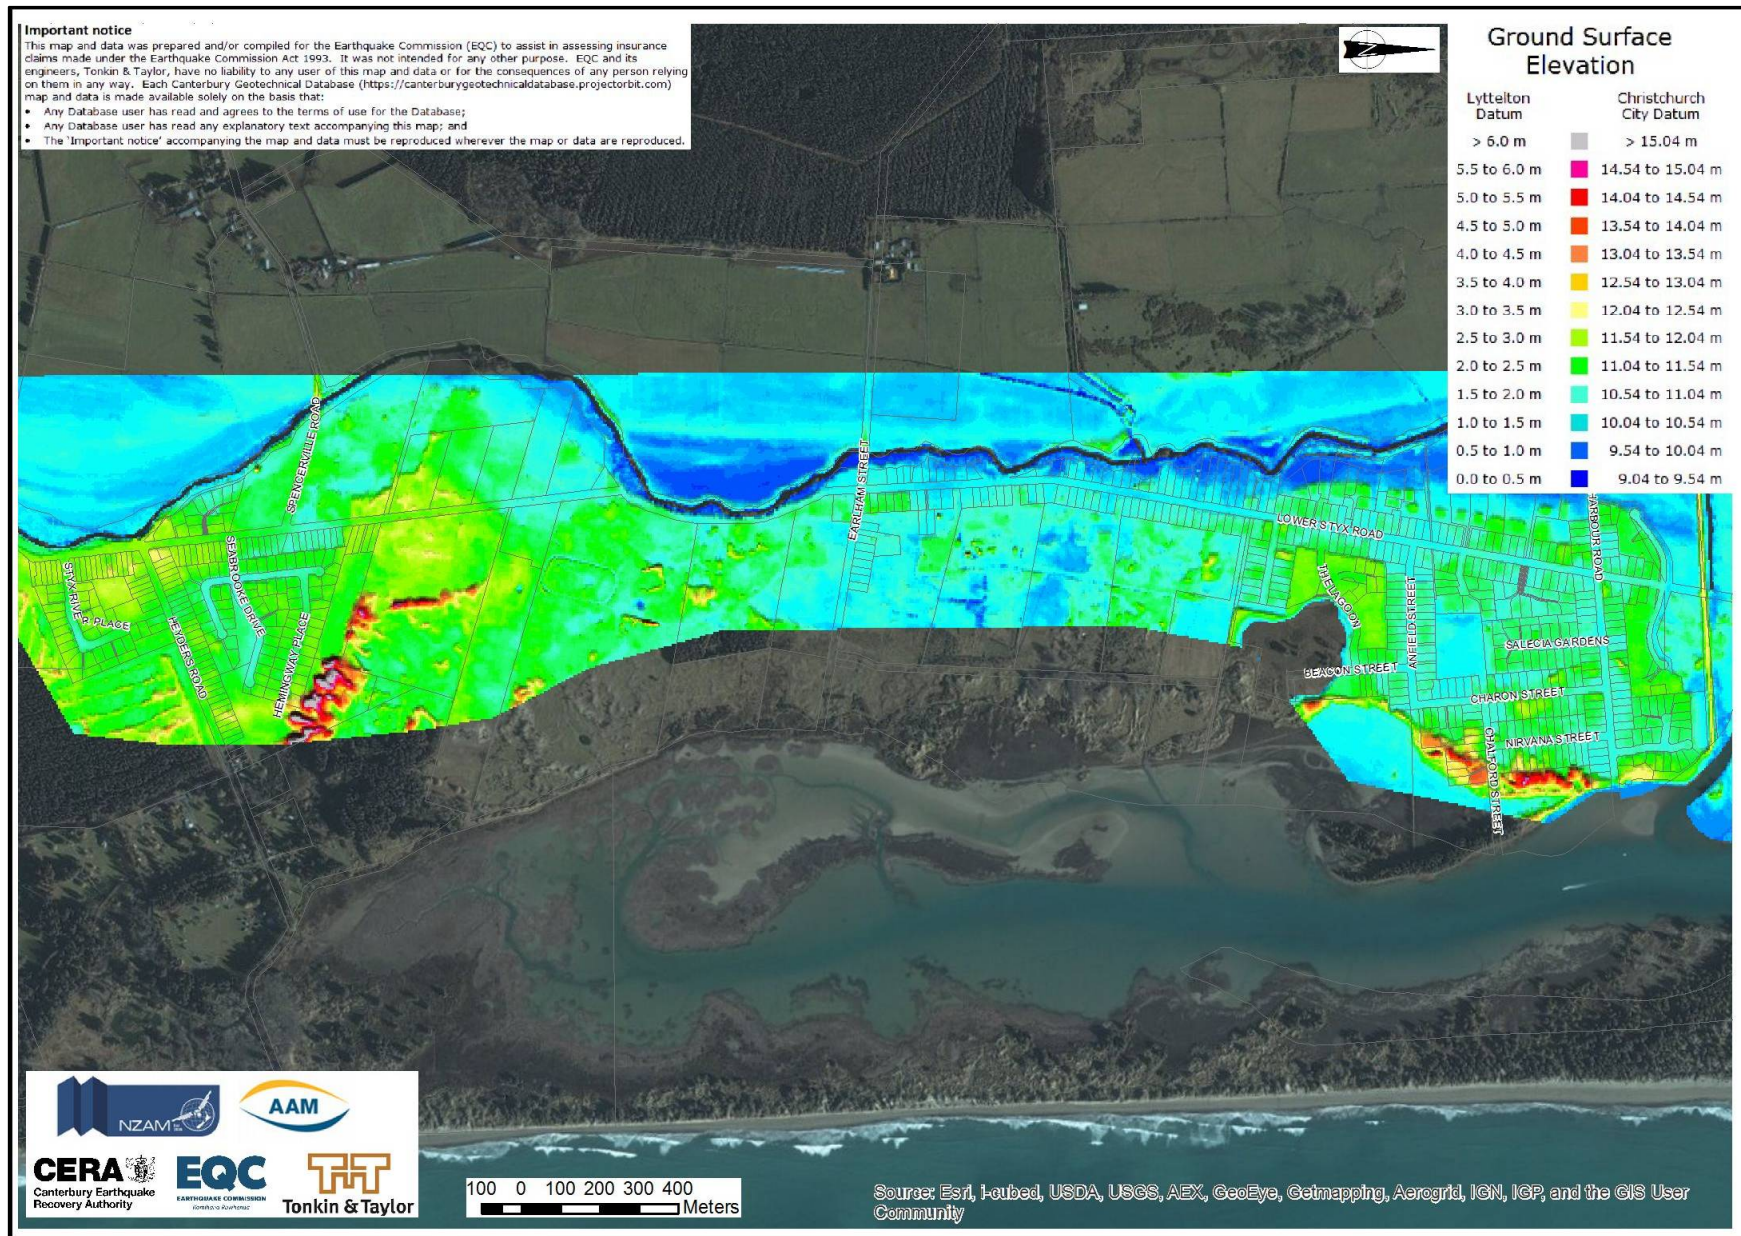
Figure 7 – Ground surface elevation from February 2012 LiDAR survey

**Fig 7** Canterbury Geotechnical Database (2012) "*LiDAR and Digital Elevation Models*", Map Layer CGD0500 - 23 May 2012, retrieved 6 July 2012 from <https://canterburygeotechnicaldatabase.projectorbit.com/>
