Area-wide geotechnical information summary for CERA zoning review panel

Table 1 – Area-wide geotechnical and engineering considerations for South New Brighton

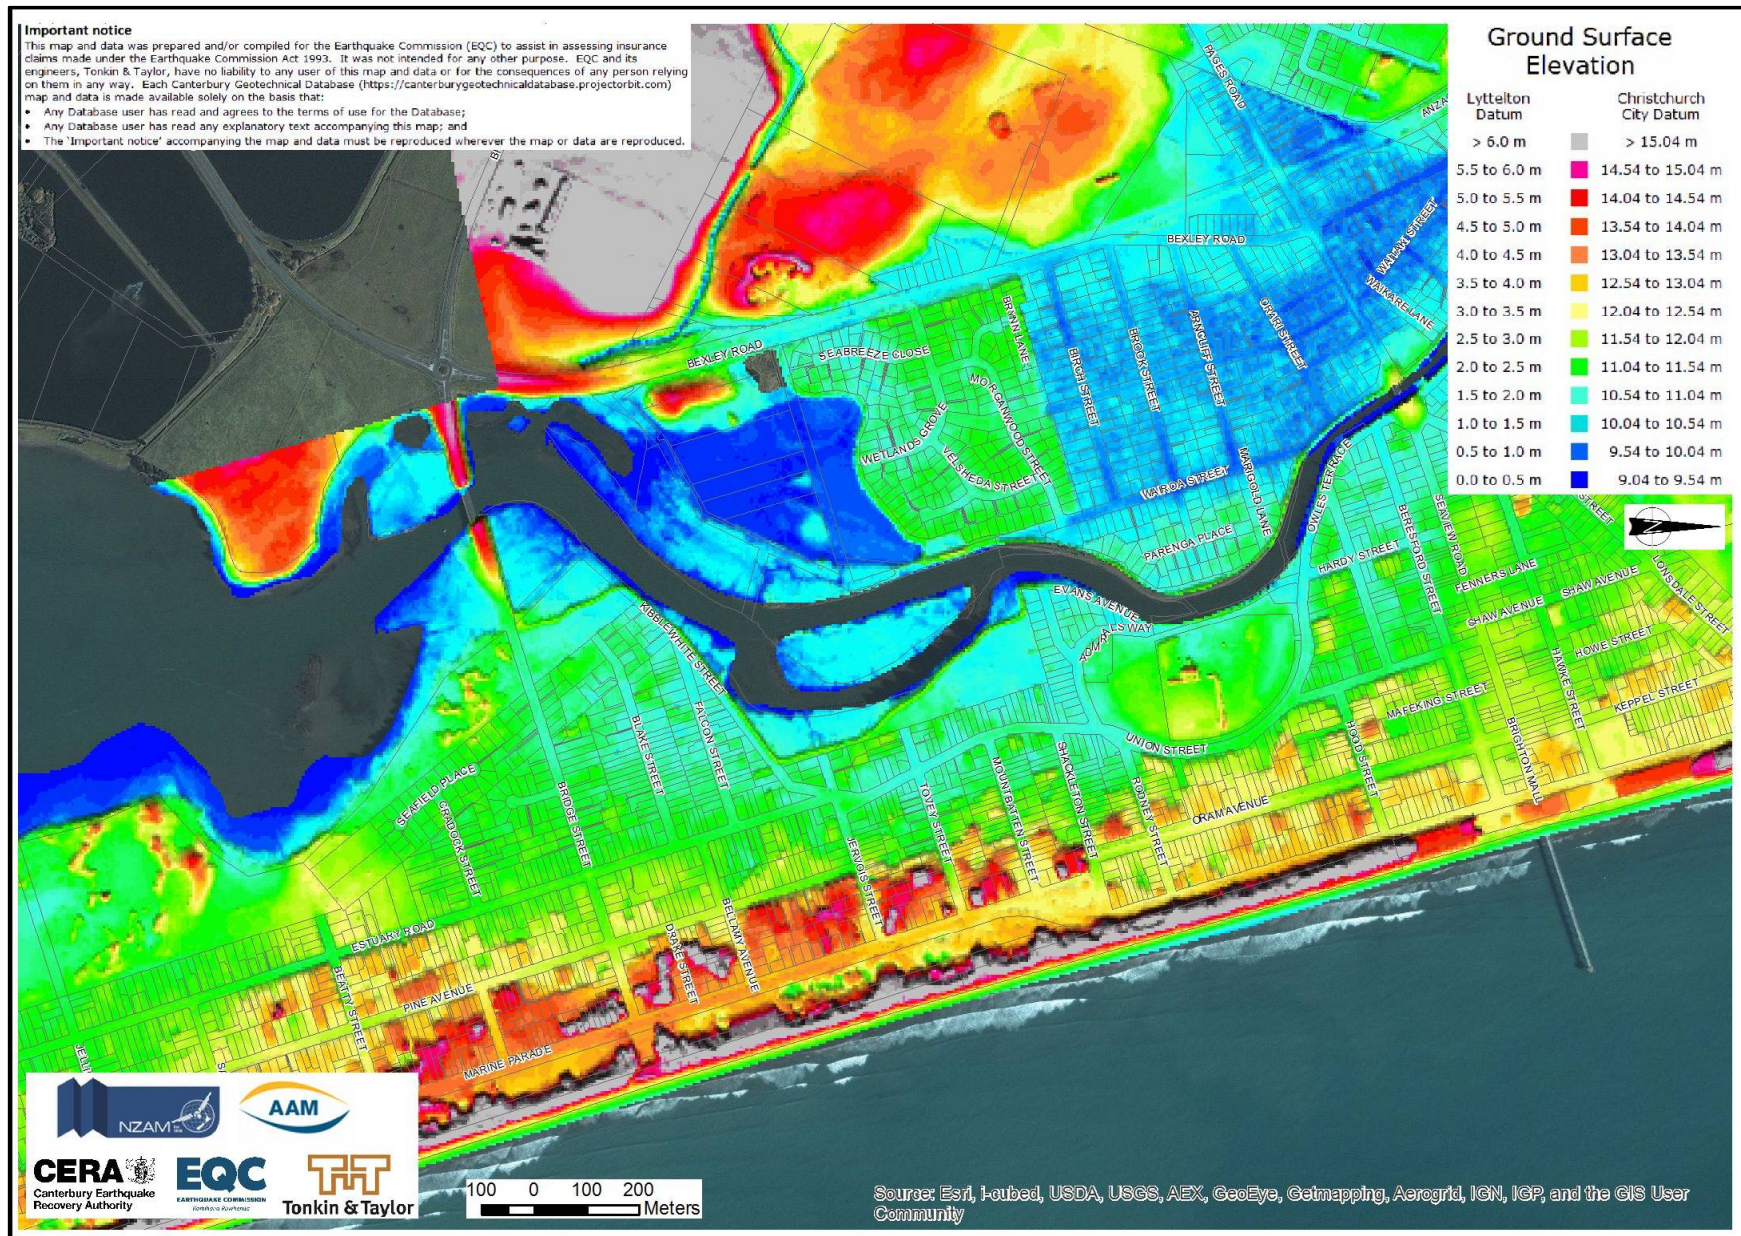
Figure 7 – Ground surface elevation from February 2012 LiDAR survey

Fig 7 Canterbury Geotechnical Database (2012) "*LiDAR and Digital Elevation Models*", Map Layer CGD0500 - 23 May 2012, retrieved 6 July 2012 from <https://canterburygeotechnicaldatabase.projectorbit.com/>
