APPENDIX 5: THE STABILISATION AND REINSTATEMENT OF THE CATHEDRAL – CONCEPT REVIEW

ChristChurch Cathedral Working Group

The Stabilisation and Reinstatement of the Cathedral – Concept Review

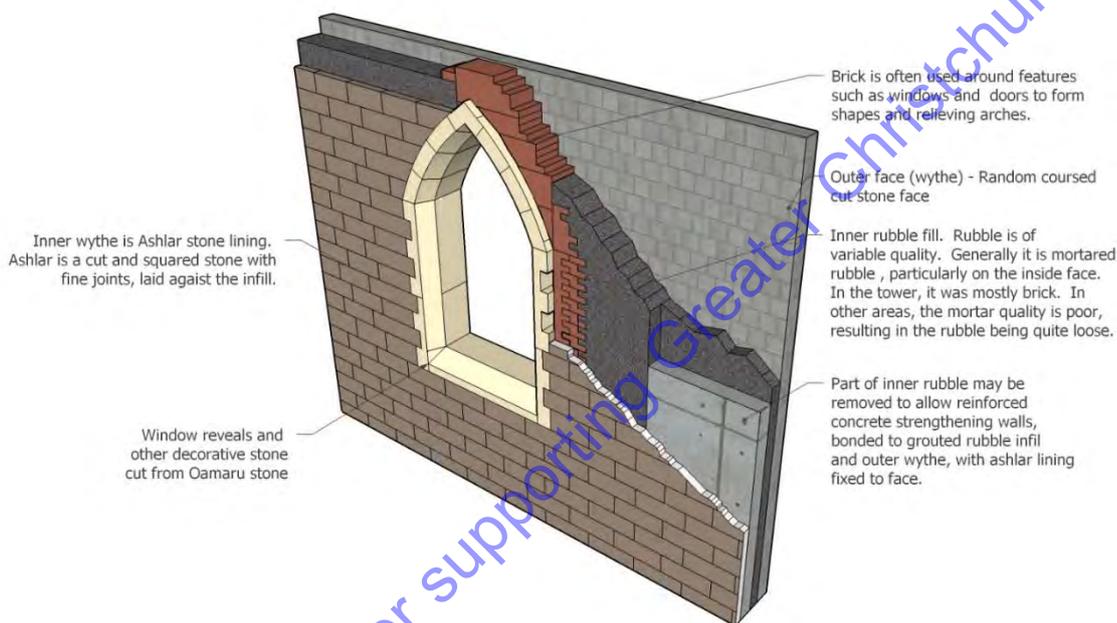
Figure 2: Typical Cathedral wall construction (from Dean report)

The existing walls were constructed using traditional masonry techniques of the time. Inner and outer wythes of cut stone were mortared into place and the gap between was filled with a weakly cemented random rubble infill. Some header elements were included in the wall as construction proceeded, linking the inner and outer wythes. Under strong seismic actions, this form of masonry is prone to brittle failure.
