Appendix D – Sector 4 Modeling Results

Sector 4 Mount Pleasant

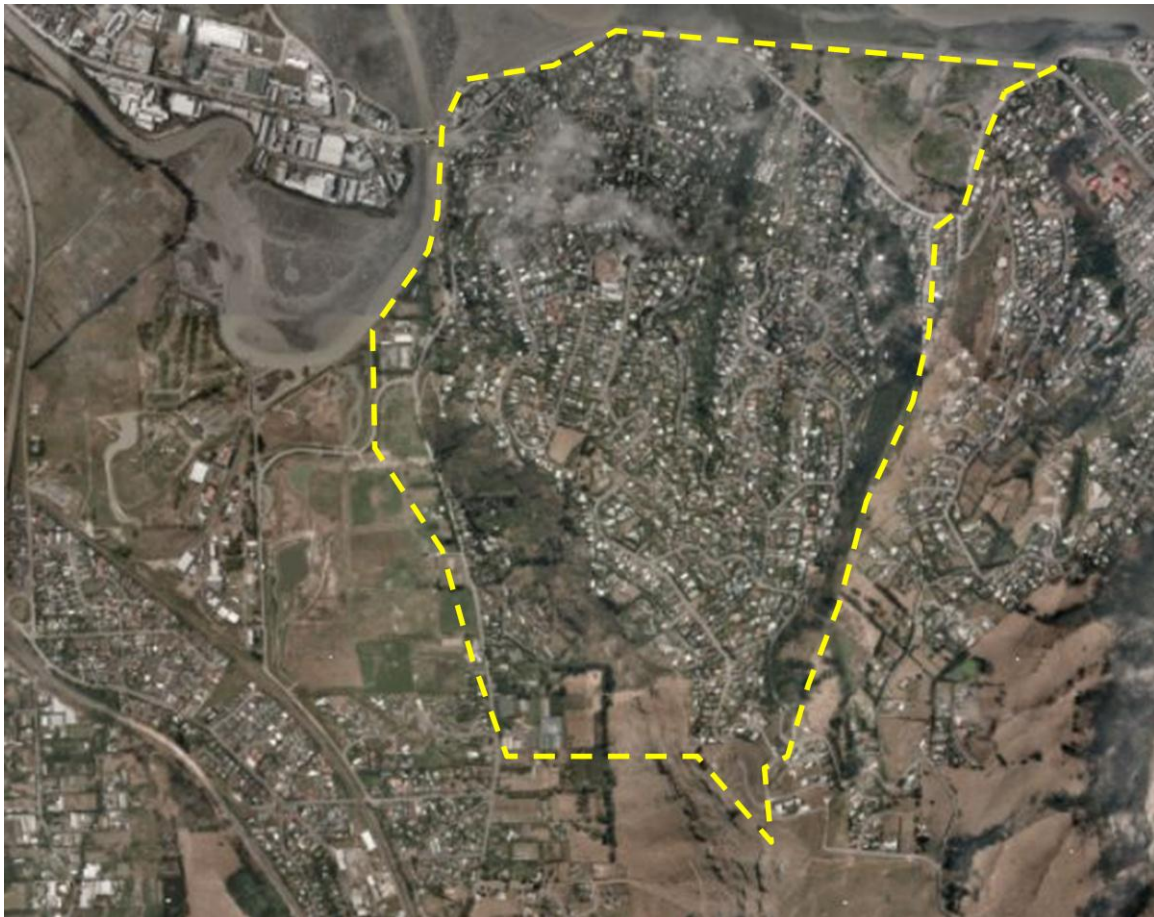
Figure 1 - Sector 4 site location showing the study area within yellow outline

The area considered in this report is shown in Figure 1 below, an area in excess of 2.5km².
