Port Hills White Zone – Cliff Collapse/Debris Inundation and Landslips- Context

Port Hills White Zone – Cliff Collapse/Debris Inundation and Landslips

Port Hills White Zone – Rock Roll

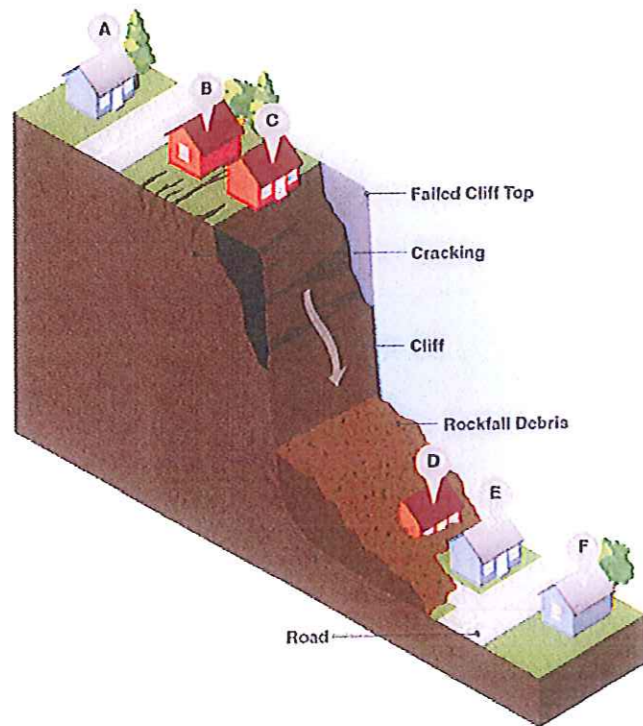
Cliff Collapse/ Debris Inundation Graphic and Legend

House	Description
C	<ul style="list-style-type: none"> • Significant land damage • Life-safety risk • High risk of further collapse • Not economically viable or practical to remediate • Group 1
D	<ul style="list-style-type: none"> • Inundated by debris • Life-safety risk • Not economically viable or practical to remediate • Group 1
B	<ul style="list-style-type: none"> • Land cracking associated with cliff collapse • No significant life-safety risks • Likely restrictions on further building • Group 2- GREEN Zone
E	<ul style="list-style-type: none"> • Little or no land damage now • No significant life-safety risk • Low risk of inundation from further events • Group 2- GREEN Zone
A	<ul style="list-style-type: none"> • Some or minor land damage • Little risk of further land damage • GREEN Zone
F	<ul style="list-style-type: none"> • No land damage, and not directly exposed to risk • GREEN Zone

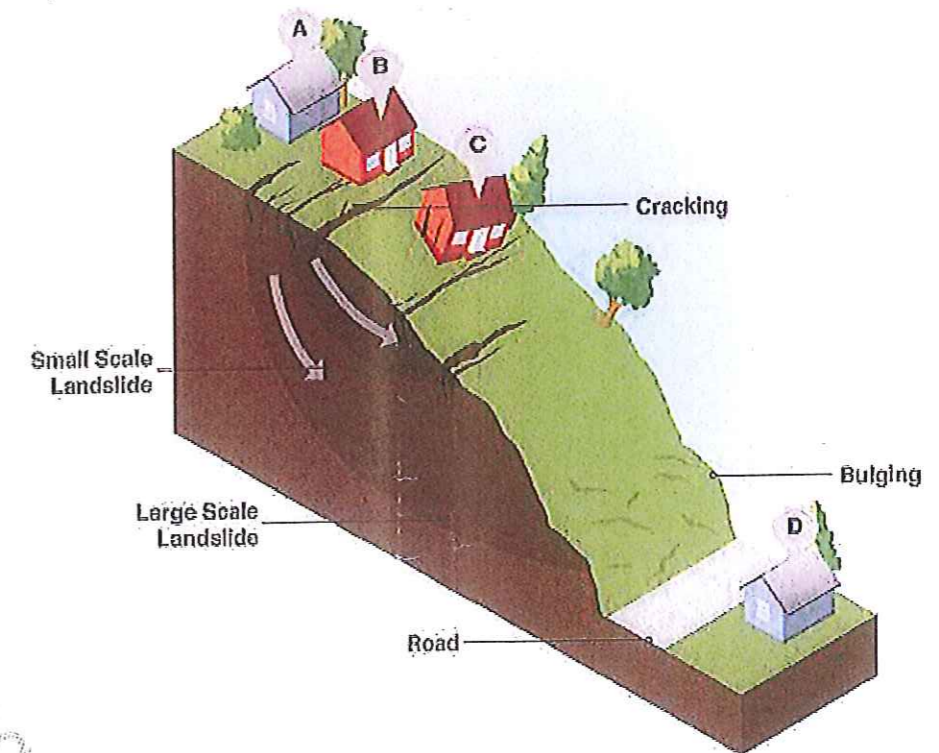
Landslip Graphic

There are 16 major landslips in the White Zone

- 5 are connected with cliff collapse/debris inundation areas (life risk)
- 1 is separate from cliff collapse/debris inundation areas (life risk) and may require a separate response (straddles Green and White Zone)
- The remaining 10 could potentially be green zoned, but further monitoring, detailed investigation and mapping will be necessary; approximately 340-360 buildings are within the area of these landslips, of which 85-110 may be badly damaged.
- There are outstanding issues with those landslip properties that have significant building or land damage given the potential comparison with cliff collapse/debris inundation-affected properties

Description of Sites	Number of Sites (16 in total)
Connected with cliff collapse/debris inundation areas	5
Can likely be green zoned (little land or building damaged observed)	1
May be possible to green zone, but more investigation required (potential life safety impact, or land damage suggests building consents may not be available)	10

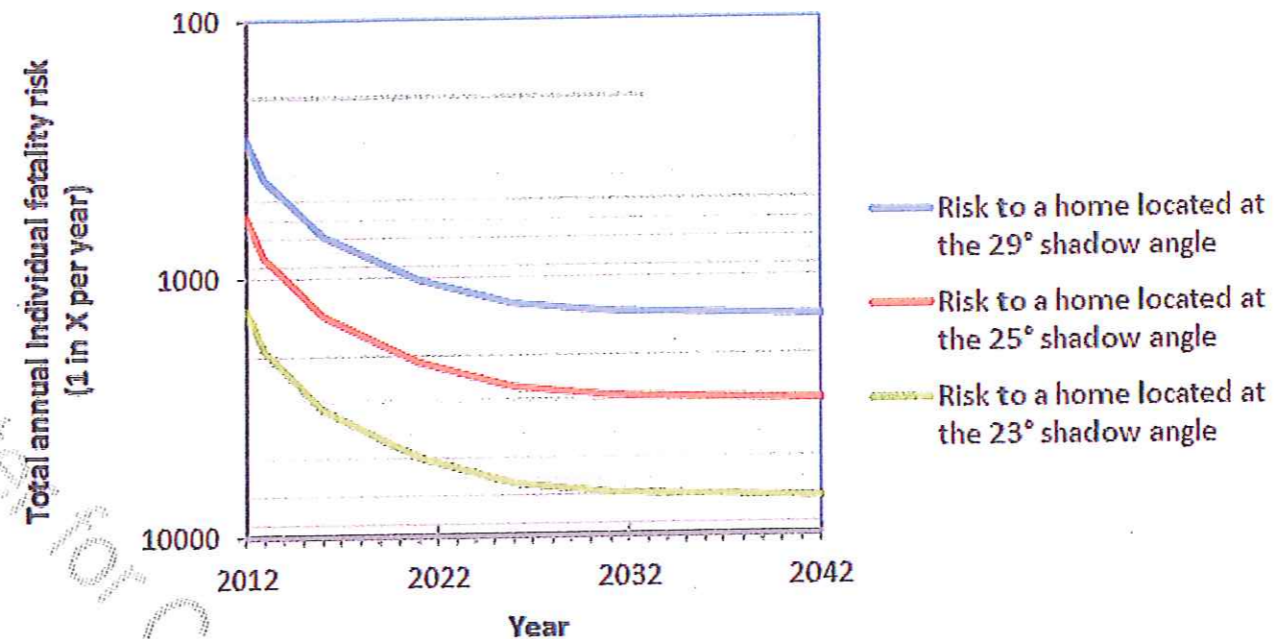
Risk levels decrease over time

- Rock roll risk will decrease over time as seismic activity reduces, further seismic events would interrupt trend
- Model assumptions and uncertainty
 - Scale factor of 1.2 to allow for unmapped boulders and rock masses having been broken and disturbed by the earthquakes
 - 0.67 occupancy ie an average person will spend 16/24 hours per day at home
 - GNS estimates uncertainties on the AIFR modelling at about an order of magnitude (factor of 10) in either direction
