100 Cathedral Square – Christchurch Cathedral

CHRISTCHURCH CATHEDRAL STRENGTHENING

106324 Damage
Report.pdf

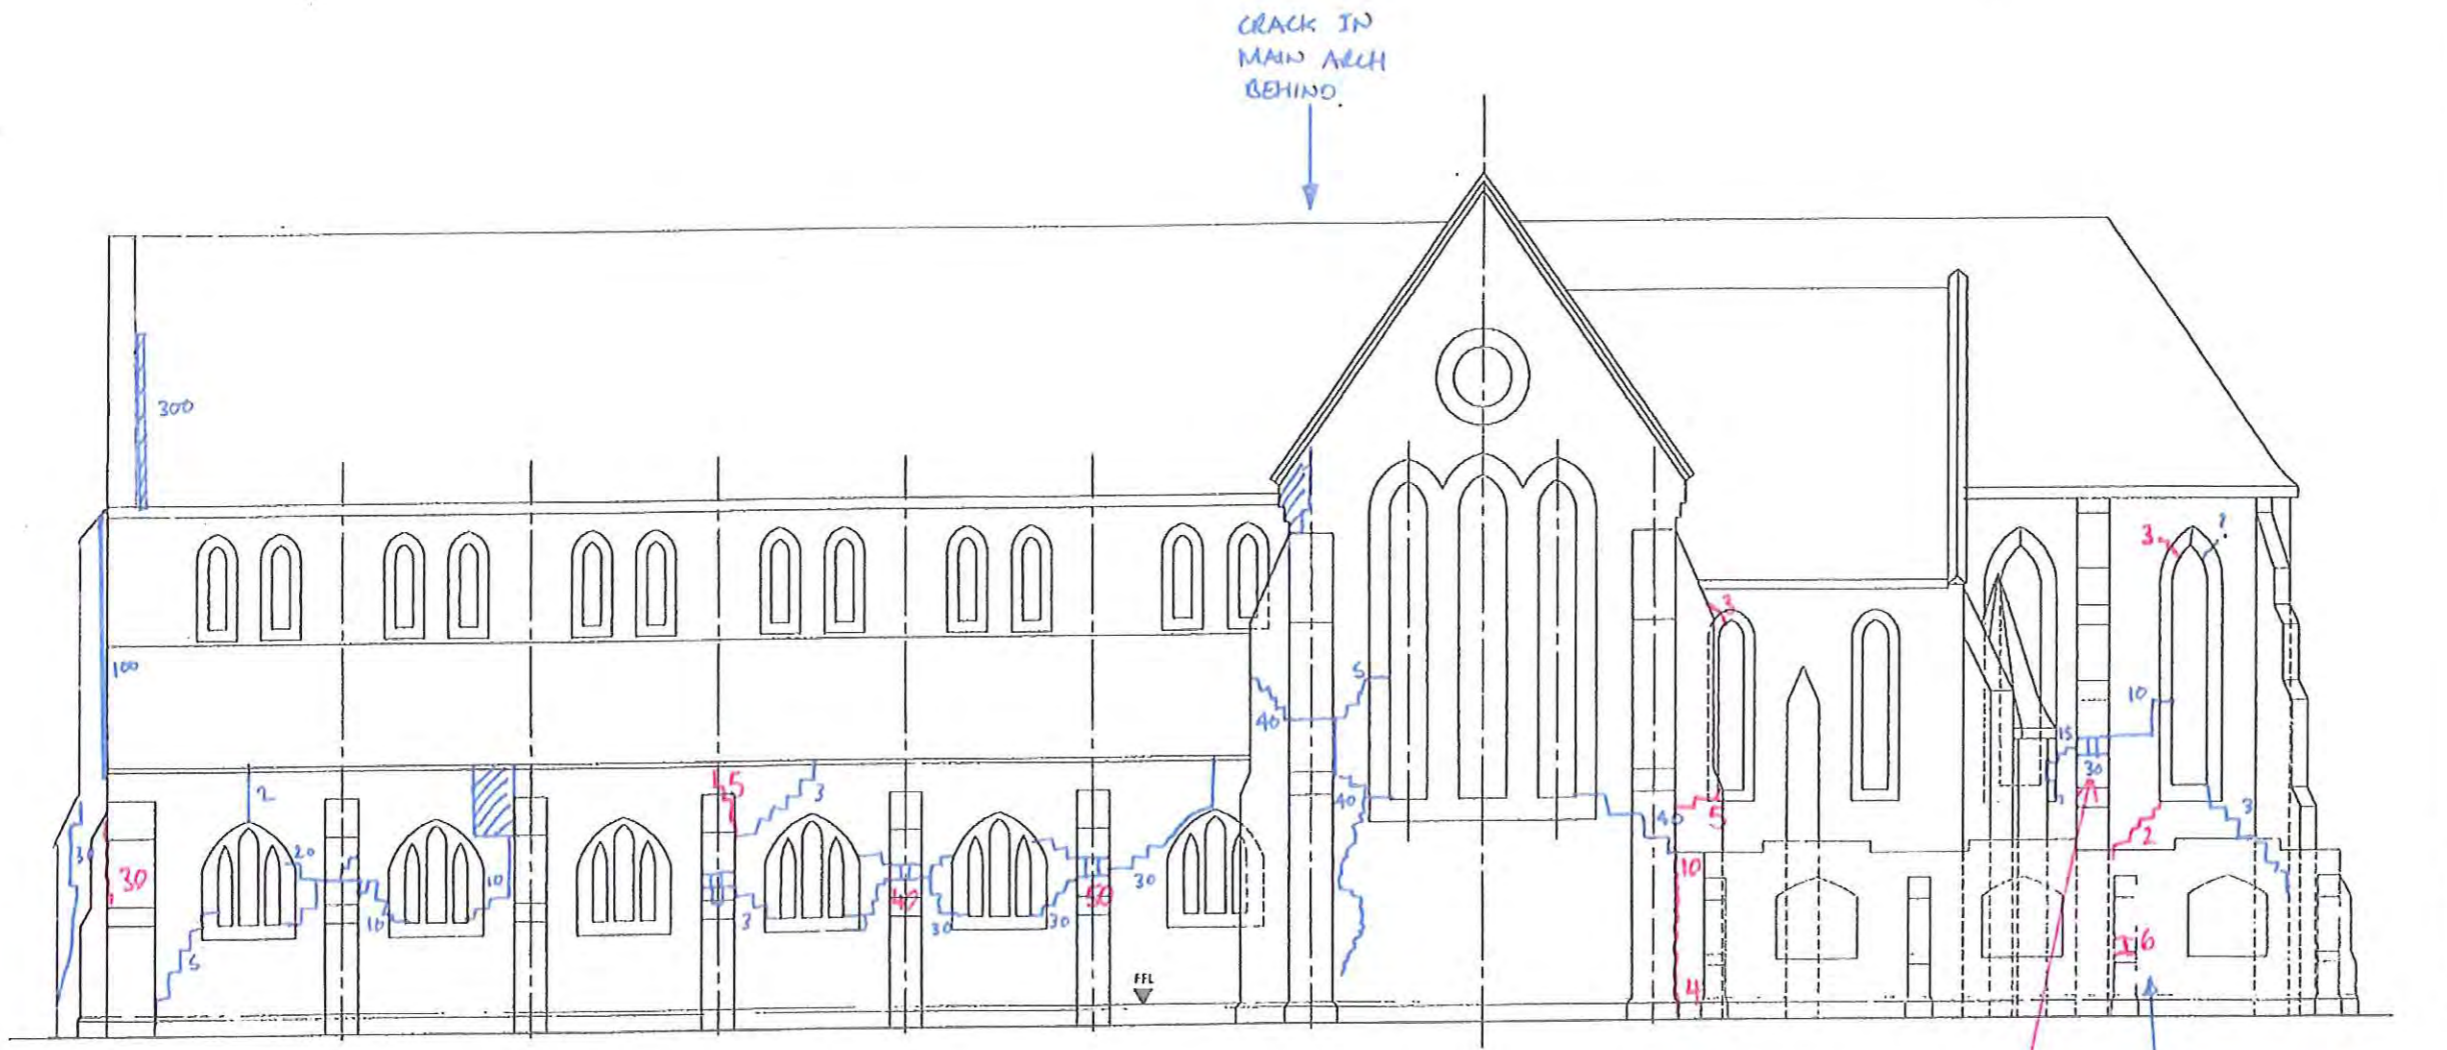
south elevation

EXTERNAL DAMAGE SURVEY 22/3/11
 SYO LIMITED TO GROUND OBSERVATION
 EXTERNAL DAMAGE SURVEY 24/6/11
